**Rose Creek Watershed Opportunities Assessment
HYDROLOGIC MODIFICATIONS
TECHNICAL MEMORANDUM**

Prepared For:
San Diego Earthworks

Prepared By:
KTU+A

Date:
April 27, 2005

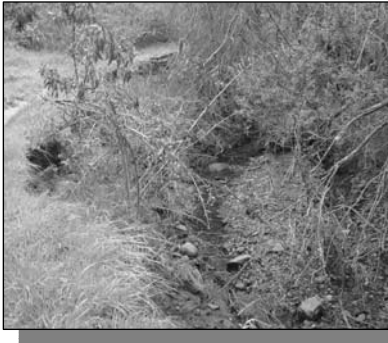
Figure 1: Eroding streambank and bed in Lakehurst channel

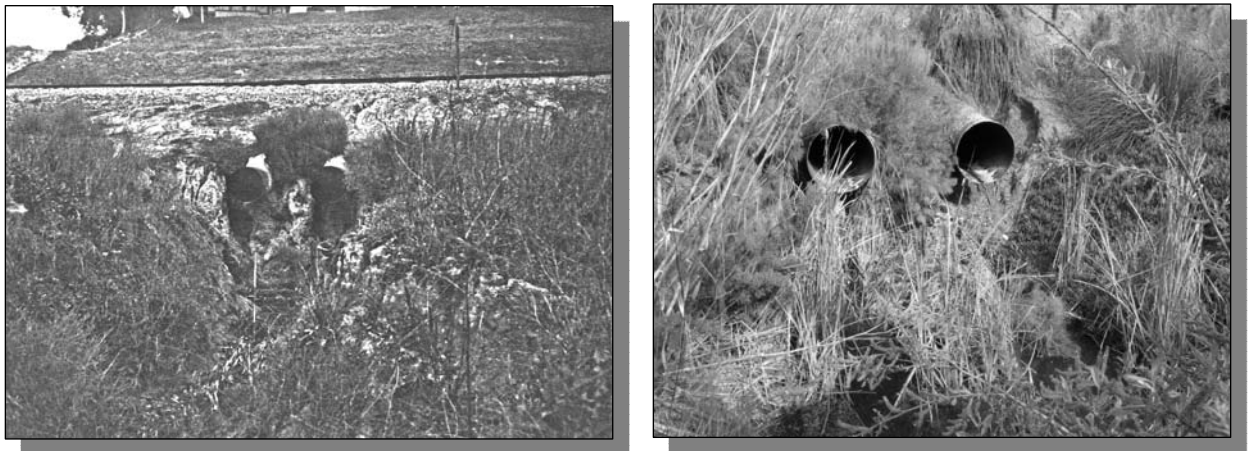
Figure 19: Comparison of 1986 and 2005 field photography of site RC-07

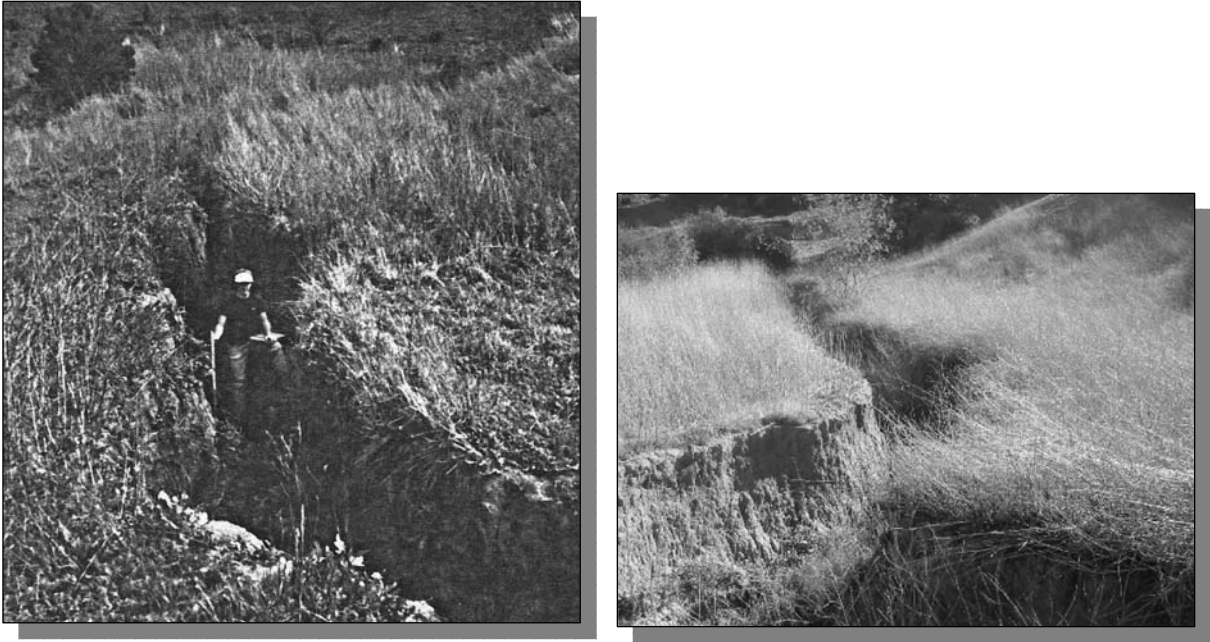
Figure 20: Comparison of 1986 and 2005 field photography of site RC-10

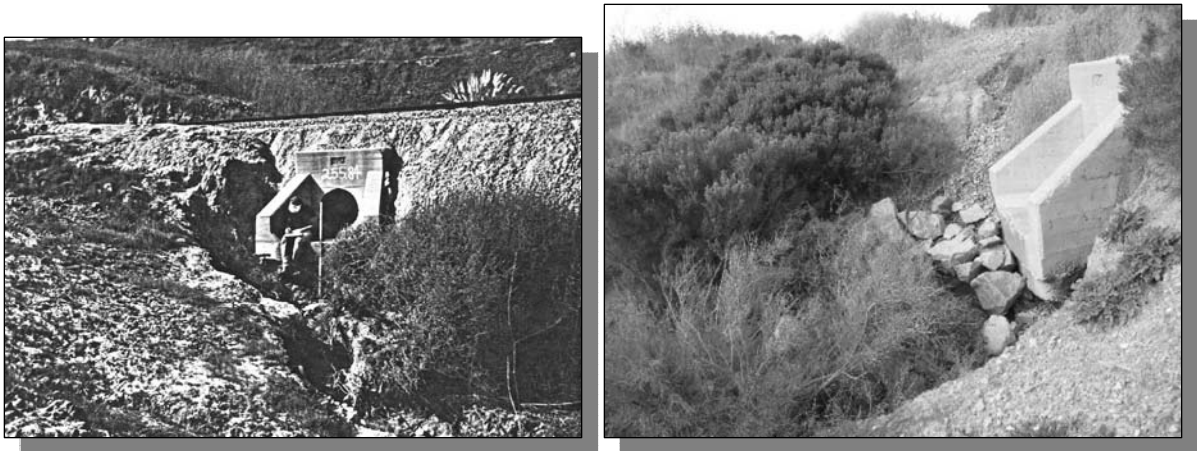
Figure 21: Comparison of 1986 and 2005 field photography of site RC-11

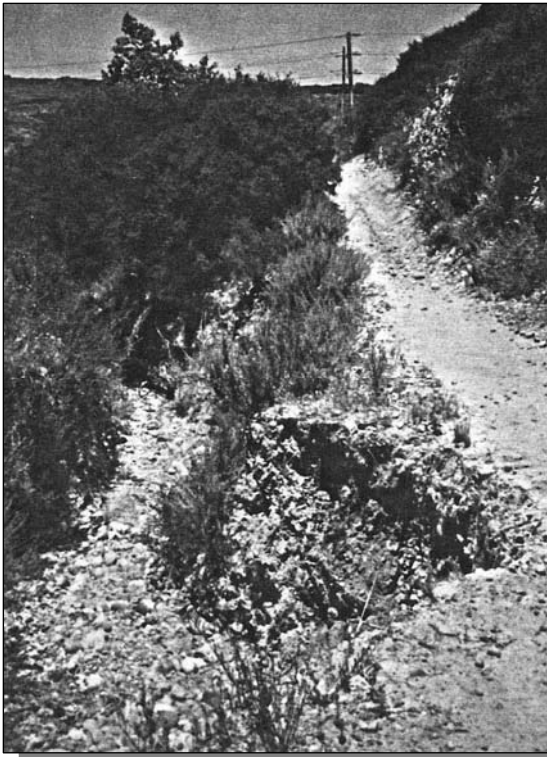
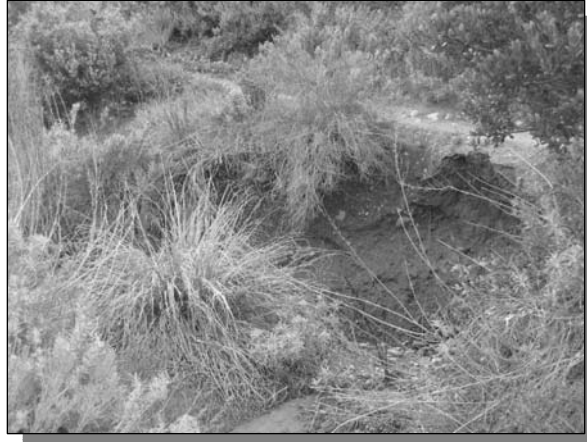
Figure 22: Comparison of 1986 and 2005 field photography of site RC-24

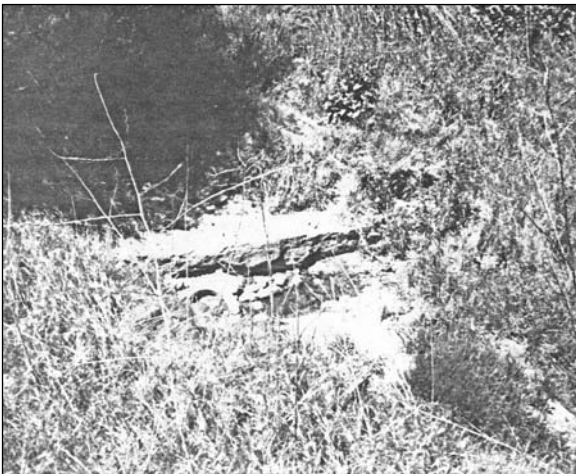
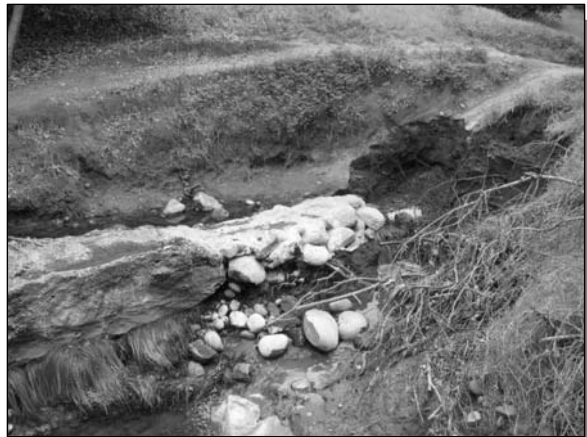
Figure 23: Comparison of 1986 and 2005 field photography at site SC-16

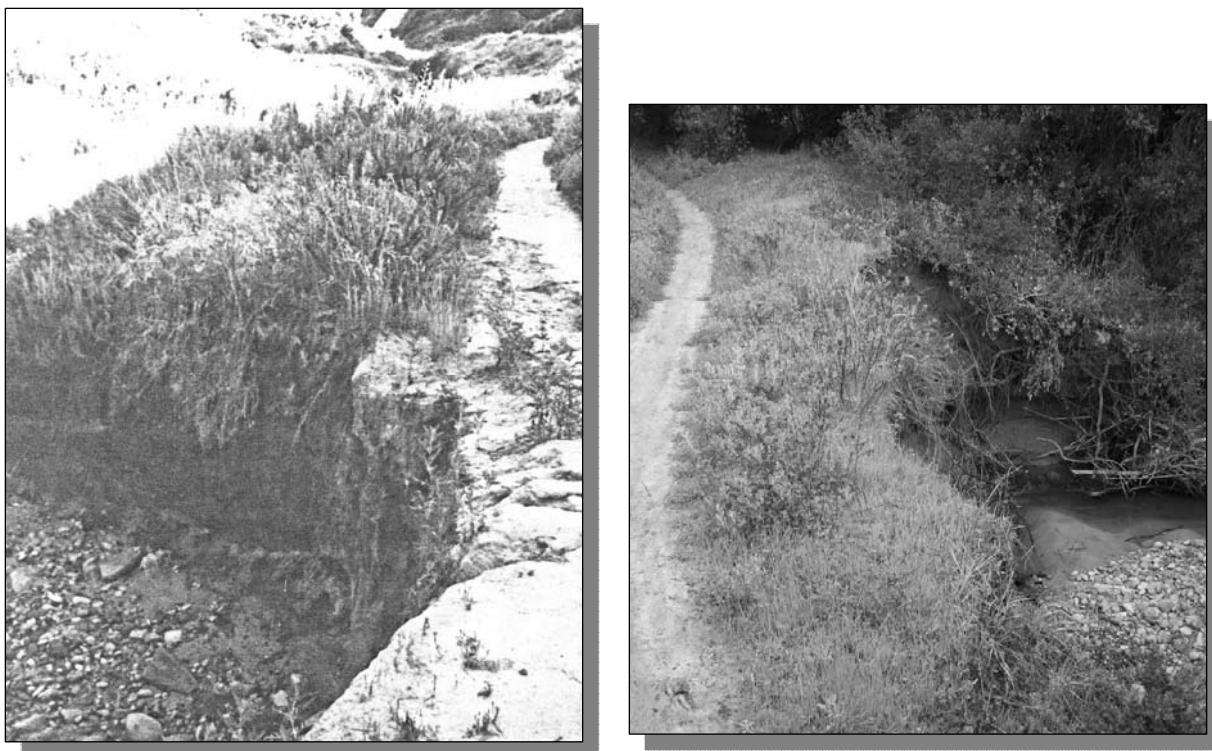
Figure 24: Comparison of 1986 and 2005 field photography at site SC-28

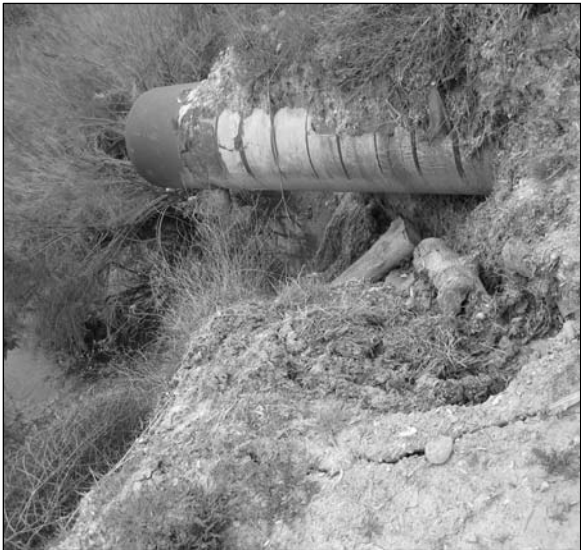
Figure 26: Eroded culvert in Rose Canyon

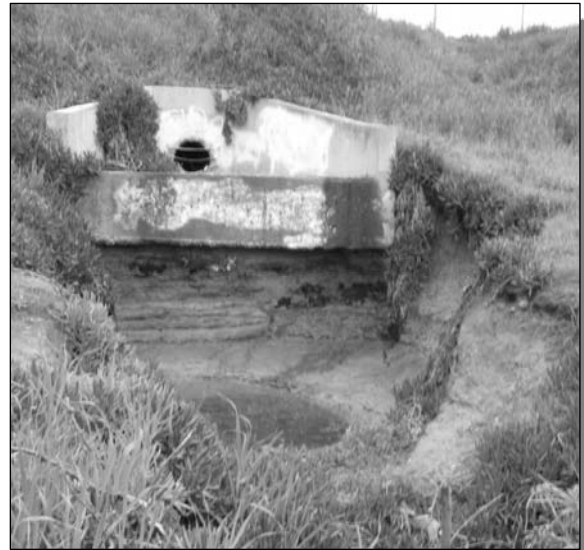
Figure 27: Eroded outfall in tributary canyon below elementary school

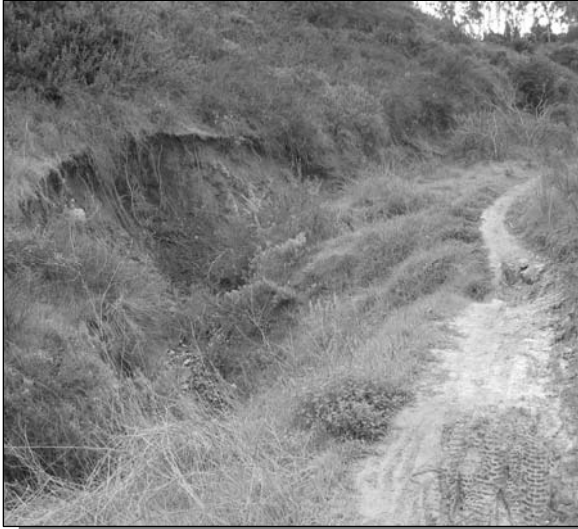
Figure 28: Erosion downstream of storm drain outfall in tributary to Rose Canyon

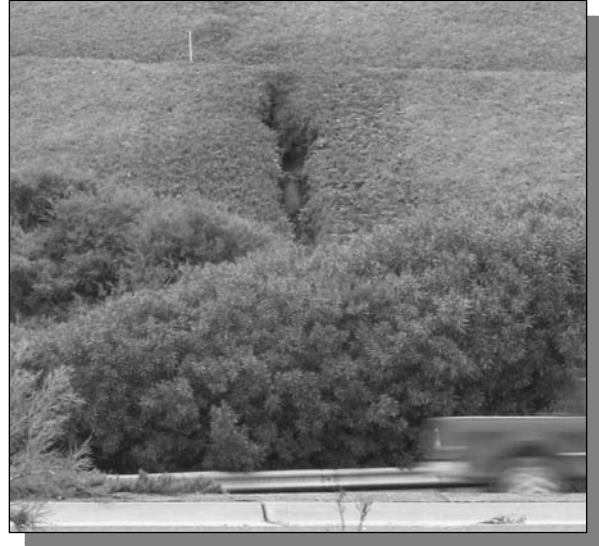
Figure 29: Storm drain related gully erosion along Interstate 5

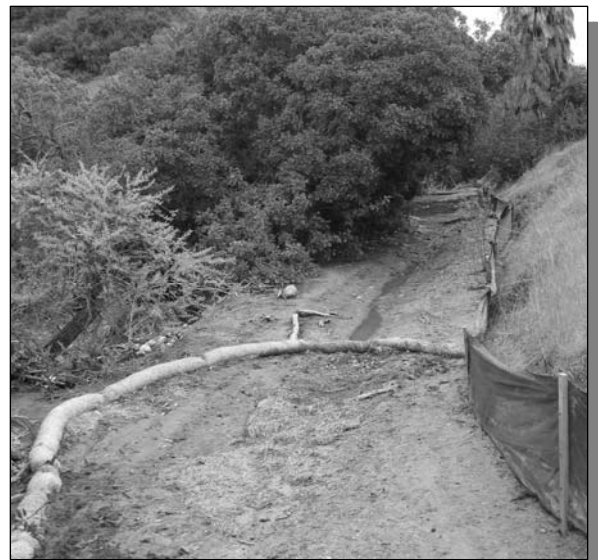
Figure 31: Sewer access road erosion and corrective best management practices below storm drain outfall

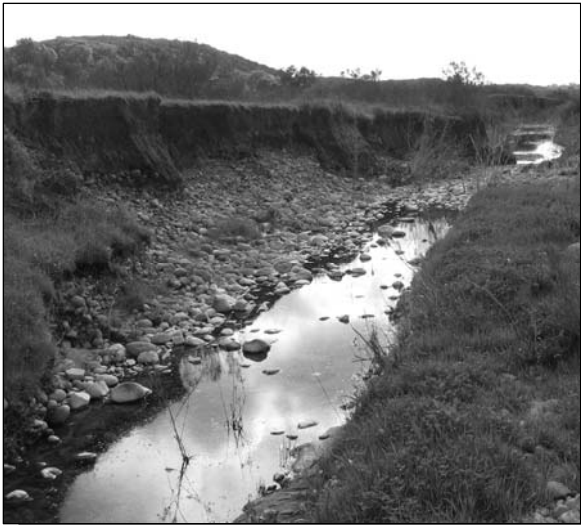
Figure 32: Active bank erosion upstream of Interstate 805 in Rose Canyon

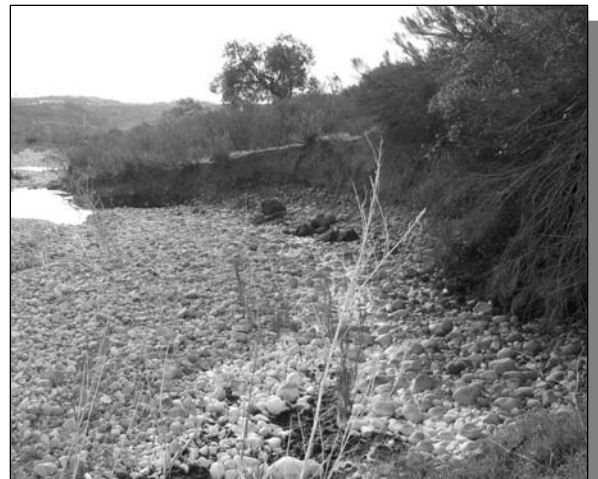
Figure 33: Active bank erosion on outer bend upstream of Interstate 805 in Rose Canyon

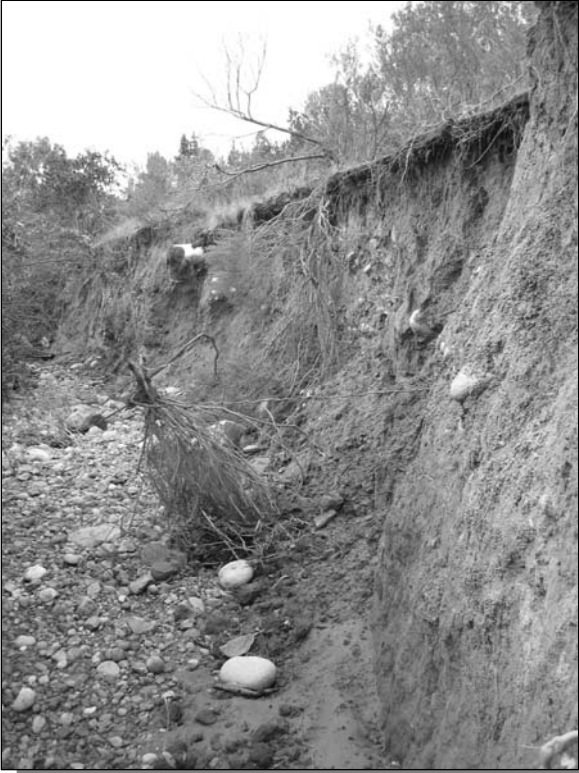
Figure 34: Active bank erosion in Stevenson Canyon

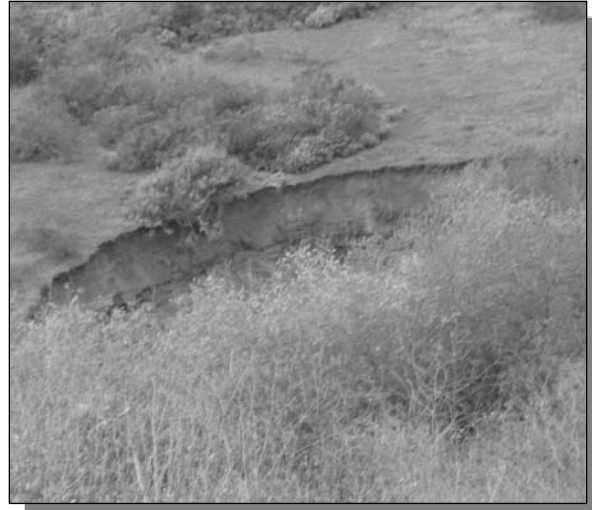
Figure 35: Active bank erosion in Gilman Canyon

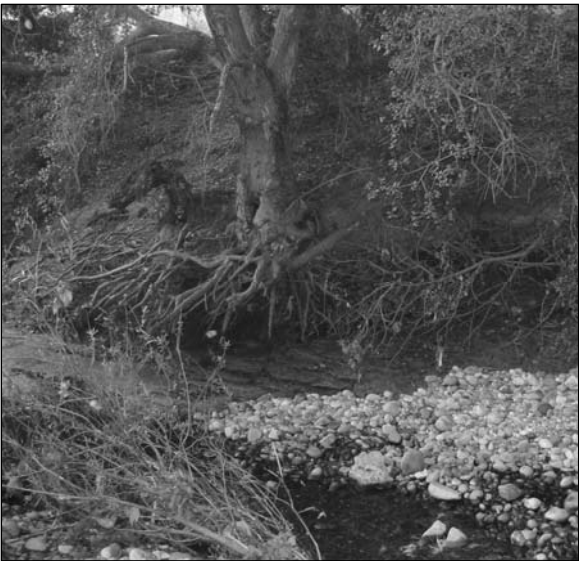
Figure 36: Streambank undercutting and exposing Oak tree roots in Rose Canyon

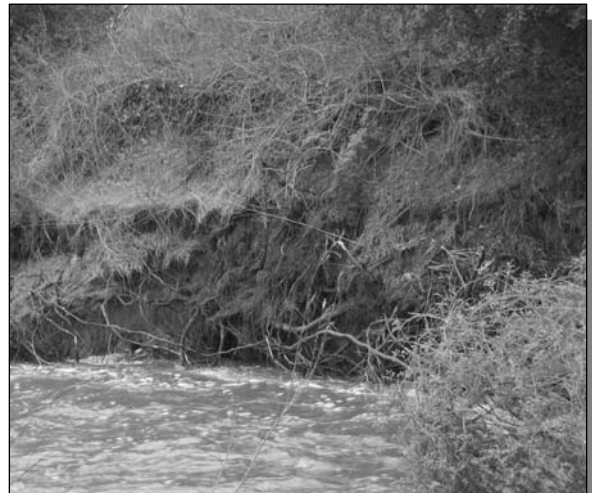
Figure 37: Active bank erosion during storm flows below confluence

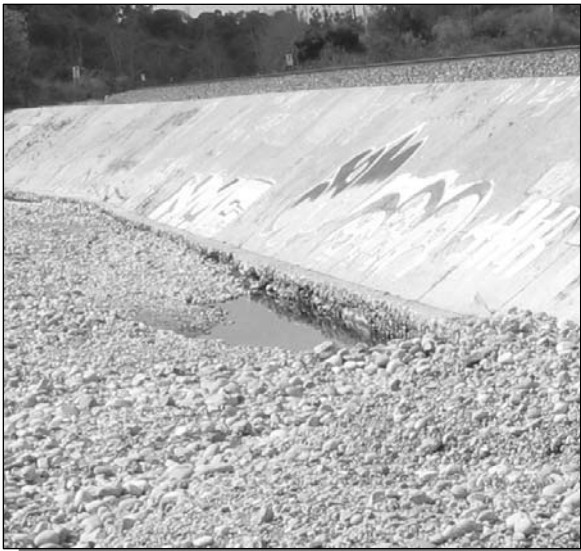
Figure 38: Streambed erosion undercutting concrete bank protection along railroad tracks in Rose Canyon

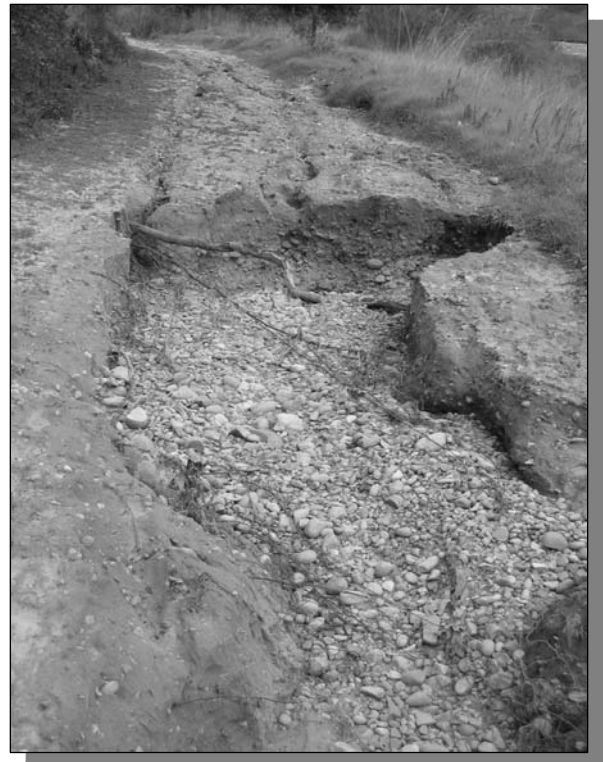
Figure 39: Streambed scour hole along tributary drainage that double as access road in Rose Canyon

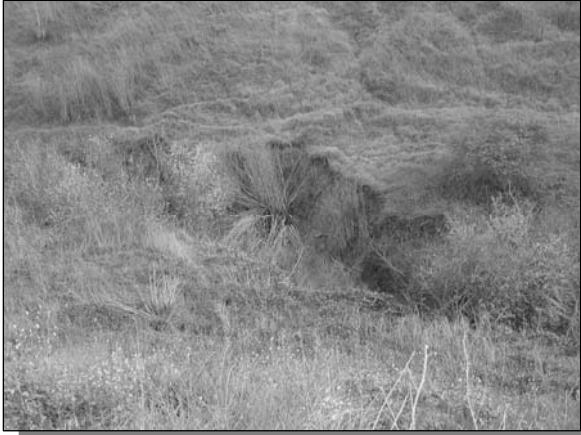
Figure 40: Tributary drainage along Rose Canyon that has experienced significant down-cutting (10-15ft) over the past 40 years

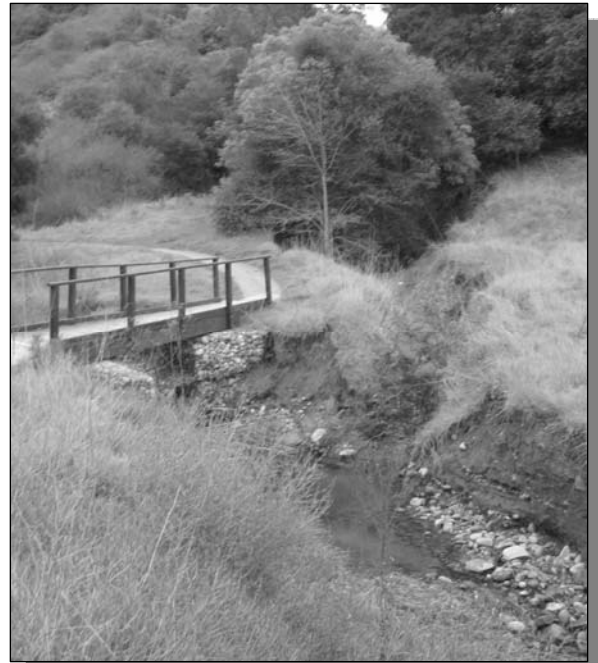
Figure 41: Tributary drainage along San Clemente Canyon that has down-cut 4-6ft over the past 40 years

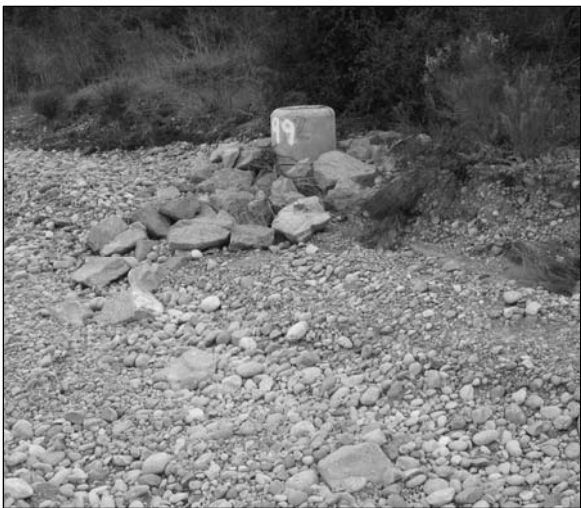
Figure 42: Streambed erosion threatened sewer manhole that is now protected with riprap in Rose Canyon

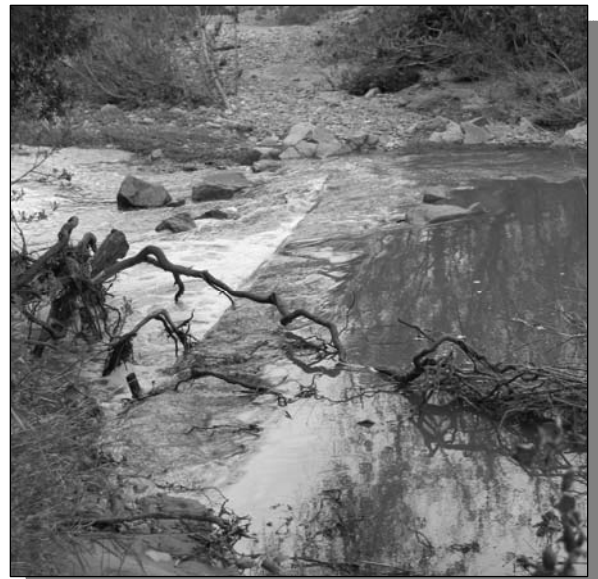
Figure 43: Concrete protect sewer main crossing Rose Creek below confluence being exposed by streambed erosion

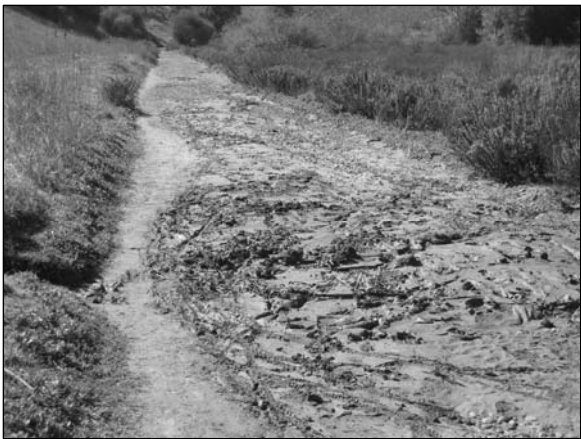
Figure 44: Sediment flowing onto Rose Canyon trail/access road from eroding storm drain channel

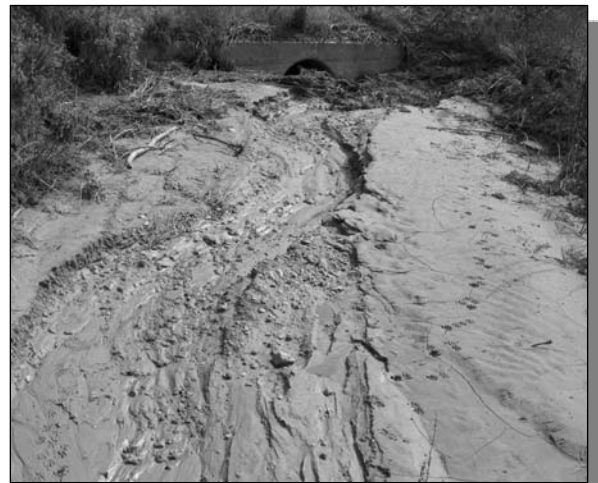
Figure 45: Sediment deposition on upstream side of culvert in Rose Canyon just north of State Route 52

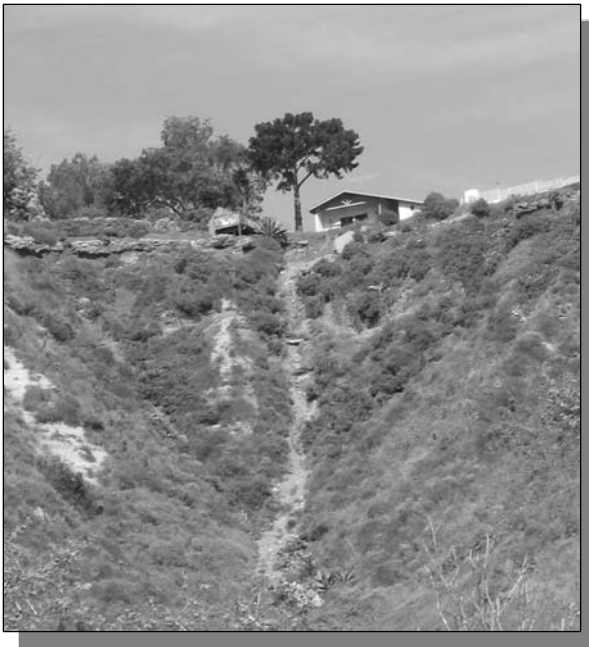
Figure 61: Slope failure along canyon rim, likely caused by storm runoff from adjacent residence

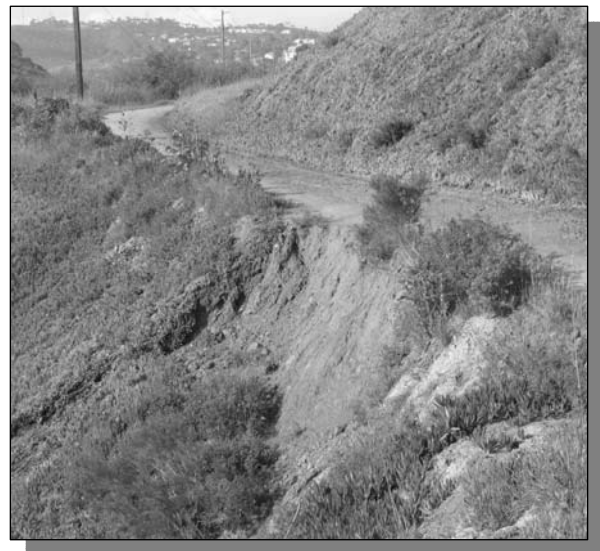
Figure 62: Slope failure related to iceplant along railroad access road in Rose Canyon

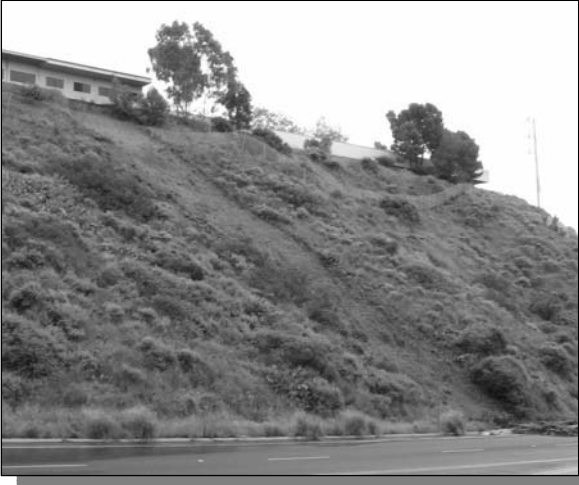
Figure 63: Slope failure related to iceplant and storm runoff below residential development

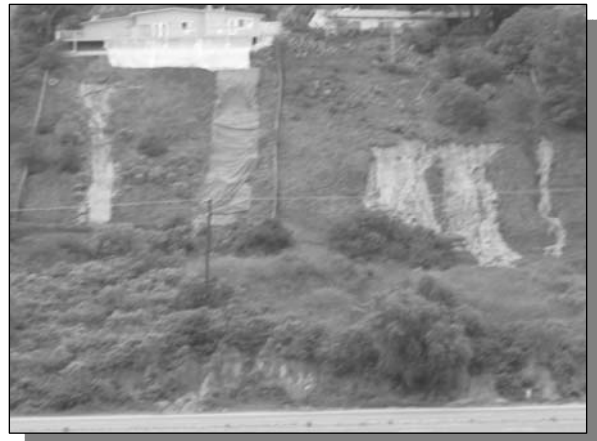
Figure 64: Slope failures related to iceplant and storm runoff from residences in Gilman Canyon

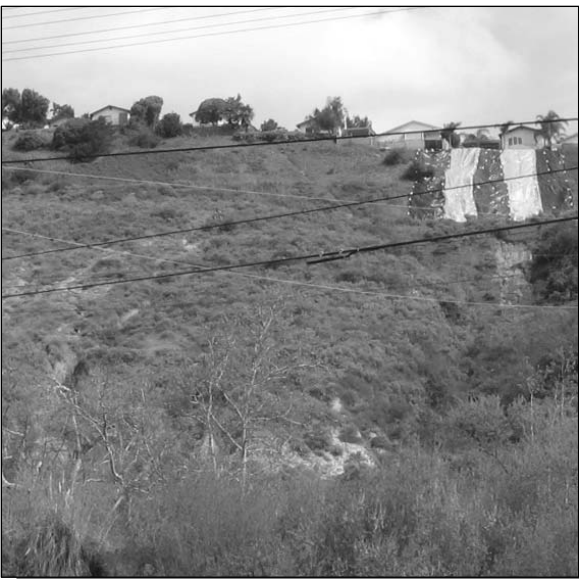
Figure 65: Slope failures related to iceplant and storm runoff from residences in Rose Canyon

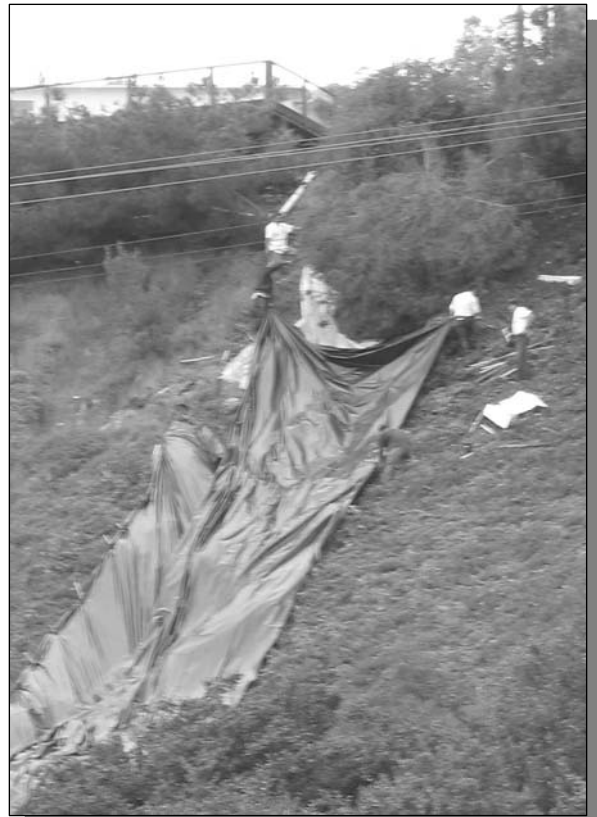
Figure 66: Slope failure related to iceplant and storm runoff from residence in Gilman Canyon
