ROSE CREEK WATERSHED

HYDROLOGIC, HYDRAULIC, SEDIMENT TRANSPORT, AND GEOMORPHIC ANALYSES

TASK 2 – STREAM NETWORK FIELD ASSESSMENT

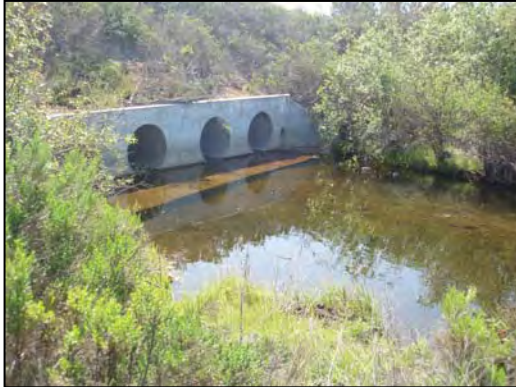
Photo: Figure 3a **Date:** April 25, 2006
Location: Upper Rose Creek at Obregon Ave
View: South, downstream
Flow: Ponded water
Description: Within MCAS Miramar, the creek passes through culverts beneath streets crossing the creek.

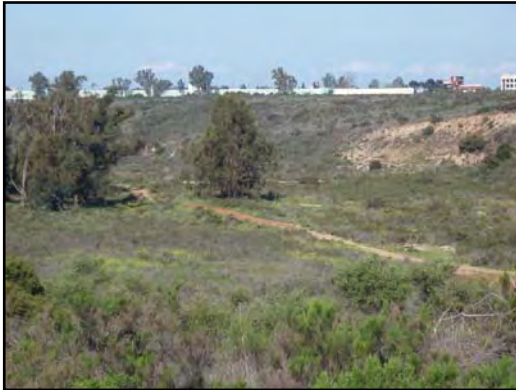
Photo: Figure 3b **Date:** April 25, 2006
Location: Upper Rose Creek along MCAS Miramar
View: Northwest, downstream
Flow: Dry
Description: The floodplain of Rose Creek within MCAS Miramar. This portion of Rose Creek has stretches of undeveloped land. The creek itself is shallow and narrow with a wide, vegetated floodplain.

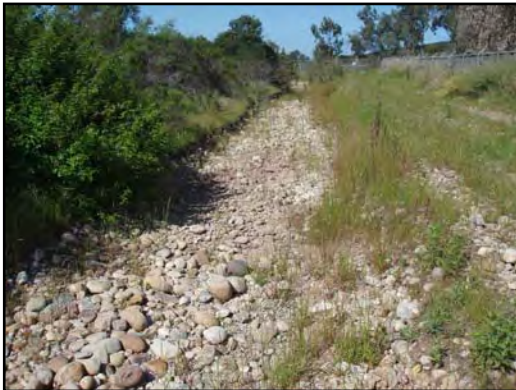
Photo: Figure 3c **Date:** April 25, 2006
Location: Upper Rose Creek downstream of Miramar Fish Pond
View: West, downstream
Flow: Dry
Description: Further downstream, the creek bed is comprised of rounded cobbles and is vegetated with grasses and brush. The photo also shows no water during dry weather.

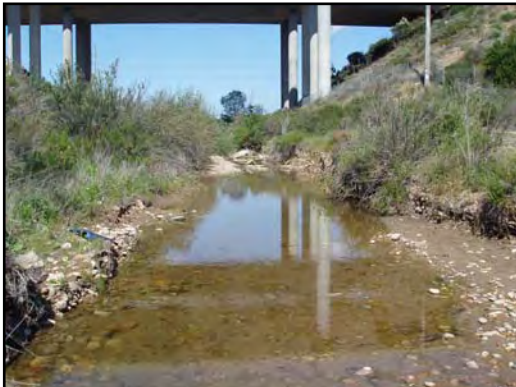
Photo: Figure 3d **Date:** April 25, 2006
Location: Upper Rose Creek at Interstate 805
View: Beneath bridge
Flow: Ponded water
Description: Rose Creek exits MCAS Miramar near Interstate 805 as shown in Figure 3d. The creek bed also has cobbles. Occasional ponds of water were observed near bridges.

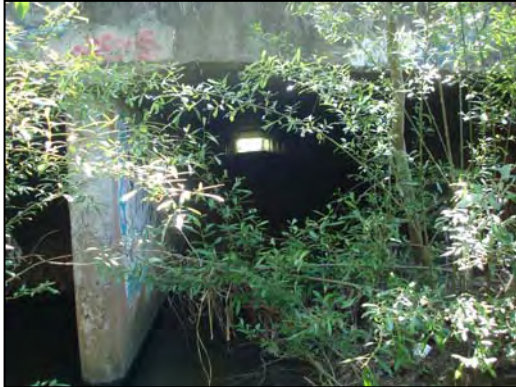
Photo: Figure 3e **Date:** April 25, 2006
Location: Upper Rose Creek at Genesee Ave
View: Downstream
Flow: Trickle
Description: A triple box culvert diverts flows beneath Genesee Avenue.

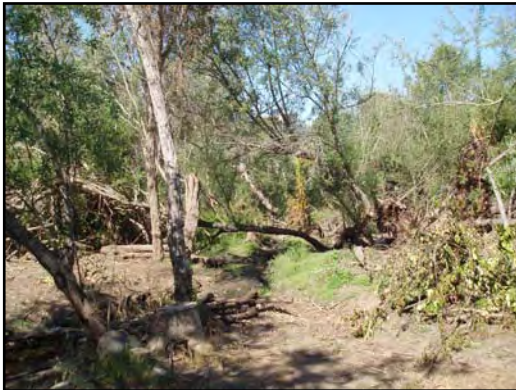
Photo: Figure 3f **Date:** April 25, 2006
Location: Upper Rose Creek downstream Genesee Ave
View: Downstream
Flow: Trickle
Description: Vegetation increases downstream of Interstate 805 and becomes dense near Genesee Ave. Occasional, localized areas of erosion were also observed primarily along tributaries.

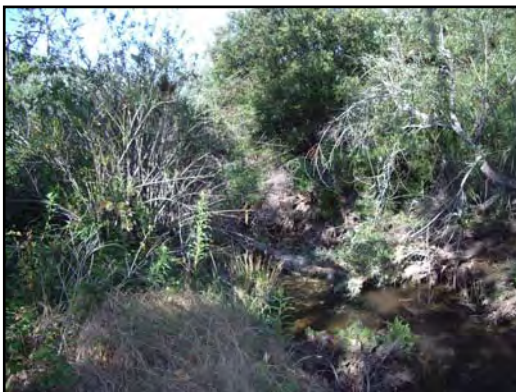
Photo: Figure 3g **Date:** May 31, 2006
Location: Upper Rose Creek below Regents Road
View: Downstream
Flow: Trickle
Description: Creek downstream of Regents Road.

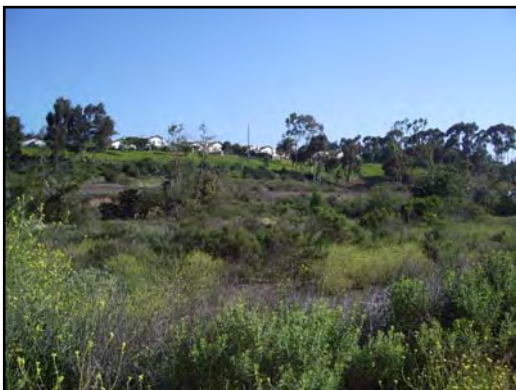
Photo: Figure 3h **Date:** May 31, 2006
Location: Upper Rose Creek below Regents Road
View: North, upstream
Flow: Trickle
Description: The vegetation within the creek floodplain also becomes denser compared to the headwaters.

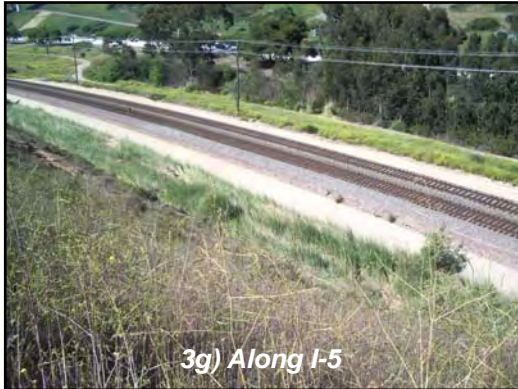
Photo: Figure 3i **Date:** May 31, 2006
Location: Upper Rose Creek along Interstate 5
View: South, downstream
Flow: Trickle
Description: Concrete lines the creek banks. In this stretch, the creek flows parallel to the railroad and Interstate 5. Reeds have grown within the channelized creek.

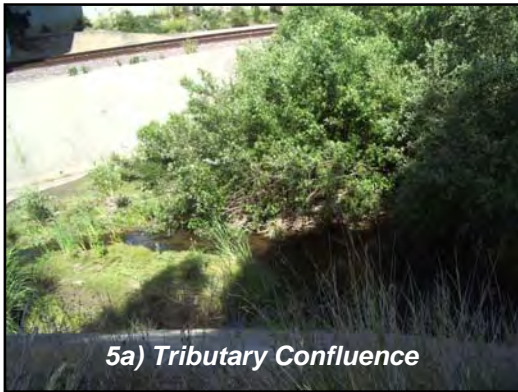
Photo: Figure 3j **Date:** May 31, 2006
Location: Upper Rose Creek at tributary confluence
View: Northwest
Flow: Trickle
Description: Rose Creek is a concrete-lined channel beneath the Interstate 5 and State Highway 52 interchanges.

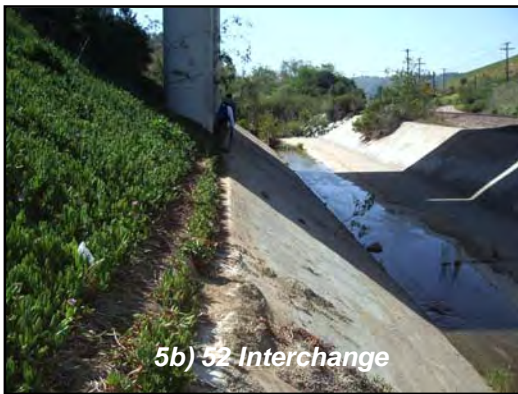
Photo: Figure 3k **Date:** May 31, 2006
Location: Upper Rose Creek beneath Interstate 5 and State Highway 52 Interchange
View: South, downstream
Flow: Trickle
Description: Concrete channel continues parallel to the railroad track and terminates upstream of confluence. The Interchange bridge columns are not located within the channel.

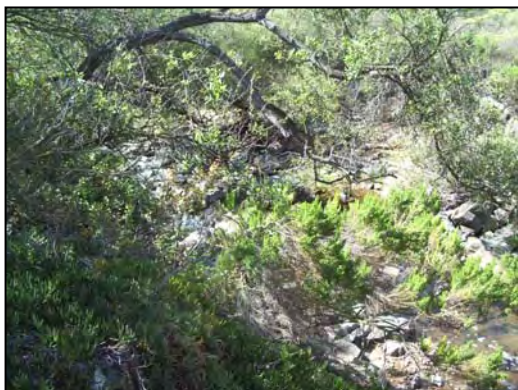
Overall, the site visit confirmed that there have been no substantial changes since the Assessment. The heavy vegetation observed in portions of the concrete-lined sections, especially along Upper Rose Creek between Genesee Avenue and the confluence, may reduce the hydraulic efficiency of the overall stream system. Although localized erosion was observed near structures (e.g., storm drains and foot bridges) primarily located along tributaries, the creek beds appeared stable indicating that observed erosion features are likely due to localized scour as opposed to general erosion associated with watershed sediment losses or increased storm flows.

Photo: Figure 3l **Date:** May 31, 2006
Location: Upper Rose Creek above confluence with San Clemente Creek
View: South, downstream
Flow: Trickle
Description: Heavy vegetation reappears downstream from the concrete channel towards the confluence with San Clemente Creek.

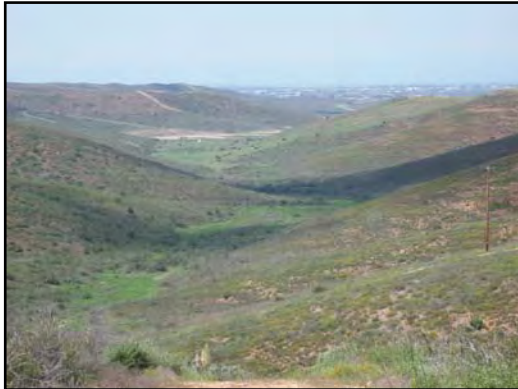
Photo: Figure 4a **Date:** April 25, 2006
Location: San Clemente Creek headwaters
View: Southwest, downstream
Flow: Dry
Description: The headwaters of San Clemente Creek are similar to Upper Rose Creek with wide undeveloped lands within MCAS Miramar.

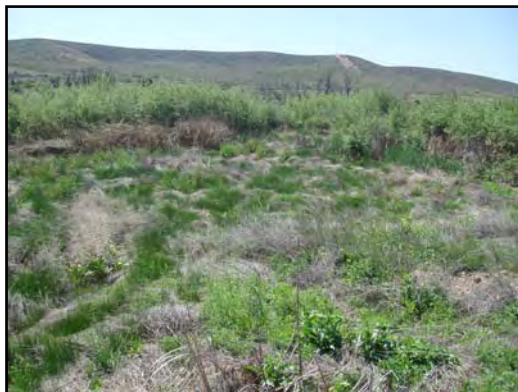
Photo: Figure 4b **Date:** April 25, 2006
Location: San Clemente Creek east of Second San Diego Aqueduct
View: West, downstream
Flow: Dry
Description: The upper portion of San Clemente Creek is vegetated primarily with grasses. There is no flow during dry weather.

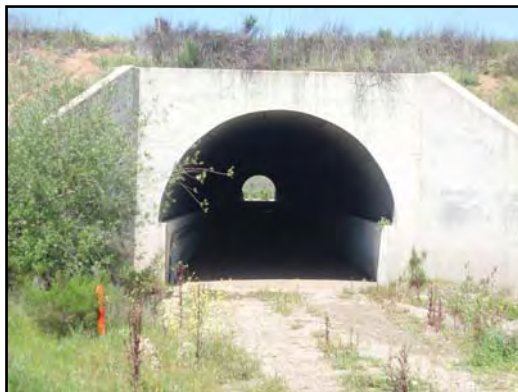
Photo: Figure 4c **Date:** April 25, 2006
Location: San Clemente Creek at Interstate-15
View: West, downstream
Flow: Dry
Description: Culvert under Interstate 15.

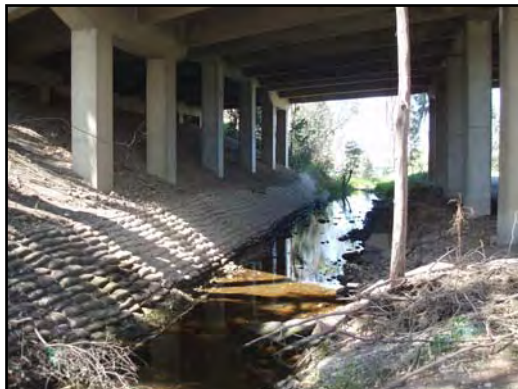
Photo: Figure 4d **Date:** April 25, 2006
Location: San Clemente Creek at Kearny Villa Rd
View: West, downstream
Flow: Trickle
Description: Kearny Villa Bridge. The bridge is not obstructed by vegetation.

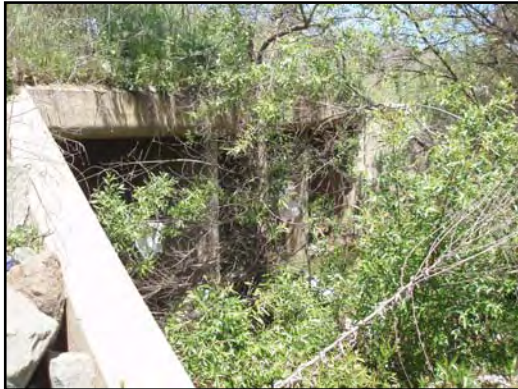
Photo: Figure 4e **Date:** April 25, 2006
Location: San Clemente Creek at Convoy Street
View: Upstream
Flow: Trickle
Description: The culvert at Convoy Street near the landfill. The photo also shows the vegetation increasing farther downstream.

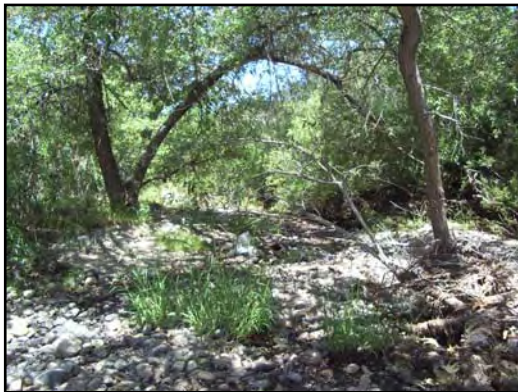
Photo: Figure 4f **Date:** May 31, 2006
Location: San Clemente Creek west of Genesee
View: West, downstream
Flow: Trickle
Description: Below Genesee Ave, the creek is densely lined with trees. The creek bed is comprised primarily of cobbles.

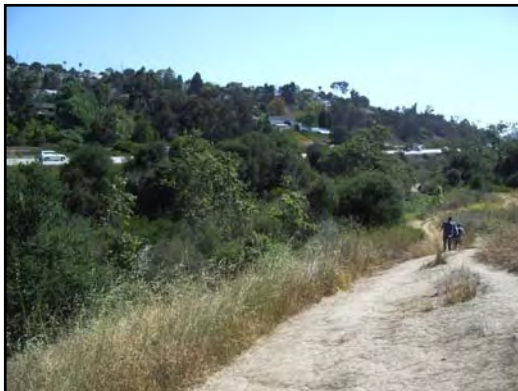
Photo: Figure 4g **Date:** May 31, 2006
Location: San Clemente Creek along State Highway 52 between Interstate 5 and Regents Road
View: East, upstream
Flow: Trickle
Description: The heavy vegetation continues down stream along State Highway 52 towards the confluence with Rose Creek.

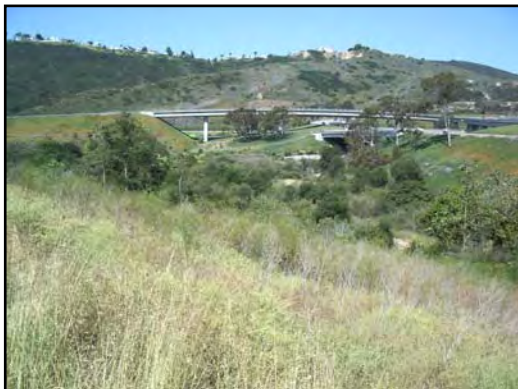
Photo: Figure 4h **Date:** May 31, 2006
Location: San Clemente Creek upstream from confluence with Rose Creek
View: West, downstream
Flow: Trickle
Description: The confluence with Rose Creek south of the Interstate 5 and State Highway 52 interchange is heavily vegetated.

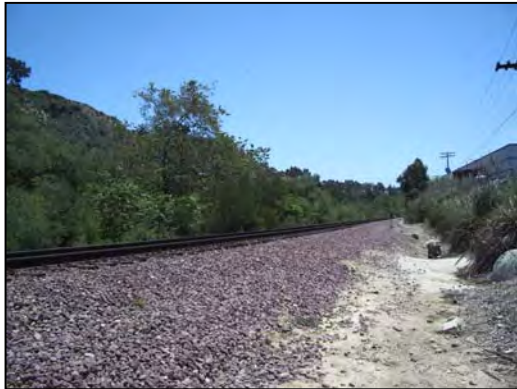
Location: Lower Rose Creek along railroad bridge downstream from confluence

Description: Lower Rose Creek continues downstream from the confluence along railroad tracks and Santa Fe Avenue. The creek is heavily vegetated with trees from the confluence.

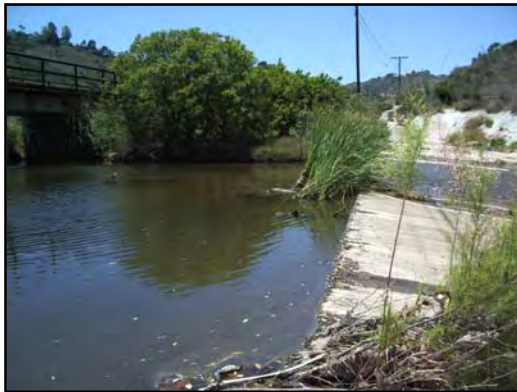
Location: Lower Rose Creek at railroad bridge near Jutland Drive

Description: Flows from Rose Creek make a 90 degree turn from the railroad bridge to a concrete channel. Water ponds beneath the railroad bridge due to the height of the concrete channel.

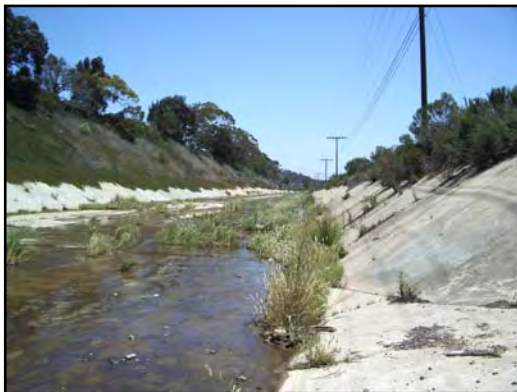
Location: Lower Rose Creek along Interstate 5

Description: The concrete channel continues along Santa Fe Avenue. The creek channel has less vegetation compared to the natural portions of Rose Creek.

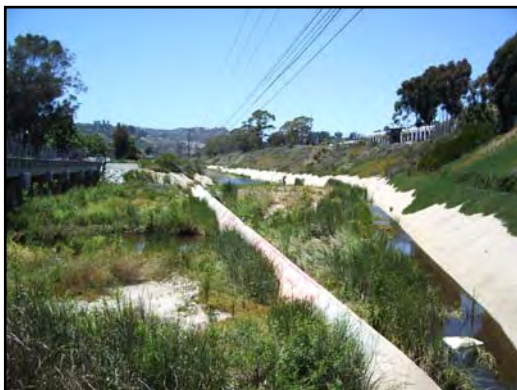
Location: Lower Rose Creek near Interstate 5

Description: A concrete weir structure is located near the Interstate 5 crossing. This area is filled with vegetation.

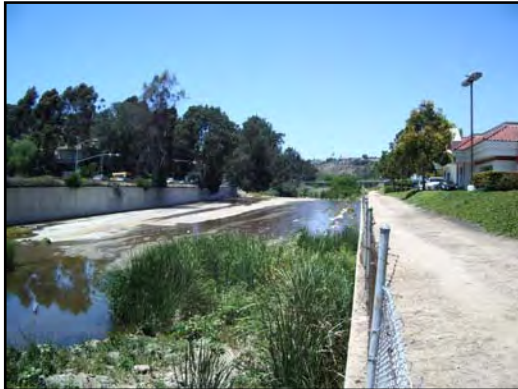
Photo: Figure 5e **Date:** May 31, 2006
Location: Lower Rose Creek between
Interstate 5 and Mission Bay Drive
View: Upstream towards Interstate 5 Bridge
Flow: Trickle
Description: Between Interstate 5 and Mission
Bay Drive, the creek is a wide concrete
channel with some vegetation.

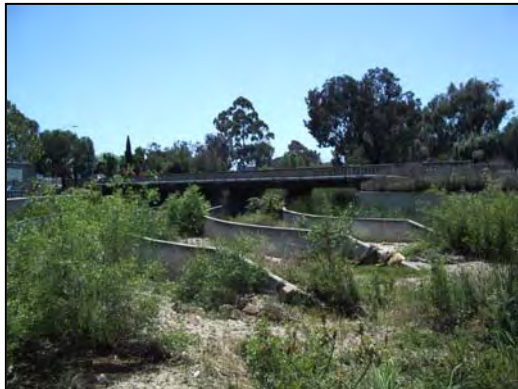
Photo: Figure 5f **Date:** May 31, 2006
Location: Lower Rose Creek at Mission Bay
Drive
View: Downstream
Flow: Trickle
Description: Concrete flow training vanes
upstream from Mission Bay Drive.

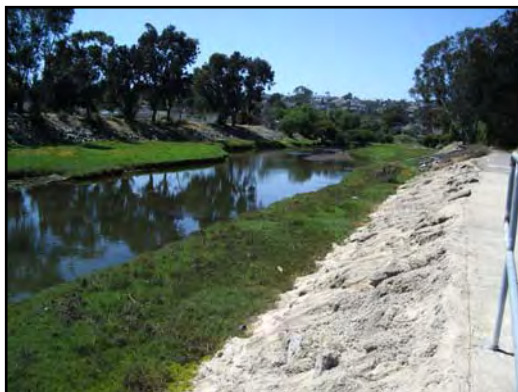
Photo: Figure 5g **Date:** May 31, 2006
Location: Lower Rose Creek upstream from
Grand Ave
View: Upstream towards Garnet Ave
Flow: Tidal
Description: The creek is tidally influenced up
to Garnet Ave. This portion of Lower Rose
Creek has riprap sides with salt marsh
vegetation.

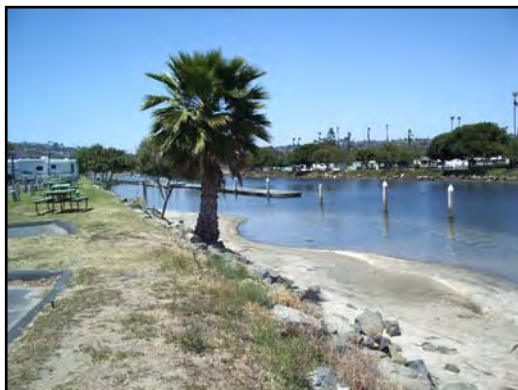
Photo: Figure 5h **Date:** May 31, 2006
Location: Lower Rose Creek at Mission Bay
View: Upstream
Flow: Tidal
Description: The mouth of Rose Creek in
Mission Bay.

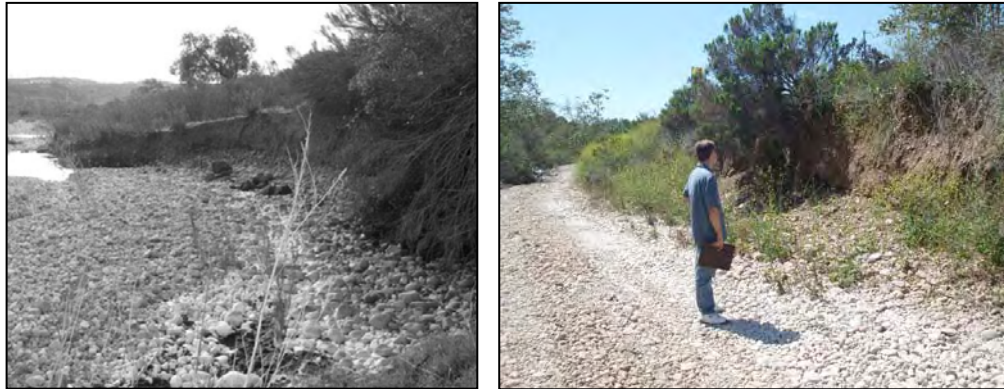
Erosion areas along Rose Creek are compared in Figure 6. In general, these erosion areas have not undergone additional erosion since the Assessment and the emergence of vegetation suggest a more stable period. Figure 6 compares streambank erosion along Rose Creek upstream from Interstate 805. The eroded streambank appears to be stable with vegetation being re-established. Erosion at the bottom of a concrete bank observed from the previous Assessment was still apparent, as shown in Figure 6b, and vegetation has started to establish. Localized erosion of the streambed along Rose Creek is compared in Figure 6c.

a) Streambank Erosion along Rose Creek above Interstate 805

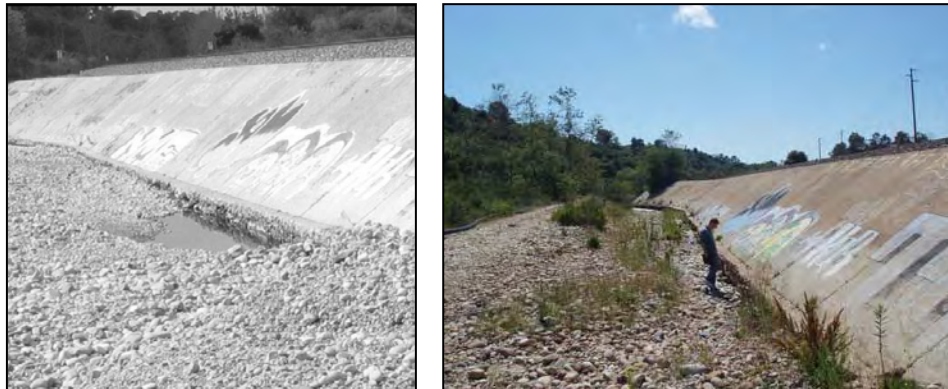
b) Streambed Erosion below Concrete Bank along Rose Creek near Interstate 805

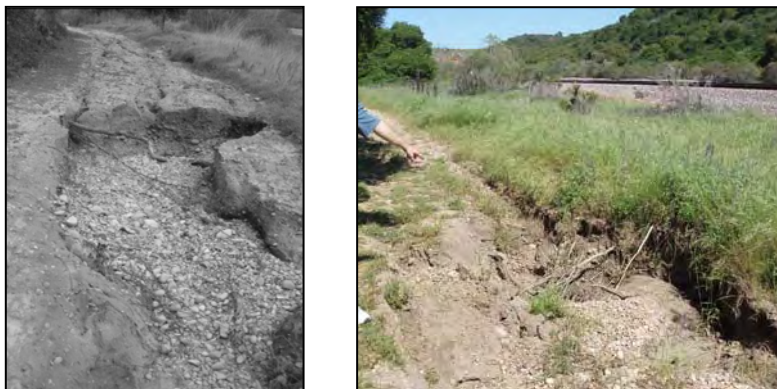
c) Streambed Erosion along Rose Creek

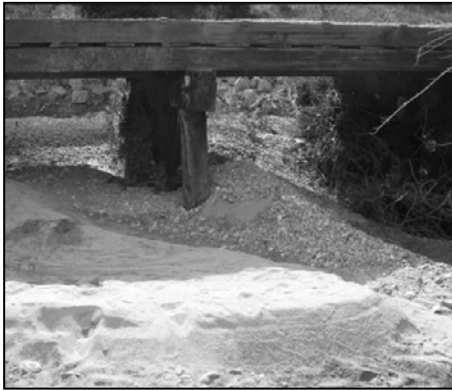
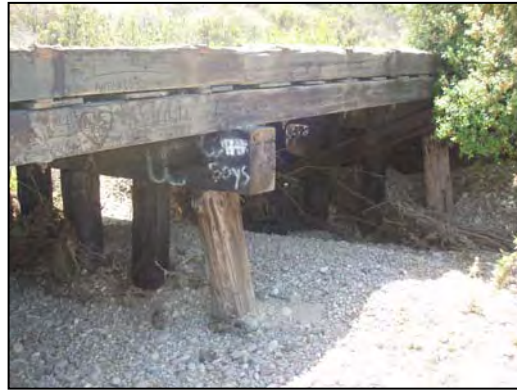
Deposition areas at two structures along Rose Creek are shown in Figure 7. Figure 7a compares depositions below an old railroad bridge. A decrease in deposition at the old railroad bridge was observed during the April 25, 2006 site visit. Deposition in a concrete deflection structure along Lower Rose Creek is compared in Figure 7b, which shows increased deposition and vegetation since the Assessment.

a) Deposition along Rose Creek beneath old Railroad Bridge

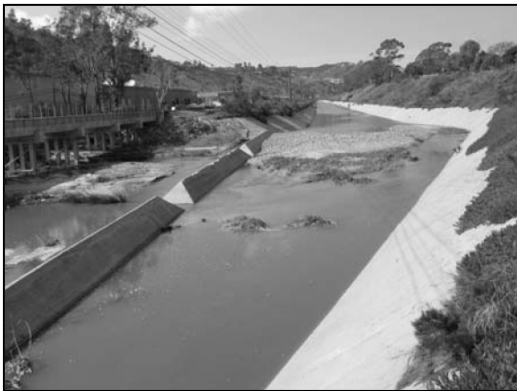
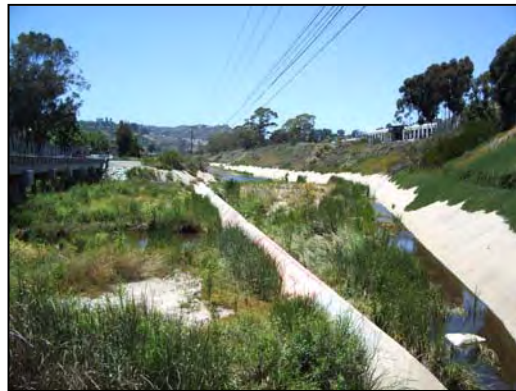
b) Deposition along Lower Rose Creek at Railroad Bridge

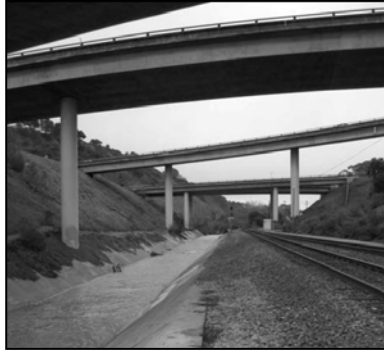
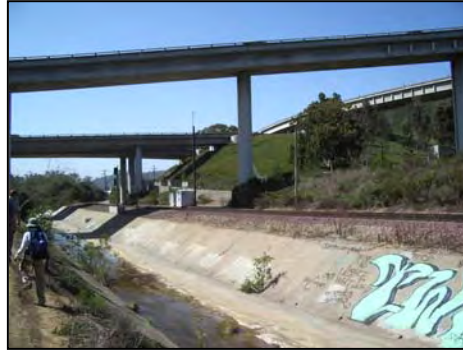
Four hydromodification locations along Lower Rose Creek are compared in Figure 8. The concrete channel below the confluence is compared in Figure 8a. Conditions within the channel have been maintained since the Assessment. The concrete flow training vanes above Mission Bay Drive are compared in Figure 8b. Deposition has continued and vegetation has emerged. Lower Rose Creek above and below Grand Avenue, shown in Figures 8c and 8d, shows no substantial changes since the Assessment.

a) Concrete Channel along Rose Creek

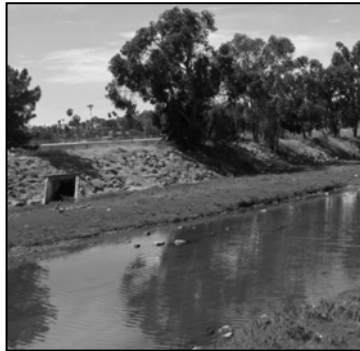
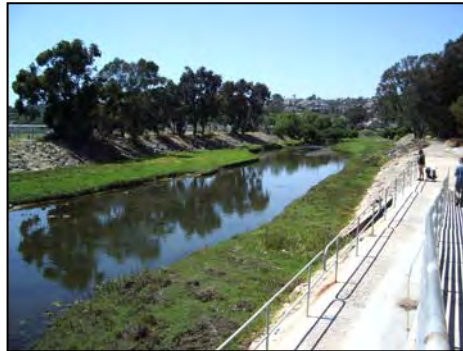
b) Riprap Protection above Grand Ave

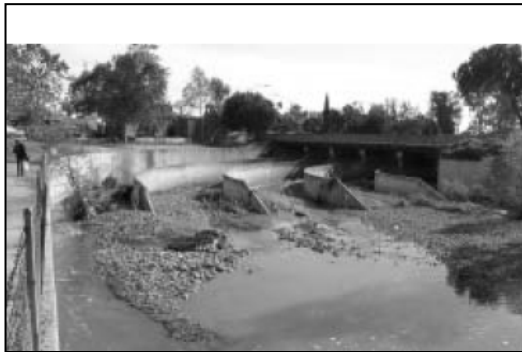
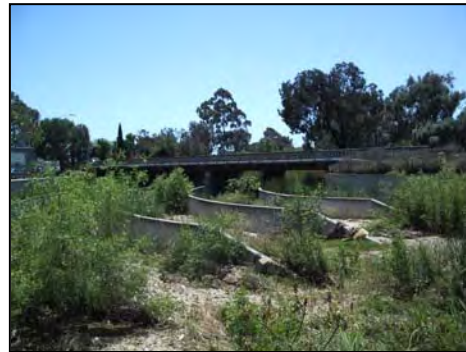
c) Concrete Flow Training Vanes above Mission Bay Drive

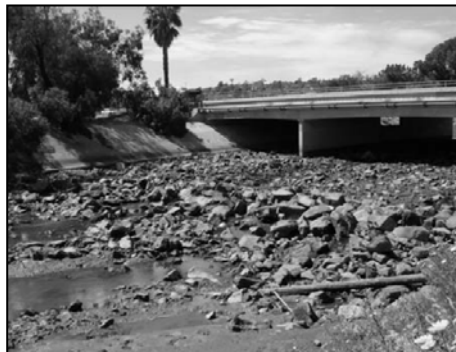
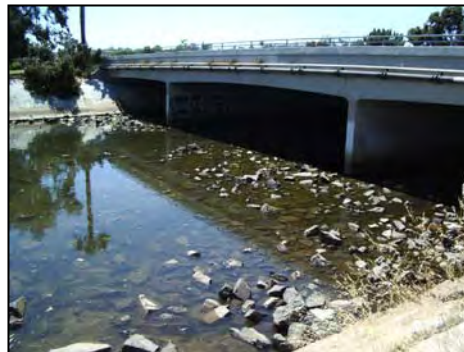
d) Streambank and bed protection below Grand Ave Bridge
