**Rose Creek Watershed Assessment Opportunities
RECREATIONAL ELEMENTS
TECHNICAL MEMORANDUM**

Prepared for:
San Diego Earthworks

Prepared by:
KTU+A Landscape Architecture and Planning

April 2005

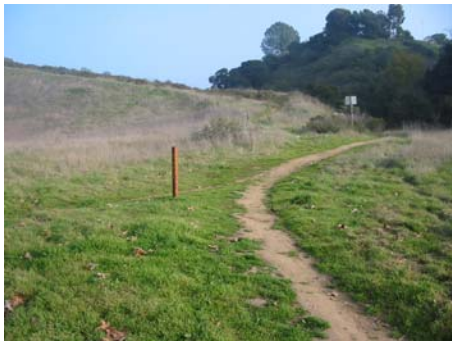
Figure 1-1: Singletrack on Biltmore Trail

Singletrack trails are trails in which users must generally travel in single file and tend to wind around obstacles such as trees, large rocks and bushes (Figure 1-1). As compared to roads or multi-use paths, singletrack trails blend into the surrounding environment, disturb much less ground and are easier to maintain.

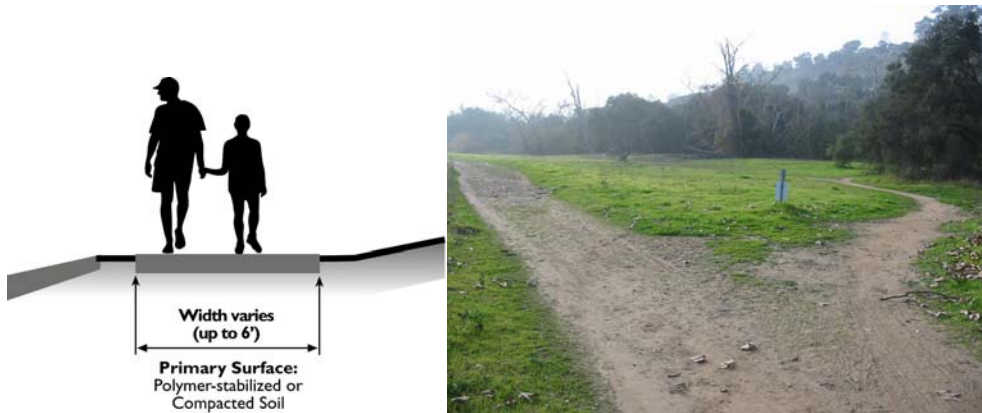
Figure 1-2: Shared-use trail

Designated trails throughout the Rose Canyon Open Space and Marian Bear Memorial Park are typically 3-6 feet in width and are a shared-use trail designated for pedestrian and cycling use only. These shared-use trails disperse users across the entire trail system and are the most cost efficient for land managers as they require fewer signs and less staff for maintenance and monitoring. Shared-use trails also require less trail miles and therefore have less impact to the ecosystem (Figure 1-2).

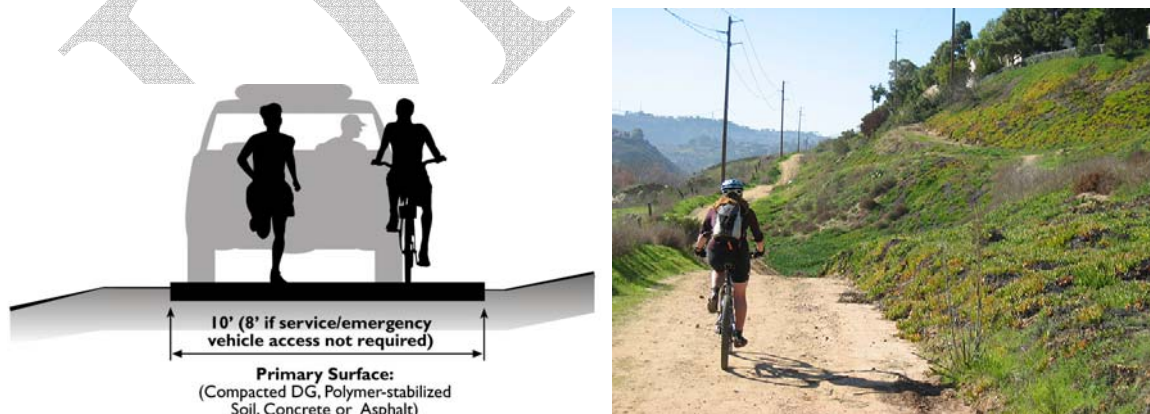
Figure 1-3: Maintenance Roads

Maintenance roads (also known as utility access paths) are typically the main trail type throughout these parks due to their heavy use and easy accessibility. The maintenance roads serve dual purpose in that they provide access for authorized vehicles for park management and recreational use for pedestrians and cyclists (Figure 1-3). These utility access paths also provide access to Metro Wastewater Department and San Diego Gas & Electric utilities. In many cases, these paths provide reasonable trail connections and linkages. As these paths are normally linear and bisect open space boundaries, they provide excellent connections between developed areas.

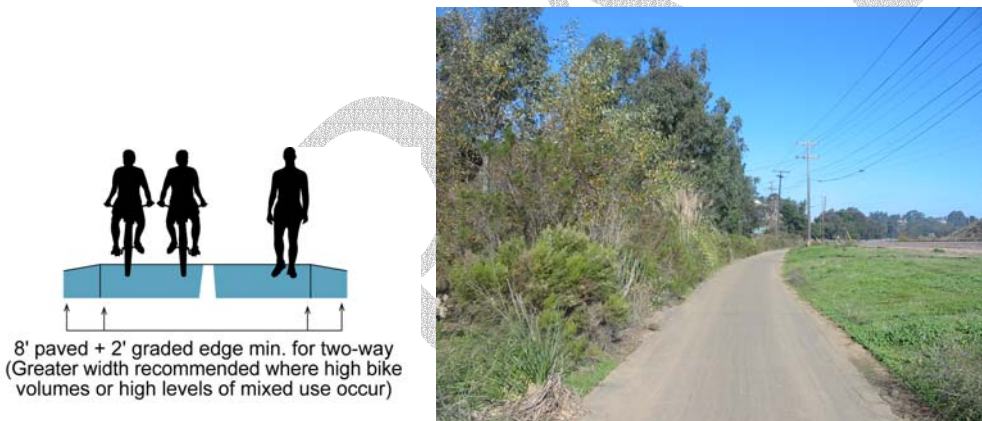
Figure 1-4: Bike Path

Class 1 – Paved “Bike Path” with an exclusive right-of-way, physically separated from vehicular roadways and intended specifically for non-motorized use (Figure 1-4). Bike paths offer opportunities not provided by the road system. They can either provide a recreational opportunity, or in some instances, can serve as a direct high-speed commute route if cross flow by motor vehicles and pedestrian conflicts can be minimized.

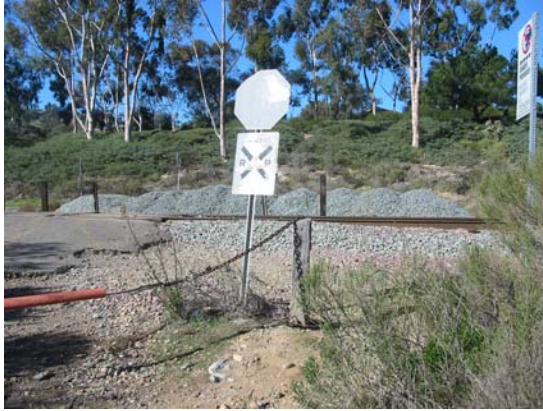
Figure 2-1: Closed railroad crossing in Rose Canyon

According to the Federal Railroad Administration, there have been five casualties due to trespassers on the railroad tracks in San Diego County in the past five years. Pedestrian safety improvement options are limited along the Rose Canyon Watershed, since stopping the train is not a viable option. The only recourse to improving conditions for park users is to improve the method of stopping users or to provide a grade separation for pedestrians and bicyclists from the tracks. Currently there is no safe railroad crossing to access the Marian Bear Memorial Park Trails just south of the State Route 52. Users must cross the tracks from the Rose Canyon Bike Path and make their way east towards Marian Bear Memorial Park and still have to cross Rose Creek before accessing the main utility access path. There is one railroad crossing to access the Rose Canyon Bike Path but it is currently closed (Figure 2-1). To access this crossing, users must exit the Rose

Canyon Bike Path and enter the railroad corridor and traverse some 500 feet alongside the railroad right-of-way to the railroad crossing.

Signage could warn users of the danger by prohibiting the crossing of the railroad tracks to access Marian Bear Memorial Park. Another solution would be to provide a safe section to cross from the Rose Canyon Bike Path that will lead directly to the Marian Bear Memorial Park trails. Solutions could include; 1) a crossing of level grade from the Rose Canyon Bike Path over the railroad tracks, 2) a pedestrian bridge crossing or 3) an underpass or tunnel. Approaches to the track and the area between the tracks should be raised to the level of the top of the rail because rail ties that are not flush with the travel surface create a tripping hazard in addition to the gap hazard. Since trains maybe coming in ether direction, the optimum condition is for pedestrians and bicyclists to cross at a 90 degree angle to the rail line (Figure 2-2). This also provides a straight angle for wheels such as bicycles, wheelchairs and strollers. Optimally, wheels should be able to cross rail lines at 90 degrees. Since this is currently a recreation trail, the surface should be hardened to reduce the debris that scatters over the tracks as users pass. Railroad crossing warnings could include stencils and signs to be placed prior to railroad crossings to warn oncoming pedestrians and bicyclists.

In the case of the Rose Canyon Open Space railroad crossing, a paved or re-worked trail with proper signage can direct users along the railroad corridor to a proper crossing and discourage illegal crossing at any given section of the railroad. Creating a railroad crossing where the Rose Canyon Bike Path ends near Gilman would also allow a safe access to the Rose Canyon Open Space trail system. Line of sight in both directions is acceptable and it will limit the amount of users walking alongside the railroad tracks to find a safe crossing.

A pedestrian bridge crossing over the railroad tracks is a possible solution to safety and accessibility issues. There is available clearance and access to create a bridge below the State Route 52 and Interstate 5 interchange to connect the Rose Canyon Bike Path to both the Rose Canyon Open Space Park and Marian Bear Memorial Park. With accessibility requirements resulting in ramped accessible bridges, all bridges must be assumed to provide service to both pedestrians and bicyclists. Clearance over railroad tracks is controlled by the railroad company but is generally at least 23 feet (GDOT, 2003). Pedestrian bridges can vary in their structure and can be constructed of cast-in-place concrete, prestressed concrete, steel or wood. Choosing the appropriate type of structure requires the knowledge of the conditions at any proposed location. Aesthetically, the bridge structure chosen should complement the site to blend in with the environment. A trail beneath the State Route 52 and I-5 interchange just above the existing concrete channel could potentially connect both parks.

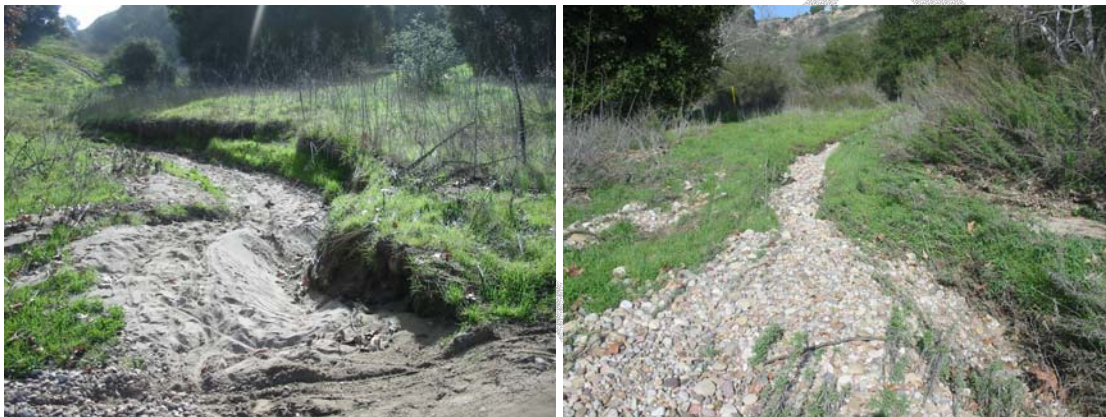
Figure 2-5. Utility erosion

Utility erosion is caused by man-made structures diverting run-off from adjacent developed areas into the stream system. Run-off from storm drains that terminate at the top of a slope can cause major erosion issues such as gullies from its terminus all the way to the bottom of the slope and into its major tributary. If the run-off is not managed, trails that intersect these gullies will be washed downstream leaving eroded trail conditions for users. One example of this is in Rose Canyon just west of Regents Road. There is an existing storm drain at the top of the slope that empties onto the slope. This has caused a 10-14 foot gully to be formed that intersects with the Rose Canyon trail. Currently a culvert directs flow beneath the trail and in wet months overflows onto the trail eliminating a continuous crossing for trail users. Erosion can also be associated with the ground disturbance caused by underground utilities and their utility easement access roads that

run throughout the Rose Creek Watershed. These access roads have little if no vegetation on the surface creating less resistance for storm water to flow. This type of erosion can be found in Marian Bear Memorial Park east of Diane Street where the gas line easement crosses Marian Bear in a north-south direction. Run-off at the bottom of this easement has created a gully and deposited sand onto the trail (Figure 2-5). The easement then continues as a cobbled stream bed into San Clemente Creek.

One potential solution to remedy utility erosion is to re-vegetate the barren strips of land above the utility lines. Plant cover will slow down run-off and provide stability to the soil and lessen the effects of sediment transfer downstream. For storm drains that empty at the top of slopes, pipelines can be introduced to transport the flow directly from the storm drain to the bottom of the slope and into the creek. Thus eliminating the run-off down the slope and causing gullies to form and run-off onto the trail system.

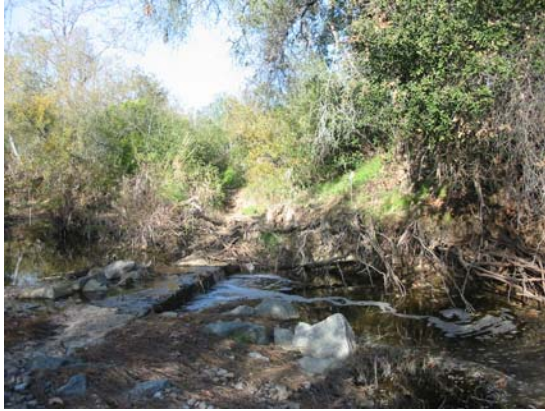
Figure 2-6: Rose Creek crossing in Marian Bear Memorial Park

The Rose Canyon Open Space Park boasts a dirt and gravel trail from approximately Gilman Drive in Clairemont Mesa to Genesee Ave in the community of University. The trail crosses Rose Creek a few times via culverts built into the system leaving a relatively flat, paved and safe trail for many types of users. Marian Bear Memorial Park is quite different. The trail system in Marian Bear Memorial Park intersects with San Clemente Creek many times throughout the park and varies in width and elevation. Marian Bear Memorial Park has a more rugged terrain particularly on the western end near the Rose Creek and San Clemente Creek confluence. These numerous intersections between trail and stream pose many trail crossing issues throughout the park. The access into Marian Bear Memorial Park from the Rose Canyon Bike Path is one of the most difficult creek crossings in the Rose Creek Watershed. Rose Creek in this section is roughly ten feet wide with running water and unstable broken concrete and rocks acting as a bridge to access the trail system (Figure 2-6). It's nearly impossible to cross with a bicycle and hikers must use the

utmost care to cross without falling in. During high flow events, it is impossible to cross and the only access is from Regents Road or Genesee Ave.

Signage would allow users to navigate through the adjacent trail and find their way across the creek to the main utility access path. Two other options for stream crossings through Marian Bear Memorial Park is utilizing bridges or armored crossings. Armored crossings are a simple and inexpensive means of allowing trail users to pass through water while minimizing sedimentation. Armoring a stream crossing is much like armoring a wet section of trail. Stones are sunk into the ground at grade to make both the streambed and the approach more durable. The new hardened surface will protect the banks, the stream and the trail. These trails can be constructed by hand with volunteer labor if the stream is small enough. Due to San Clemente Creek typically experiencing low flows throughout the year, armored crossings would benefit users at the shallow stream crossings.

Bridges and boardwalks are more labor intensive, expensive and frequently require permits. However if the stream needing to be crossed is large enough, bridges are the best means of crossing. By putting the trail above water, impact will be minimized in relation to each other. Today there are wide ranges of bridge designs from simple one-log-and-a-hand-rail versions, to wooden bridges to pre-built steel bridges. Ladder bridges can be implemented on the residential access trails as they provide a continuous trail segment over intersecting tributaries (Figure 2-8). Ladder bridges can also be used at shallow creek crossings as they can be built to meander to a flat section on the opposite side of the stream.

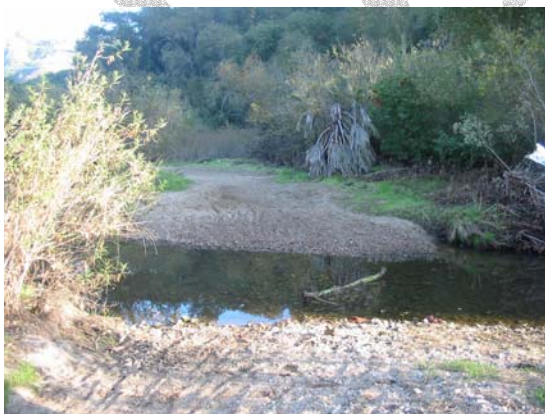
Figure 2-7: Stream crossing from Regents Road parking lot in Marian Bear

To access the western portion of the Marian Bear Memorial Park from Regents Road, users must cross the San Clemente Creek in about 6-12 inches of water. There is no bridge or large rocks to aid in the crossing (Figure 2-7). In low flow events, the water level could be low enough to allow hikers and bicyclists to cross with little resistance but during higher flow events, crossing would be difficult. There is a small single track path that runs adjacent to the main trail and eventually crosses the creek where there are more cobbles and debris to make crossing less difficult. This trail is not easily identifiable and thus can be missed by new users to the park.

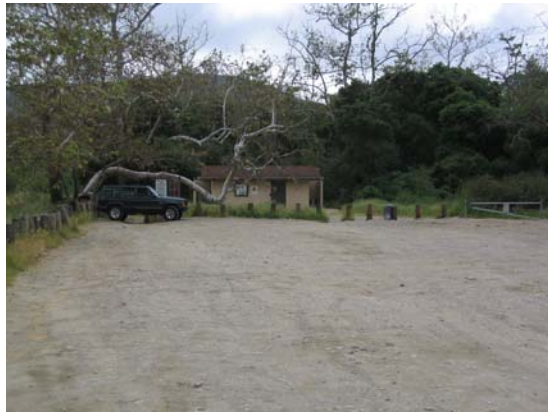
Figure 2-9: Regents Road access into Marian Bear Memorial Park

Trail amenities can be found in both Marian Bear Memorial Park and Rose Canyon Open Space Park, although they are very sparse in Rose Canyon. Marian Bear Memorial Park does have better amenities such as benches, restrooms, trash receptacles and parking for users. Restrooms can be found at the Genesee Ave parking lot and both Regents Road parking lots in Marian Bear (Figure 2-9). Picnic tables can also be found on both Regents Road parking lots in Marian Bear Memorial Park. Here users can read informative kiosks to traverse east or west throughout the park. Individual trail maps can be found at the eastern parking lot of Regents Road before they head onto

the main trail. The kiosks at Genesee Ave and west Regents Road provide an outdated trail map for users to use. The kiosks at all the Marian Bear parking lots range in educational information from California's biodiversity to the wildlife and history of the Marian Bear Memorial Park. Plastic bags for picking up after dog feces can be found at these entrances as well as drinking bowls for dogs and water fountains. Along the main utility access paths, benches are spread about for users needing a quick break. The current signage of Marian Bear Memorial park is inadequate for the users and more informative kiosks along the main trail could educate users as they pass connecting trails, cultural resources and sensitive habitat.

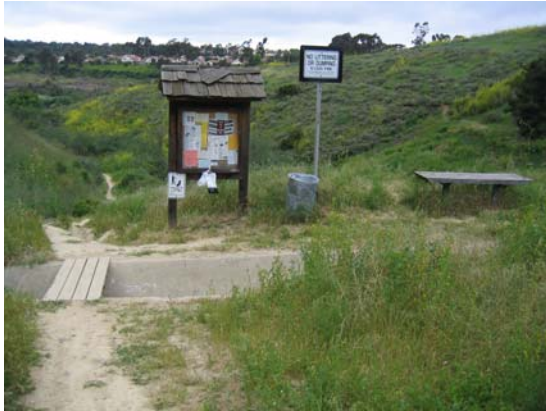
Figure 2-10: Regents Road access into Rose Canyon Open Space

Within Rose Canyon, there are benches near the La Jolla Golden Triangle Rotary Club Nature Trail off of Genesee Ave. There is no parking off Genesee to access Rose Canyon so users must either commute by foot, bicycle or park at University City High School which is across the street. Benches and kiosks are rare throughout Rose Canyon and can be found at the trail head off Genesee Ave and the Regents Road access trail (Figure 2-10 and 2-11). The kiosks at these two entrances do not provide as much educational information as those of Marian Bear and lack trail maps for users to orient themselves within the park. There are currently no public restrooms, picnic tables or trash receptacles in Rose Canyon but plastic bags for dogs are present at the kiosks. Kiosks near the Rose Canyon Bike Path entrance would be a good place to put a kiosk for users entering the park from the west. More kiosks or signage, benches, picnic tables and a public restroom would be a good start to promote the use and preservation of the Rose Canyon Open Space Park.
