ROSE CREEK WATERSHED OPPORTUNITIES ASSESSMENT

Trail and Recreational Issues

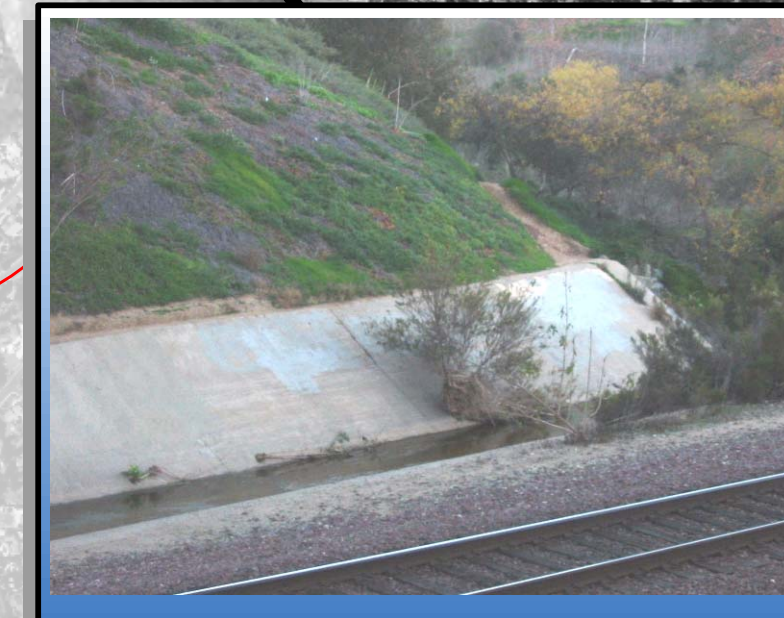
Erosion
Highly eroded tributaries have begun to erode adjacent trails

Closed railroad crossing
Lack of appropriate railroad crossings force users to unsafely cross the railroad tracks

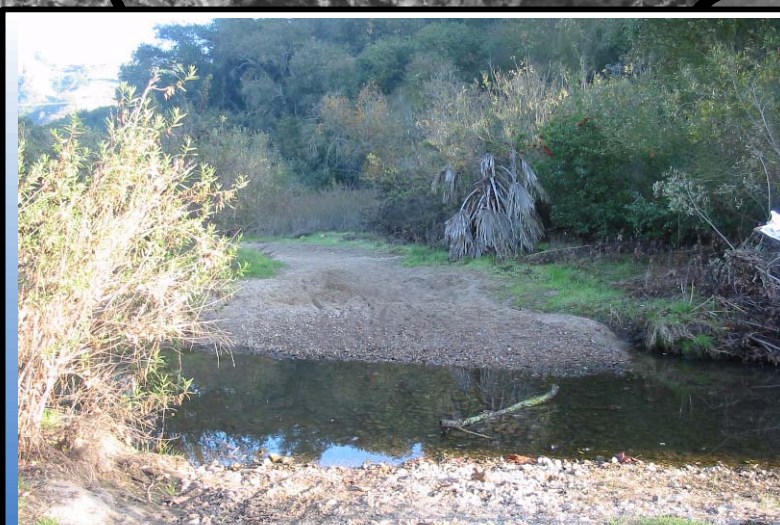
Disconnected trail system
Non-existing trail connection between Marian Bear Memorial Park and Rose Canyon Open Space

Unsafe creek crossing
Users must cross Rose Creek without a bridge or safe path to access the Marian Bear Memorial Park trail system.
