ROSE CREEK WATERSHED

HYDROLOGIC, HYDRAULIC, SEDIMENT TRANSPORT, AND GEOMORPHIC ANALYSES

TASK 4 – DATA GAPS PROGRAM

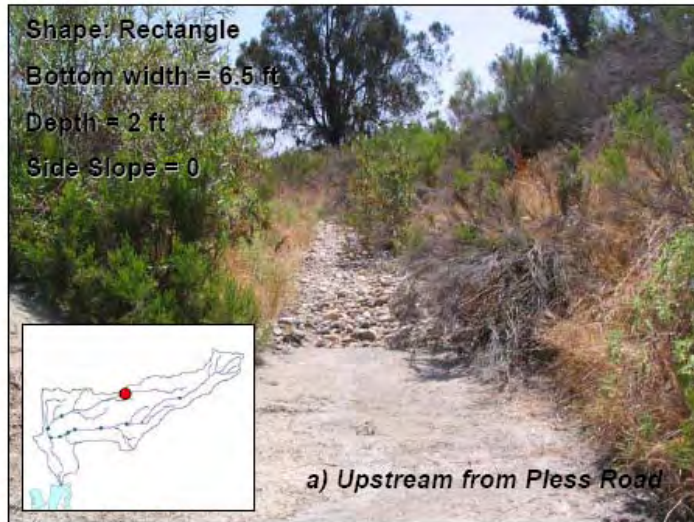
Figure 3 – Creek Channel Measurements along Rose Creek

Creek channel measurements along Rose Creek and San Clemente Creek are shown in Figures 3 and 4, respectively. Creek and concrete channel dimensions of width and side slopes were used to define the creek cross-sections. In general, the creek channel east of I-805 was shallow and narrow while to the west of I-805 the creek channel became wider.

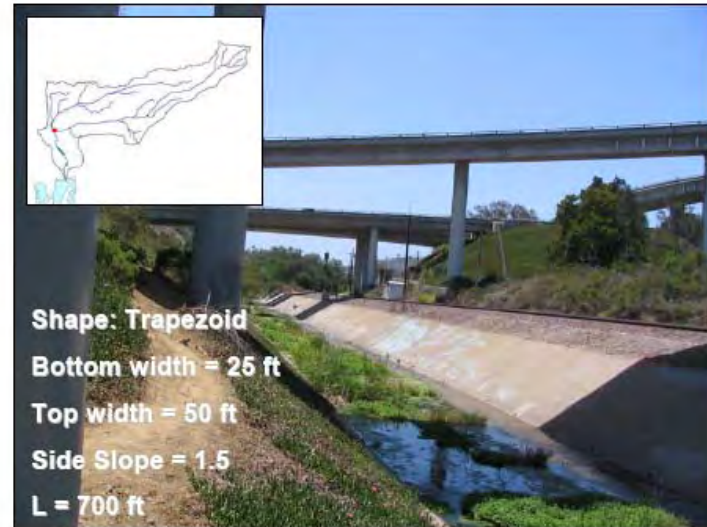
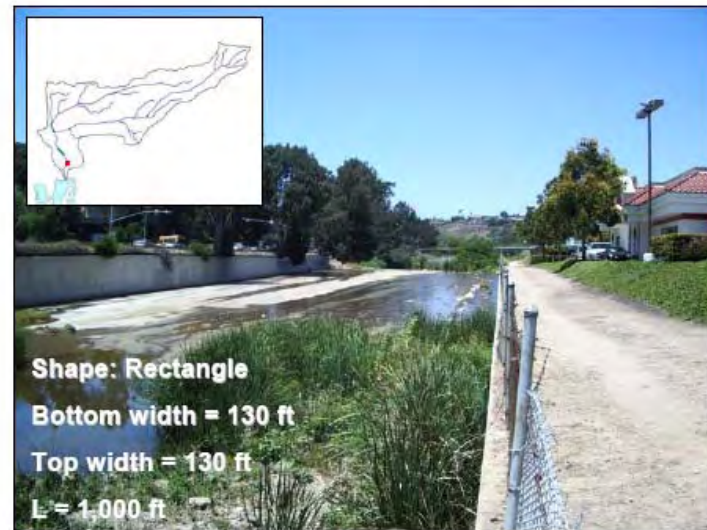
Figure 5 – Concrete Channel Measurements along Rose Creek

The concrete channel measurements along Rose Creek are shown in Figure 5. Measurements of concrete channel dimensions of width and side slopes were made at the four concrete channel sections.

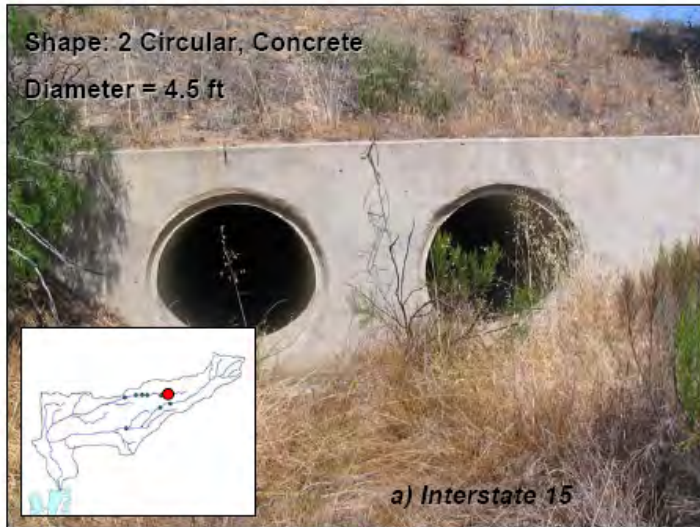
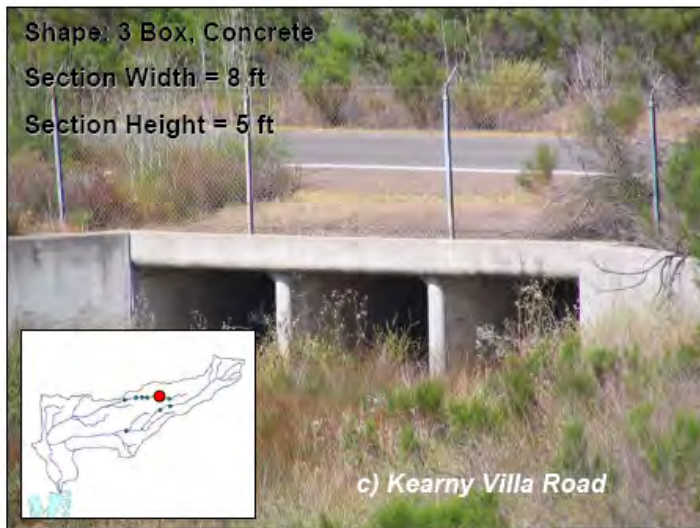
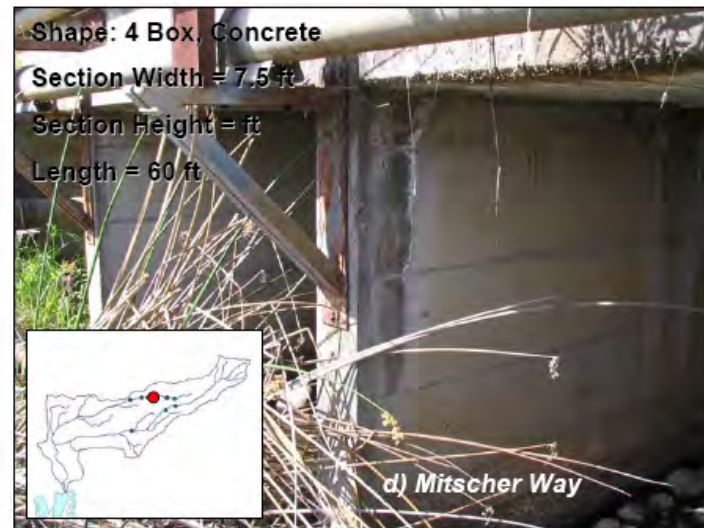
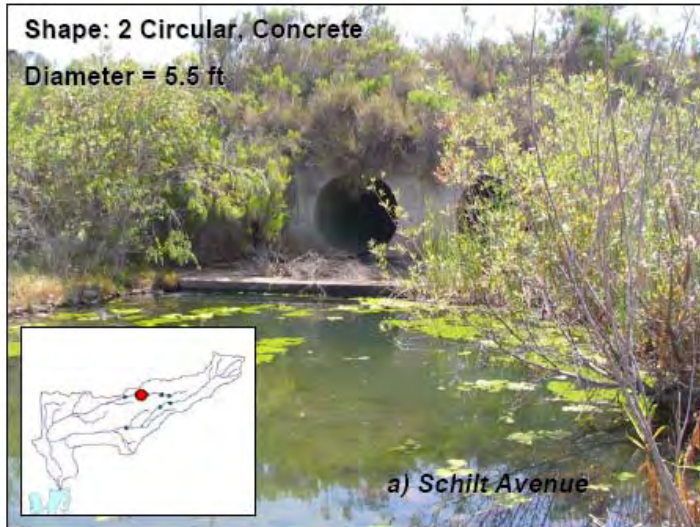
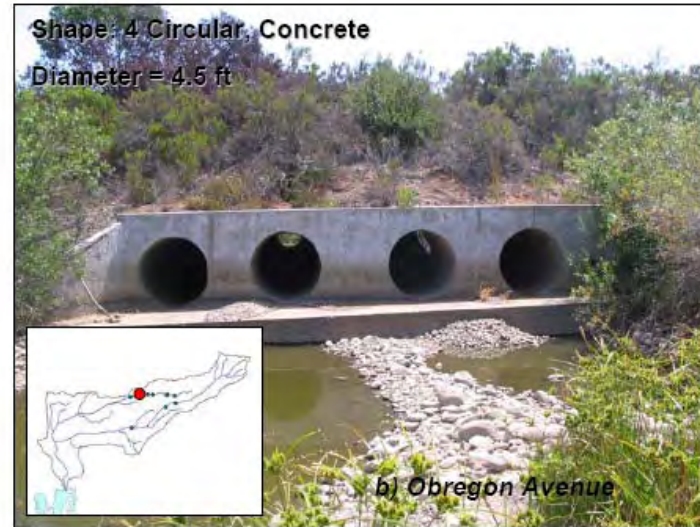
Figure 6 – Culvert Measurements along Rose Creek

Culvert measurements along Rose Creek are shown in Figure 6 and culvert measurements along San Clemente Creek are shown in Figure 7. All culverts were located within MCAS Miramar. Culvert dimensions included shape and width.

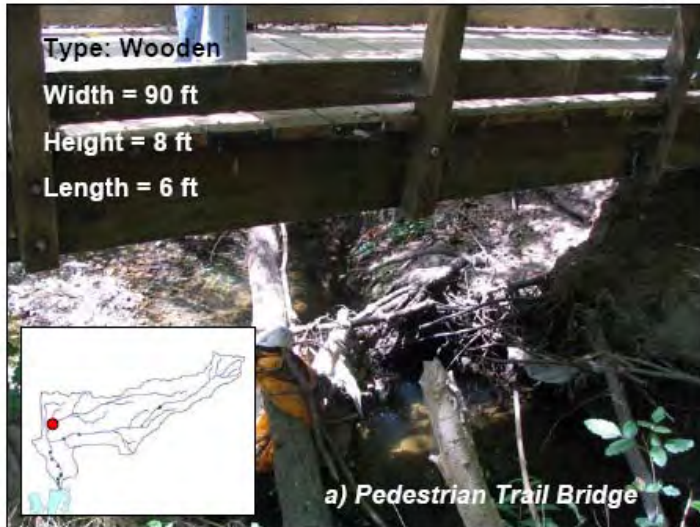
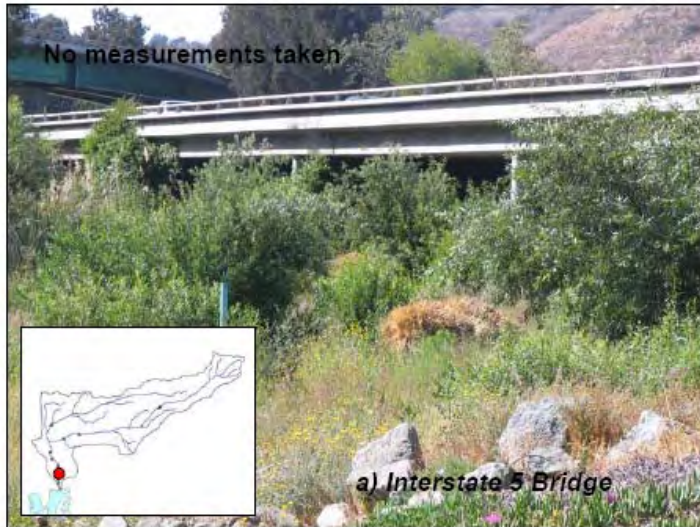
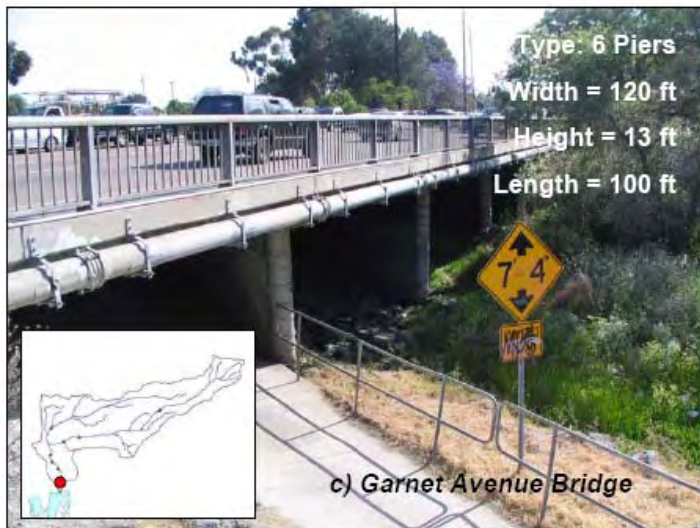
Figure 8 – Bridge Measurements along Rose Creek

Bridge measurements are shown in Figures 8 and 9 for Rose Creek and San Clemente Creek, respectively. Bridge dimensions measured included width, number of piers, and length.

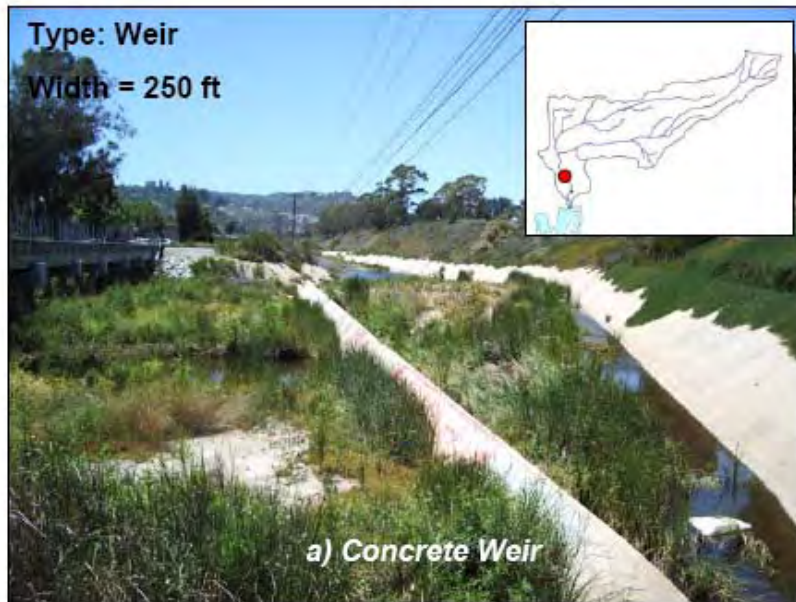
Figure 10 – Other Structure Measurements along Rose Creek

Measurements of the other structures along Rose Creek are shown in Figure 10. The structures were a concrete weir and flow training vanes.
