2 Action Recommendations

Rose Creek Watershed Opportunities Assessment

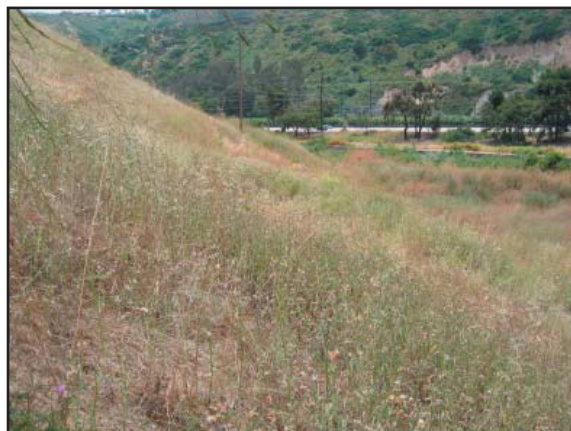
Figure 2-6: Wetland and Upland Restoration Potential within Upper Rose Canyon

The twenty-one proposed sites consist of low laying land adjacent to the main drainages of Rose and San Clemente creeks or at the bottom of tributary drainages where limited landform grading could create conditions suitable for the establishment of wetland plant communities. Targeted wetland and riparian vegetation communities should include: Southern Coast Live Oak Riparian Forest, Southern Cottonwood-Willow Riparian Forest, Southern Sycamore-Alder Riparian Woodland, Southern Willow Scrub, Freshwater Marsh, and Mule Fat Scrub. Descriptions of the twenty sites can be found in Chapter 4, Section 4.2.2 on page 4-5.

Opportunities for upland restoration exist throughout the RCW wherever areas of non-native grassland exist, as these areas are typically dominated not only by non-native annual grasses, but also by a variety of invasive exotic plant species as well, including: Black Mustard, Bull Thistle, Italian Thistle, Yellow Star Thistle, Tocalote, Sweet Fennel, Periwinkle, Fountain Grass, Cheeseweed, and Bristly Ox-Tongue. Approximately 182 acres are identified in Figures 2-6 to 2-8 making it impracticable to define individual sites as was done with the wetland restoration/creation opportunities. Within the identified areas targeted upland vegetation communities should include: Native Grassland, Coastal Sage Scrub, Southern Maritime Chaparral, Southern Mixed Chaparral, and Coast Live Oak Woodland.

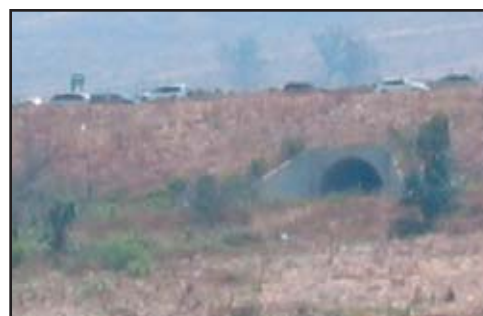
Figure 2-9: Impaired Wildlife Corridors within Upper Rose Canyon

- A. Interstate 15 over San Clemente Creek currently consists of a large 24 foot wide culvert connection 500 feet long that limits wildlife movement to and from the headwaters of Rose and San Clemente Creeks, as well as Mission Trails Regional Park and other open space areas within the San Diego River and Penasquitos watersheds. Discussions with Caltrans are recommended to identify long-range plans for construction activities along this stretch of Interstate 15 to determine if an opportunity to modify this under-crossing could be incorporated as a project element, or if the modification should be planned and implemented as a stand alone project. Without improvement, populations of mammals, reptiles, and other ground-based species to the west in Interstate 15 will likely decline due in part to this restrictive wildlife connection.

Three road under-crossings are significantly more restrictive to wildlife movement than the others and warrant further attention as described below as they effectively divide the RCW into four distinct regions and result in limited species interchange between them.

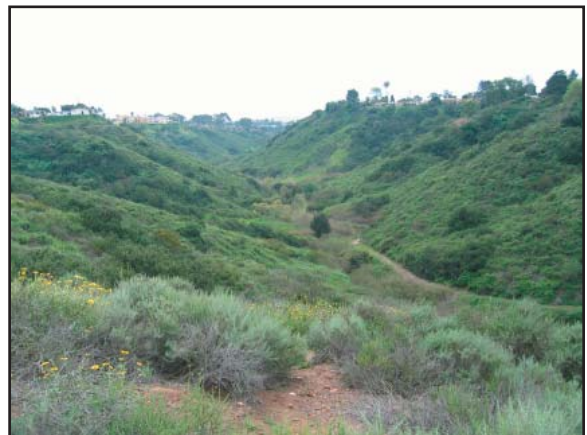
Figure 2-13: Potential Land Acquisitions

The City of San Diego currently owns and manages most of the natural open space west of MCAS Miramar. However, there are three significant privately owned areas that are recommended for acquisition in fee or easement (Figure 2-13). All three of the areas targeted in this recommendation are privately held properties currently being used to some degree for public purposes. For example, residents of Clairemont are using the trails in Lakehurst Canyon as park trails. The properties are not being managed for public purposes and all are infested with invasive exotic species, thus contributing seeds to infest public lands downstream. Under public ownership, they could be managed for public purposes including biological resources, recreation and public safety. A variety of state funding sources may be applicable to this effort. These potential acquisitions include:

- A. The first area targeted for acquisition is the vacant open space area within Stevenson Canyon. This significant natural area (72 acres) is predominantly in private ownership, with only a few owners (16 parcels).

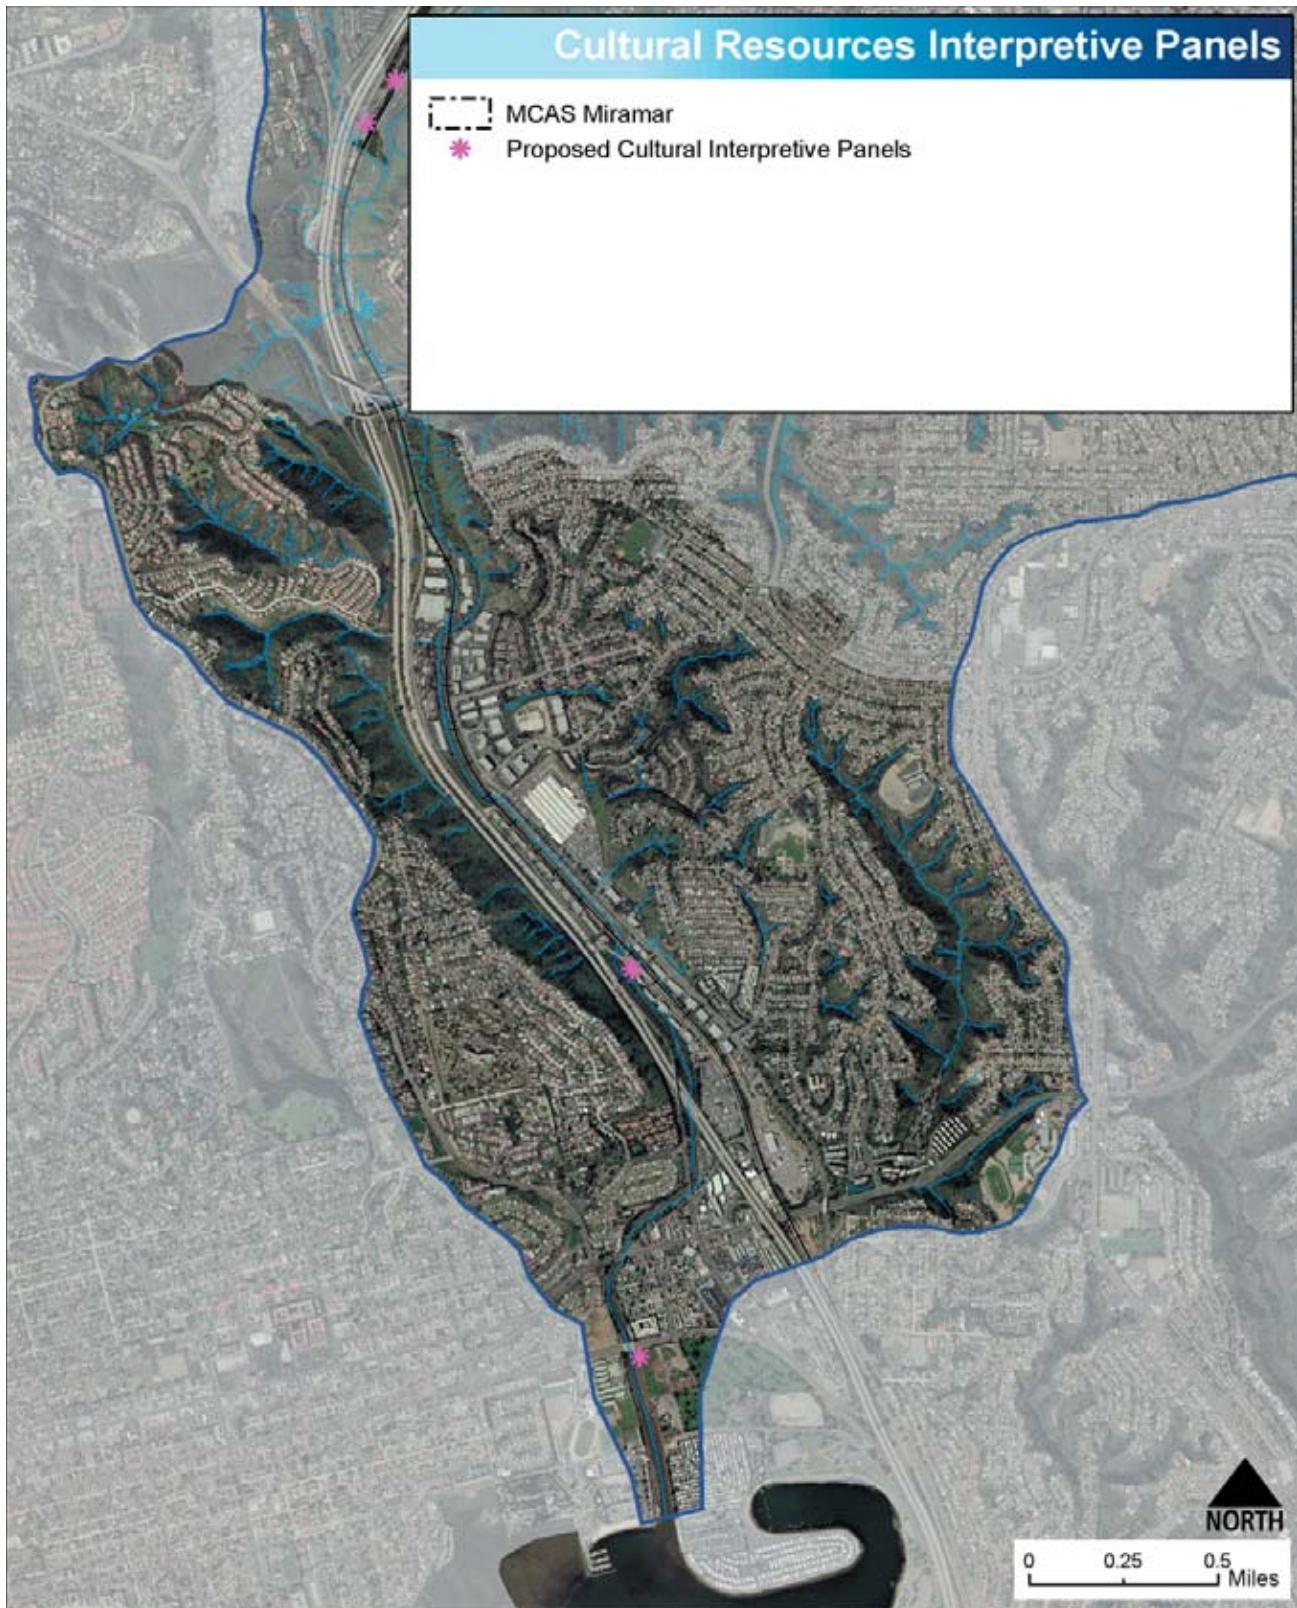
Figure 2-18: Aerial Map showing RC watershed fire line imposed over watershed line

In light of the 2003 wildfires in San Diego, many residents, community leaders and public officials are looking for ways of preventing another round of devastating fires while preserving the natural qualities that we value. Active fire risk management is an important first step, especially in areas like the RCW where substantial areas of natural vegetation occur directly adjacent to urban development. This is especially critical when you consider that if it were not for a slight shift in the wind patterns during the October 2003 Cedar fire, the fire could have continued through MCAS Miramar, across I-805 and down San Clemente Canyon, potentially traveling all the way to the coast (Figure 2-18).

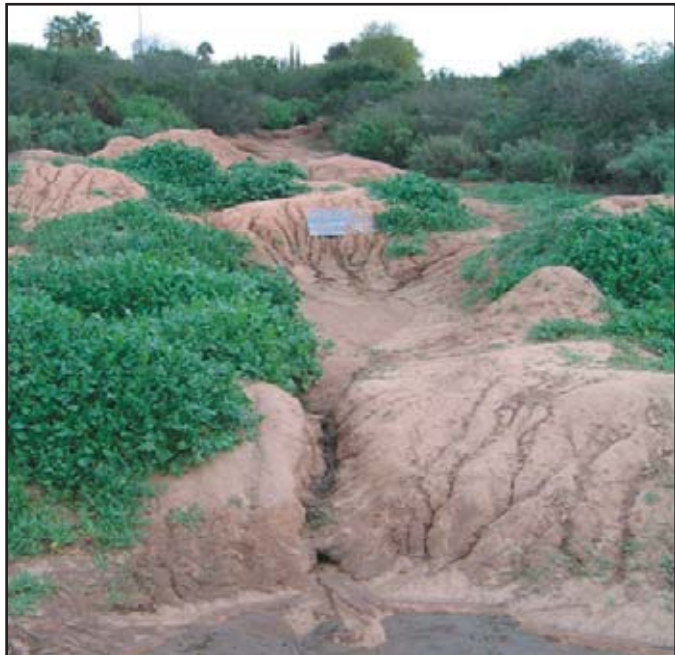
An Illegal BMX track eroding after spring rains

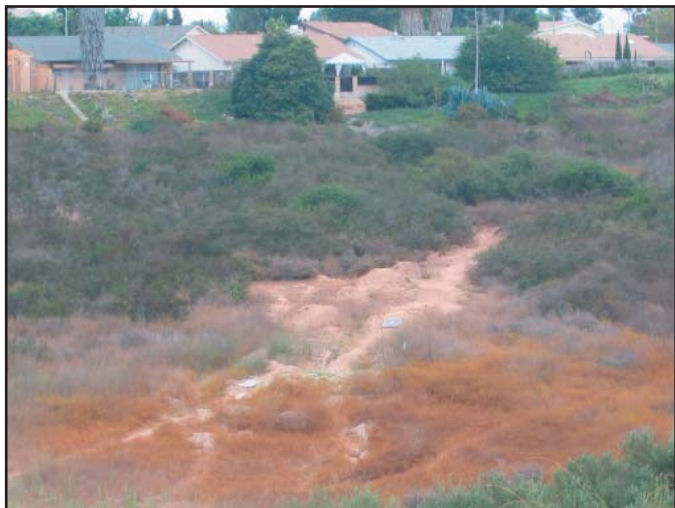
Same Illegal BMX track showing its adjacency to residential development

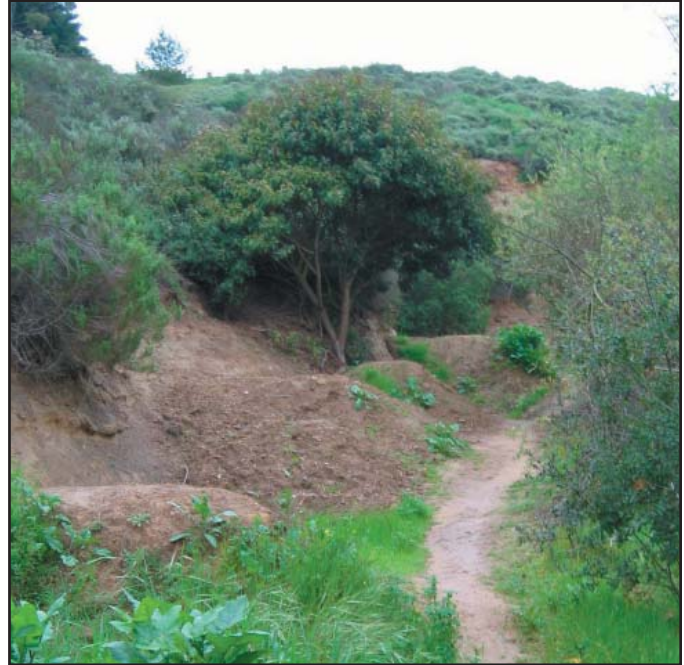
Illegal BMX/Motorcycle track hidden in tributary canyon

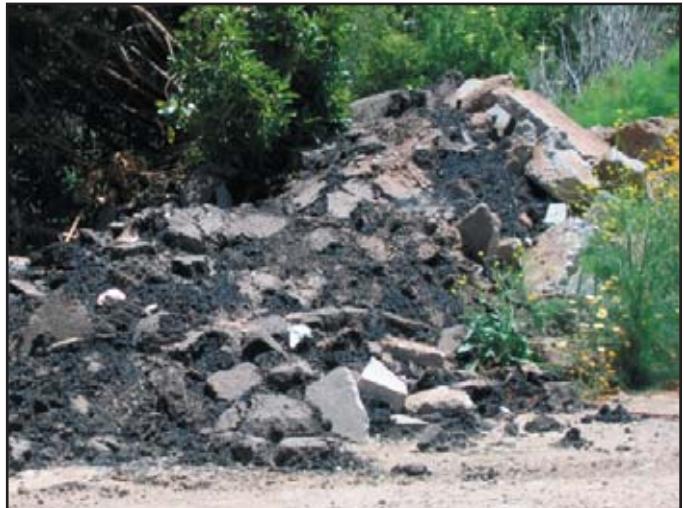
Illegal dumping of construction and landscape waste

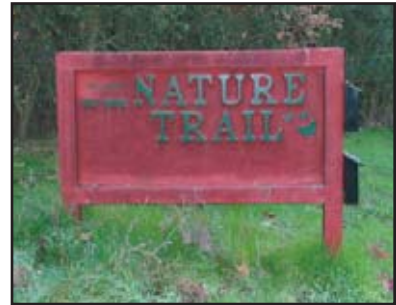
Interpretive nature trail in San Clemente Canyon at western most end of Regents Road parking lot

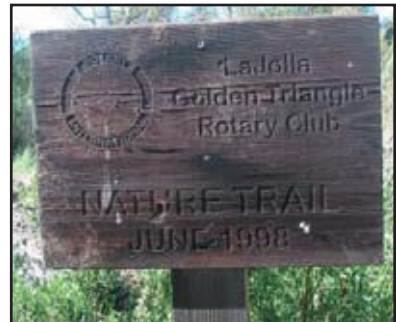
Interpretive nature trail in Rose Canyon at west end of Governor Drive

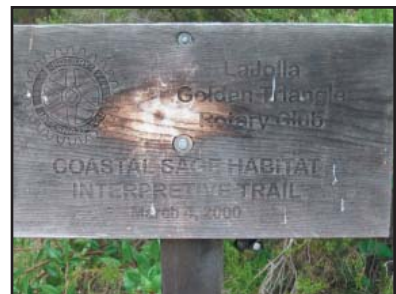
Interpretive nature trail in Rose Canyon near Genesee Avenue

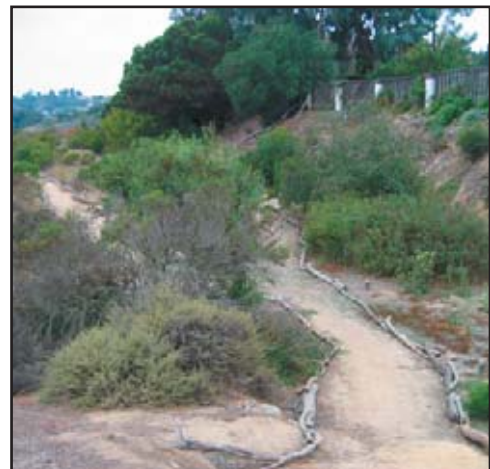
Interpretive nature trail in Rose Canyon at the end of Governor

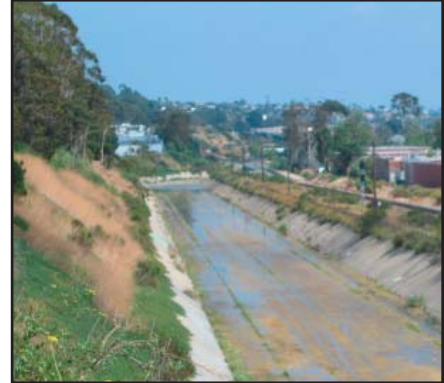
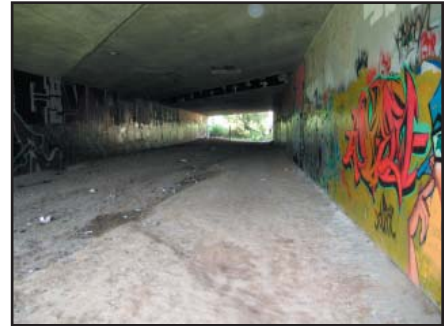
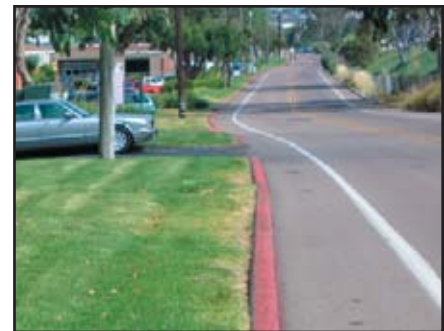
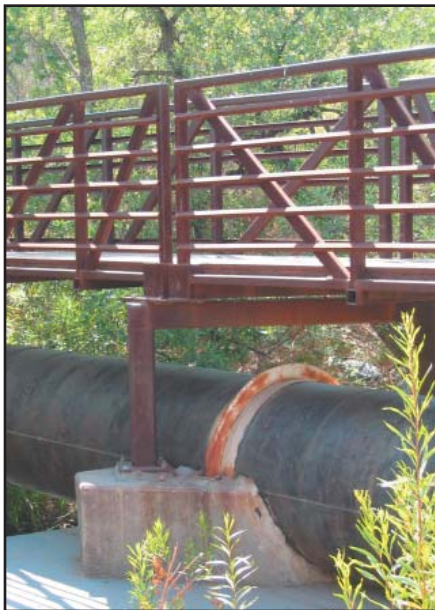
Figure 2-34: lower Rose Creek Class I Path – Alternative A

Alternative 'A' (Figure 2-34) begins at the end of the Rose Canyon Bike Path and immediately crosses over the railroad tracks via a bridge structure and then runs parallel to the railroad tracks past the business development to the east until the railroad crosses over Rose Creek via a trestle. At this point, the path departs from the railroad and utilizes the private road crossing over Rose Creek and then proceeds along the slope to come back parallel with the railroad tracks. The path follows the railroad tracks to the south until Jutland Drive, where it diverts to the east to follow along the top of the existing concrete flood control channel. At the south end of the channel, the path drops down the stream bank to cross under the railroad trestle and Santa Fe Drive. Once under Santa Fe Drive, the path comes back to the top of the stream bank and parallels the businesses along this portion of Santa Fe Drive before diverting to the west slightly to follow an existing earthen berm behind the SDG&E maintenance yard to Interstate 5, where it drops back down the stream bank to cross under Interstate 5 through one of the two eastern most openings. Once under Interstate 5, the path comes back up the stream bank and uses an existing path along the top of the concrete flood channel past the In-N-Out Burger towards North Mission Bay Drive, where a ramp is needed to allow the path to cross under North Mission Bay Drive and connect to the existing Class I path that continues down Rose Creek towards Mission Bay.

Both alternatives were assessed for preliminary feasibility through cross-sectional studies at the locations shown in Figures 2-34/35. Figure 2-36 is a sample of one of those cross-sections depicting the various elements proposed within the corridor. The remainder of the cross-sectional studies are included in Chapter 4, Section 4.5.4 on page 4-21.

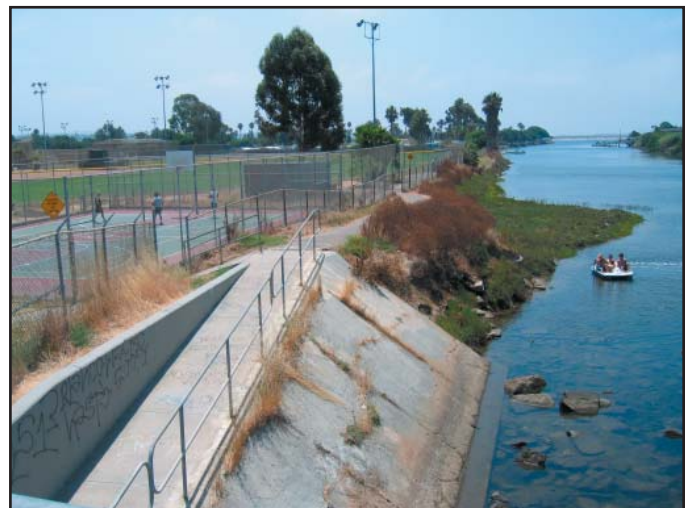
Figure 2-37: Grand Avenue to Mission Bay Class I Improvements

- An additional section of a Class I path is proposed to replace and re-align the sub-standard path that currently connects from Grand Avenue to Mission Bay Drive around the Boat and Ski Club facility (Figure 2-37). The proposed alignment would route through the Boat and Ski Club lease area along lower Rose Creek and connect to Mission Bay Drive where the planned bicycle/pedestrian bridge over Rose Creek is proposed. Should the city have an opportunity to re-negotiate the Boat and Ski Club lease prior to its termination, it would be advisable to realign, redesign and widen the trail to one more fitting to its role as a gateway to Mission Bay Park. At a minimum, these improvements should be planned and designed for implementation as part of the long-range proposals described in the Mission Bay Park Master Plan for the De Anza Special Study Area.

As an interim measure, in addition to the re-alignment, the western 6-foot tall chain-link fence with constantine razor wire should be removed and replaced with a City of San Diego Park and Recreation Department standard lodge-pole fence. The facility would also be widened to meet Class I standards (width is as narrow as 5.5ft now, should be at least 8ft) and opportunities to create rest areas with benches to facilitate safe wildlife viewing and interpretive areas should be assessed as shown in Figure 2-37.

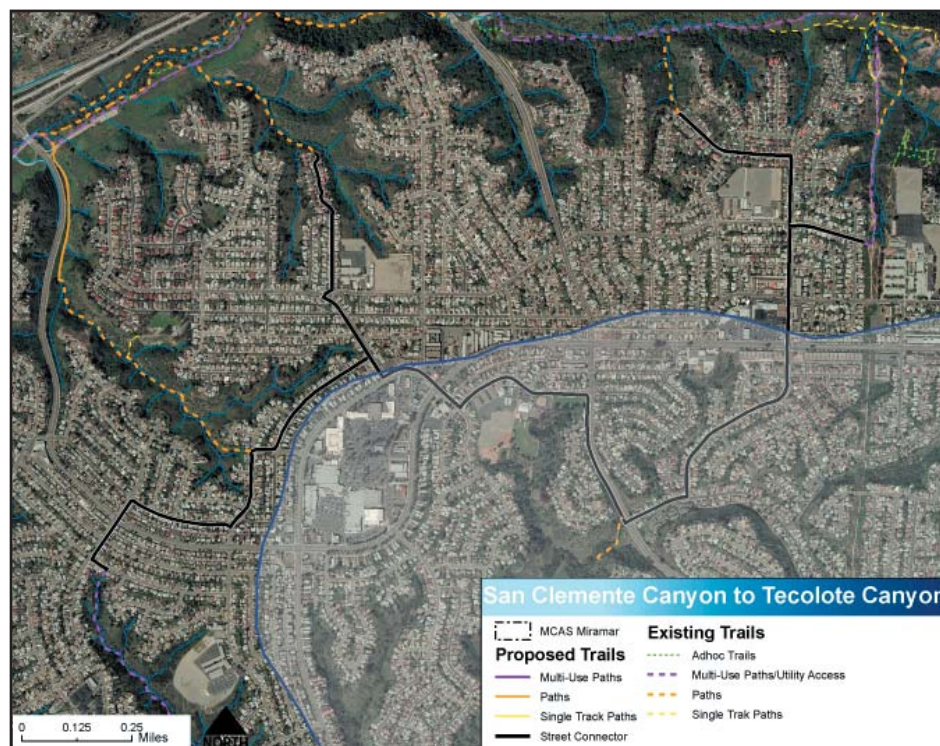
Figure 2-38: Connecting Marian Bear Memorial Natural Park and Tecolote Canyon

The southern portion of this alignment could also be accomplished through the implementation of the Class I path being proposed via a separate project by the City of San Diego to connect Governor Drive to Convoy Street.

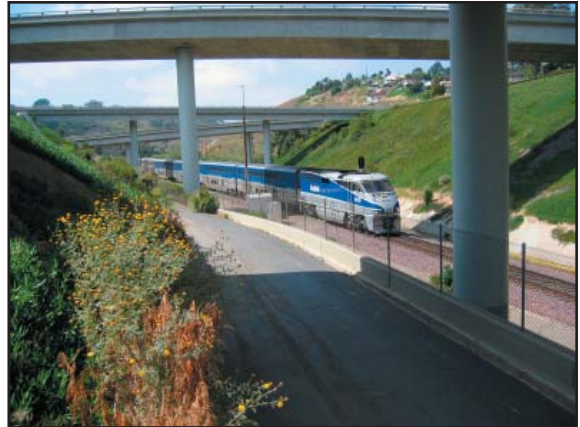
Figure 2-39: Recommended Improvements to the At-grade Railroad Crossing

Some solutions to the at-grade railroad crossing include: leveling the traveling surface for trail users; reducing gaps caused by the railroad tracks; reducing the loose material around the crossing; incorporating signals and signage; and separating the railroad tracks and the trail. A travel surface that is flush with the railroad tracks and without large gaps can reduce the potential for tripping hazards and allow wheelchairs and bikes to safely cross. The trail surface should be hardened to reduce the debris that scatters over the tracks as users pass. Eliminating the ballast fillings can prevent loose material from accumulating across the travel surface.

Separation between the railroad tracks and the trail is another solution to limit the trespassing along the railroad corridor and improve the safety and welfare of the trail users. Examples of barriers include vegetation, fencing and vertical grade separation. Based on the physical conditions surrounding the at-grade crossing, neither a vegetative barrier nor vertical grade separation are practical. A fence 4 to 6 feet high is the most appropriate barrier at this location. The fence should be installed as shown in Figure 2-39 and run at least 100 feet in either direction to deter trail users from crossing at other locations than the improved at-grade crossing.

The existing railroad crossing north of the Rose Canyon Bike Path currently has deficiencies that prevent the immediate opening of the crossing for trail users, even if access were approved by the railroad. The surface is an uneven mix of timber railroad ties, patches of ballast and an uneven asphalt surface between the two tracks. The northbound track is elevated 1-2 inches above the southbound track. The railroad ties are uneven and rise almost an inch over the tracks in certain spots, creating a trip hazard. There are also gaps of 3 to 4 inches between the railroad ties and the tracks. The ramps that approach the tracks are paved with asphalt and are 9 feet in length, but tend to be littered with ballast from passing trains, maintenance vehicles and trail users. There currently is no fencing that prevents trail users from illegally

The at-grade crossing currently is roped off and incorporates a passive warning device; a sign that alerts trail users not to cross the tracks. This warning device does not comply with the Manual on Uniform Traffic Control Device (MUTCD) minimum recommended treatment where each approach to the crossing has at least one Crossbuck sign. If the crossing is to be opened, an active warning device should be used at this crossing. Active warning devices include a combination of bells, flashing lights, automatic gates and other devices that are triggered by the presence of an oncoming train.

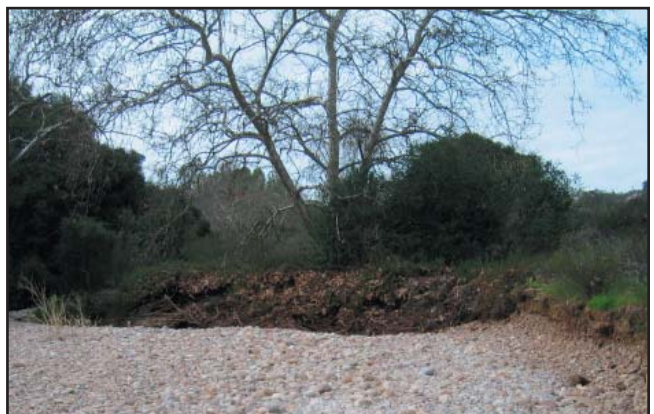
Figure 2-46: Cross-section depicting a more natural stream channel environment

Vegetative Cover: Vegetative cover is an important characteristic to help gauge the health and stability of the stream channel. Under natural conditions, the streambeds of the Rose Creek Watershed are part of a highly dynamic environment with a cobble substrate and mobile sands and fine sediments being constantly introduced and transported through the stream channels by natural erosion. Vegetative cover was likely comprised of minimal riparian vegetation stabilizing the stream banks and quickly transition to upland communities (Figure 2-46).

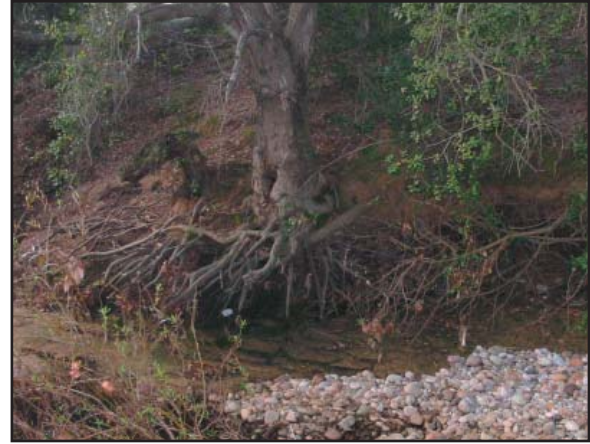
Figure 2-47: Cross-section depicting an eroded stream channel environment

Under pre-development conditions, the highly erosive native soils maintained a sufficient supply of transportable sediment within the stream channels, and vegetative cover kept stream bank erosion at natural rates, with significant stream channel changes only occurring during episodic flood events. As the watershed has developed, the natural erosion processes have been interrupted as land has been covered with impervious surfaces, which has not only reduced the amount of natural sediment supply, but has also increased the runoff volume and velocity associated with a given storm event. The increased runoff volume and velocity from larger storm events generates enough energy to move the protective cobble substrate and expose the underlying streambed to these erosive stream discharges. As the streambed gradually erodes, the stream banks become undercut and often collapse, thereby displacing the vegetative cover that was stabilizing the stream bank under natural conditions (Figure 2-47). The new un-vegetated stream banks are highly susceptible to continued erosion and may continue to recede until the stream discharges reach a new equilibrium with the sediment transport, or new vegetation becomes established and stabilizes the bank. Re-introducing native vegetative cover on stream banks needs to be a component of any stream restoration action.

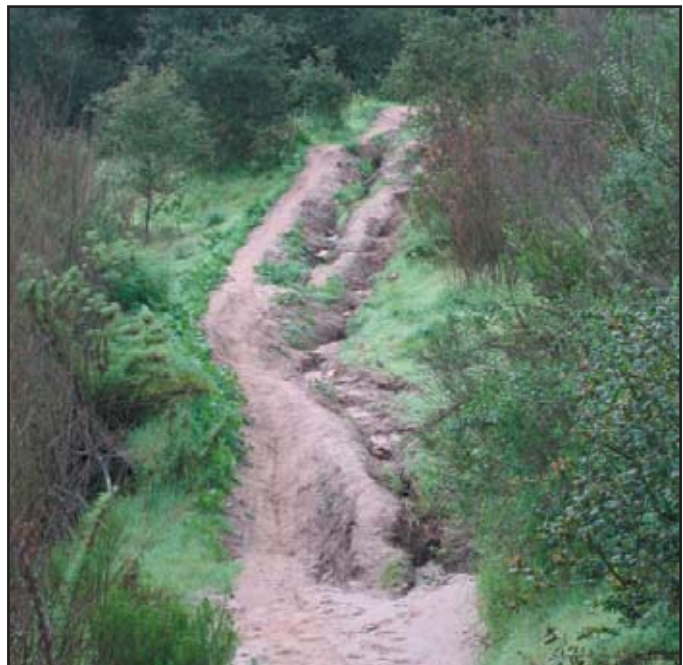
Figure 2-48: Areas of Erosion within Upper Rose Canyon

Trail related erosion occurs in a variety of forms throughout the watershed west of Interstate 805. Most of the eroding areas are relatively small in scale and act as a minor sediment source to down stream areas, but can result in significant degradation of the recreational trail system. Figures 2-48 to 2-50 show the locations of identified trail erosion issues. The vast majority of these erosion issues relate to improper handling of storm water runoff that has led to the erosion and degradation of the recreational trails. Many of these problem areas can be fairly easily fixed through the use of knicks or rolling grade dips to help stabilize the trails and create a self sustaining drainage system to minimize future trail erosion. See Chapter 4, Section 4.6.5 on page 4-33 for more information.

Many of the stream banks and streambeds within the RCW are experiencing varying degrees of erosion (Figures 2-48 to 2-50). In addition to the erosion that is occurring within the main drainages of Rose and San Clemente creeks, most of the tributary canyons have been impacted by erosion associated with storm drain discharges and are currently characterized by moderate to severe erosion and gully formation. Some of these gullies are deep, as much as 15-20 feet, and could pose a hazard to the public.

In addition to the erosion that is occurring within Rose and San Clemente creeks, most of the tributary canyons have been impacted by storm drain discharges and are currently characterized by moderate to severe erosion and gully formation (Figures 2-48 to 2-50). Due to the severity (15-20 feet deep) and length (>0.5 mile) of some of these gullies, a long-term adaptive management approach (e.g. incremental improvements starting at the downstream extents of the gully to raise the streambed and stabilize the stream banks) may be necessary to correct the conditions that led to and continue to contribute to the erosion, as well as restore the gullies to more stable vegetated conditions. Before or while the gully erosion is addressed, the storm drain and culvert outfalls need to be altered to correct, or at least alleviate, the physical characteristics that led to the erosion problems initially.

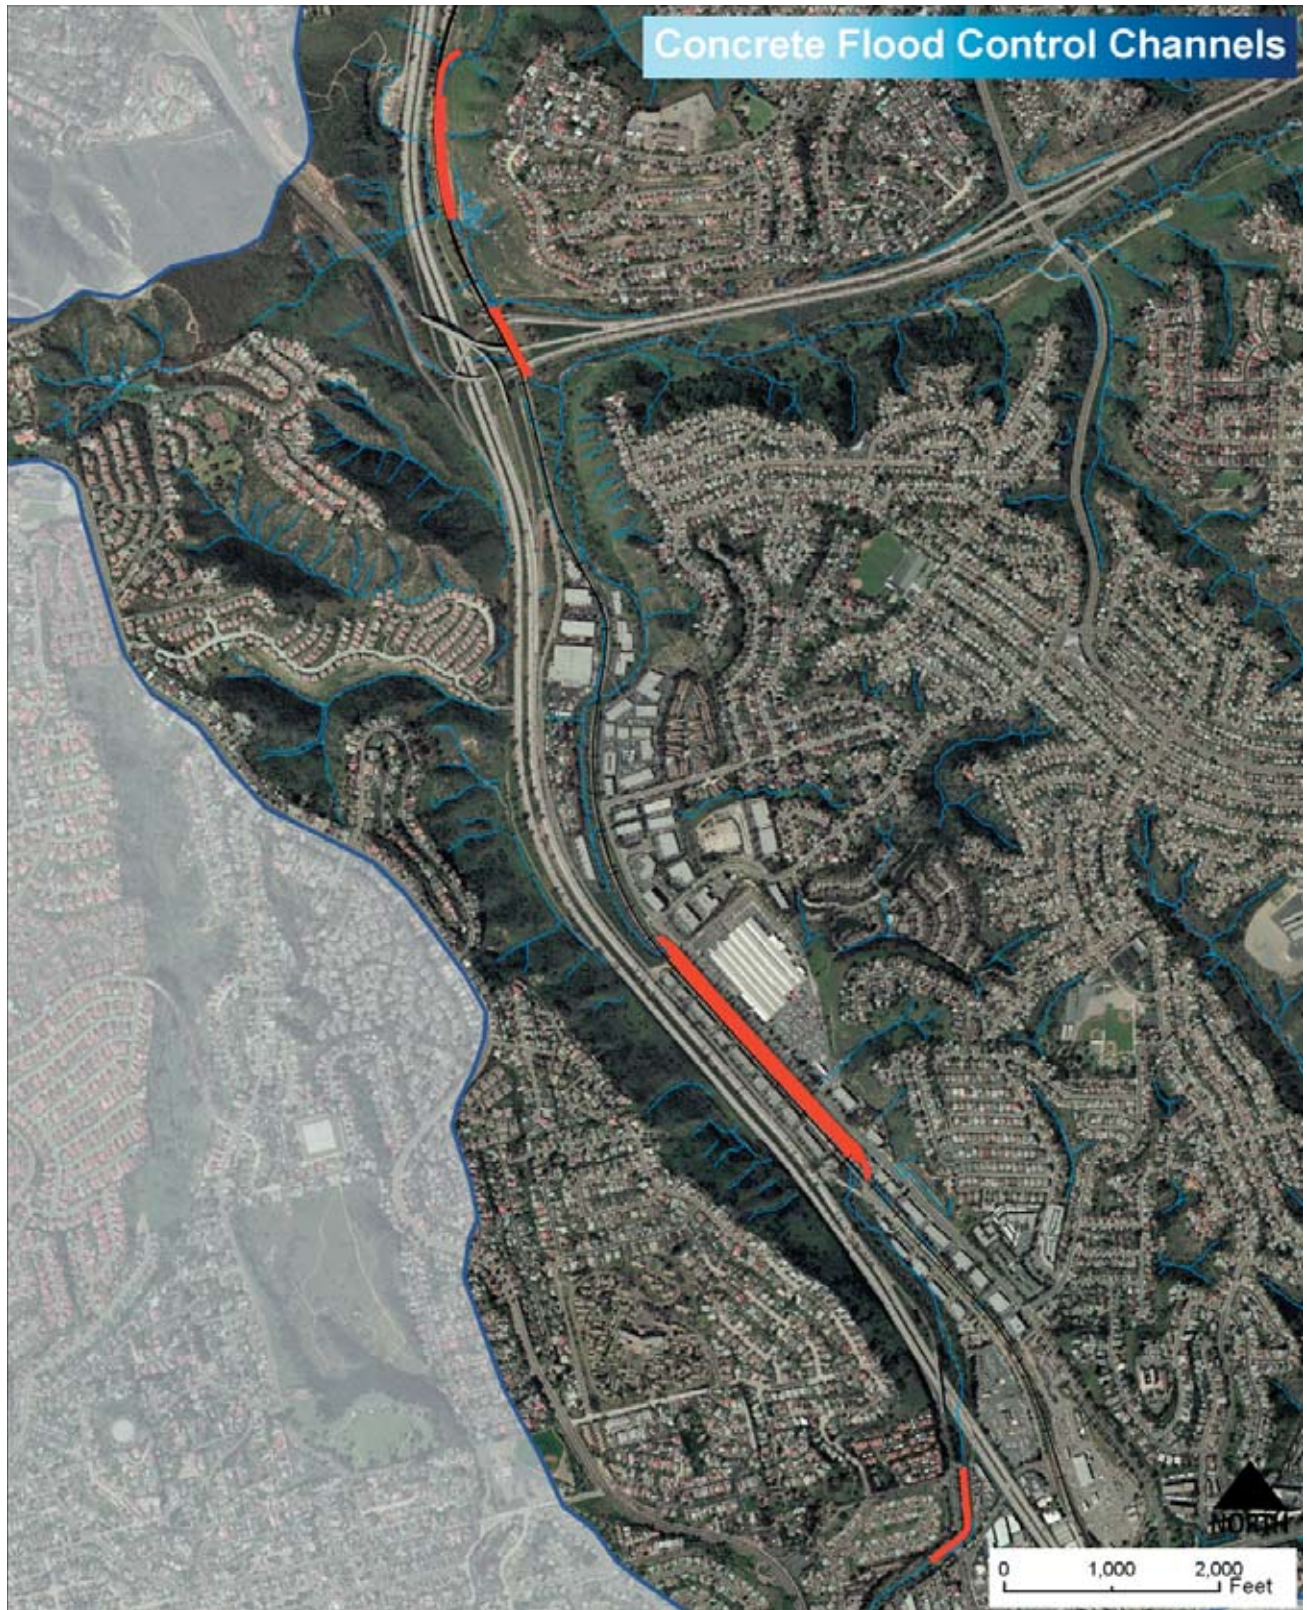
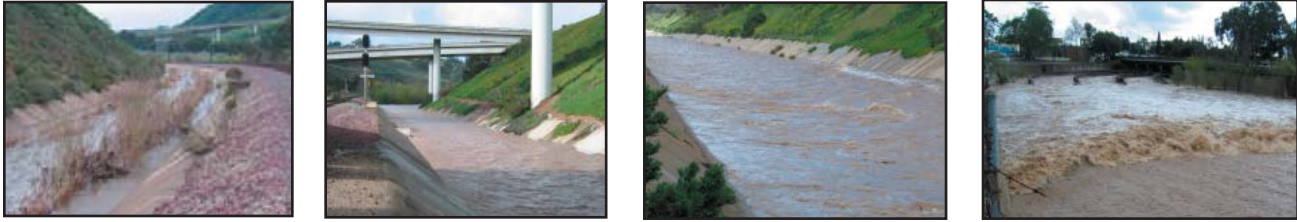
Figure 2-51: Concrete flood control channels

There are four significant reaches of concrete channel (Figure 2-51) from Gilman Drive to Mission Bay that have been targeted for potential removal and conversion to alternative materials and designs that would allow the establishment of native vegetation communities and public access.

The first is a 1,500-foot long concrete trapezoidal channel located about 0.25 miles above the State Route 52/ Interstate 5 interchange along the railroad tracks. The second is a 700-foot long concrete trapezoidal channel occurring underneath the State Route 5 /Interstate 5 interchange along the railroad tracks. The third is a 3,000-foot long concrete trapezoidal that occurs between Morena Boulevard and Santa Fe Street and is terminated at either end by railroad bridges. The fourth is a 800-foot long concrete box channel with flow direction fins that occurs between Interstate 5 and Mission Bay Drive.

The conversion of these concrete channels to native plant communities would provide for a number of potential benefits: 1) improve public safety in lower Rose Creek; 2) provide missing habitat linkages for various species; 3) provide structurally varied vegetation communities (canopy trees, understory trees/shrub, groundcover) that can help improve overall bio-diversity of the watershed; 4) improve water quality through bio-filtering and stream shading; 5) improve storm water detention through increases in channel roughness and the introduction of pervious substrates; and 6) provide new public recreation benefits.

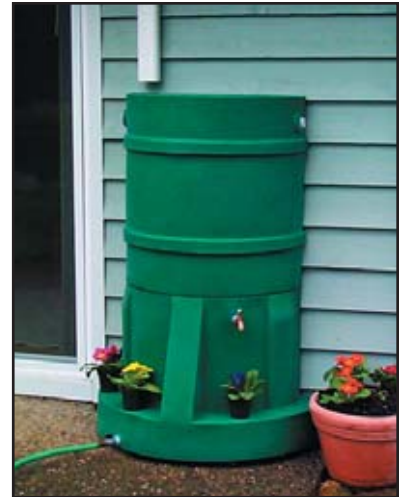
The reduction of storm water runoff is a necessary component of the successful restoration of the storm drain and culvert outfalls, the eroded tributaries, and the main stream channels of Rose and San Clemente creeks. Reduction efforts can be undertaken at a variety of scales using a variety of best management practices. The goal of this action is the actual reduction of storm water runoff through the use of best management practices (BMPs) that utilize infiltration techniques to capture and allow storm water to soak into the soil for storage and more natural release into the stream channels. A description of recommended BMPs (dry well, trench drain, rain garden, rain barrel) for storm water reduction can be found in Chapter 4, Section 4.6.6 on page 4-34. Due to the low infiltration rates that naturally occur throughout most of the RCW; infiltration tests done by a professional geotechnical engineer are highly recommended to ensure the BMP will properly drain and not create a nuisance with standing subsurface water. To account for the natural limitations of the native soils, the BMPs are recommended for installation in series (rain barrel to trench drain to rain garden to dry well to storm drain system) to ensure the least amount of runoff reaches the dry well as possible, thus minimizing the potential for standing subsurface water.

The purpose of these BMPs is not to capture 100 percent of the runoff from all storm events, but to capture the runoff from the first one-half to one inch of rainfall, which represents the most frequent storms within the San Diego region. A typical volume of rainfall targeted for capture (retention or re-use) from a 2,000 square foot home with a two car garage and 20 foot long driveway is as follows:
