3.0 Watershed Overview

Rose Creek Watershed Opportunities Assessment

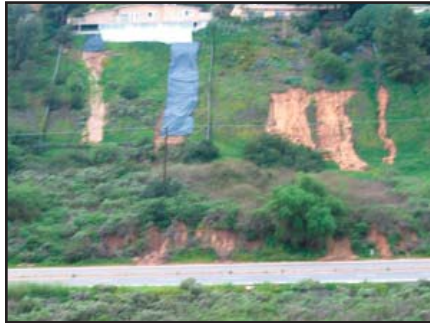
Figure 3-3: Geologic Hazards

Based in part on this 'layer cake' of sedimentary rock deposits, a variety of geologic hazards (Figure 3-3) exist within the RCW that need to be accounted for and potentially addressed during the planning and implementation of improvement projects.

Landslides, a type of "mass wasting" denotes a downward movement of soil and rock under the influence of gravity. Landslides vary in sizes depending on the geology and initial cause of the landslide. Landslides have predominantly occurred on the steep slopes of Rose Creek south of the confluence with San Clemente Creek.

Liquefaction occurs in saturated soils in which the space between individual particles is completely filled with water. Increased water pressure caused by the shaking of an earthquake allows the particles to move in respect to each other thereby decreasing the stability of the soil. Potential liquefaction can be found along the entire length of both San Clemente Creek and Rose Creek and at the mouth of Rose Creek in Mission Bay.

Slide Prone Formations are areas of neutral to unfavorable geologic formations that can cause landslides. These areas can be identified as having steep slopes with very little vegetation to stabilize the slope. Slide Prone Formations can be found along the steep hills along Rose

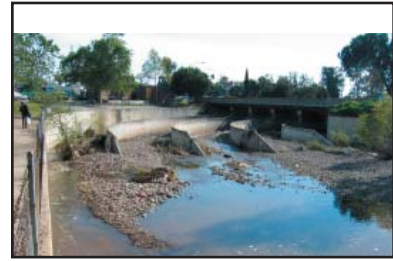
lower end of the watershed at the vertical sided concrete channel beneath East Mission Bay Drive. This un-vegetated concrete channel is frequently flooded and has vertical sides that abut high traffic businesses such as In-N-Out Burger, effectively precluding wildlife, particularly species such as the light-footed Clapper Rail, from moving between the riparian habitats of Rose Creek and the fringe habitats around Mission Bay. Other barren concrete trapezoidal channel sections occur upstream along Rose Creek and further impair wildlife movement within the lower portions of Rose Creek.

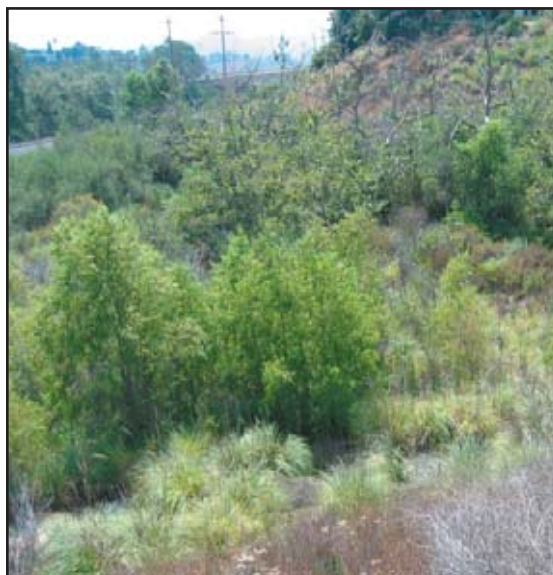
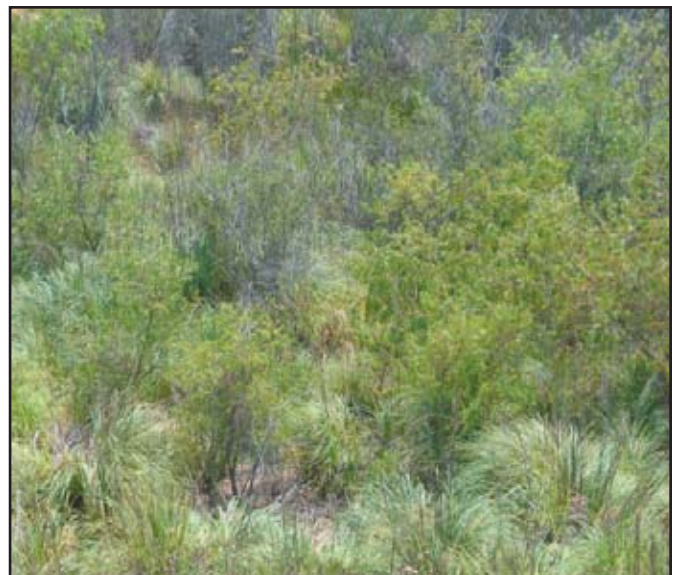
Figure 3-11: Mitigation Sites

Documenting where previous restoration, enhancement, or mitigation efforts have occurred throughout the RCW is important in determining where future efforts can be appropriately planned and implemented. Figure 3-11 shows the restoration, enhancement, or mitigation efforts that the project team has identified to date. These represent efforts undertaken by MCAS Miramar, various City of San Diego departments, private developers, and volunteers. The three types of mitigation areas on MCAS Miramar are vernal pool restoration, coastal sage scrub mitigation and riparian mitigation. Currently, MCAS Miramar is restoring about five acres of vernal pool habitat, 88 acres of coastal sage scrub and 2.4 acres of riparian wetland. It should also be noted that some of the older mitigation sites that are beyond the five-year monitoring period have declined and are now infested with invasive exotics. The decline of these sites underscores the necessity for long-term maintenance and management of restoration and mitigation sites to prevent their gradual degradation by invasive exotic plants or human activities.

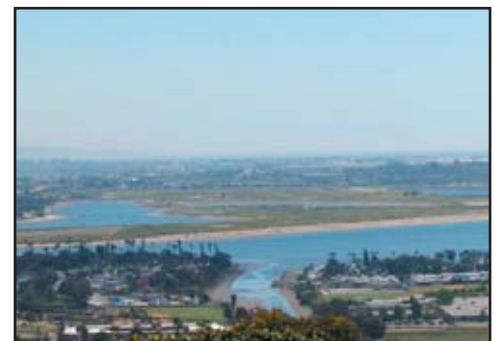
Figure 3-12: Surface Water Features

Both creek systems are very cobbled in nature with numerous sections of standing water in their lower reaches. The portions of Rose and San Clemente creeks east of Interstate 805 are intermittent streams with cobblestone streambeds and various trees growing intermittently within them (Figure 3-12). As the creeks progress southwest beyond Interstate 805, their character changes as dry-weather flows are added from adjacent urban development from over-irrigation of landscapes. These dry-weather flows have allowed for the formation of dense riparian scrub habitat with numerous small in-stream ponds as wide as six feet. Various types of riparian trees have taken root within the drier channel segments, or within the over-bank floodplain, including sycamores, bay laurel, coast live oak, and various willows. Along the lower portions of the creeks, the riparian scrub habitat is dense with a healthy understory and narrow channels varying from two feet to six feet wide. The San Clemente Creek channel is typically a bit wider than Rose Creek, which may in part be due to the less dense riparian understory that exposes the stream banks to more direct storm flows and erosion potential.

The major surface water resources within the RCW are Rose Creek and San Clemente Creek. Both creeks flow southwesterly until their confluence near the interchange between Interstate 5 and State Route 52, then flow south to Mission Bay. Both creeks would naturally only have precipitation driven seasonal flows with riparian and aquatic communities adapted to periods of dry conditions. With the contribution of dry weather flows from the nearby urbanized landscaping, the lower sections of both Rose Creek and San Clemente Creek are now nearly perennial in nature. There are no significant groundwater aquifers present in the RCW. The aquifers that do exist are narrow shallow alluvium deposits that support the existing riparian communities along the canyon bottoms.

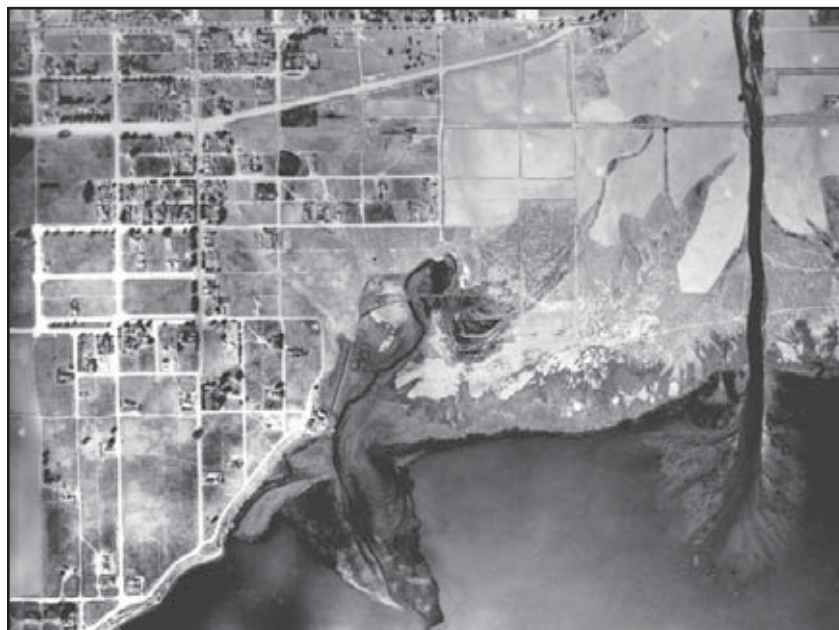
Figure 3-13. 1935 Aerial photograph of Rose Creek

Bay and preparing it for the twentieth century. Gradual improvements to the new channel were accelerated in the 1930s (Figure 3-13) to accommodate WWII military needs, as well as postwar land development in the 1940s. The creek's straightened channel allowed development to squeeze the waterway in the same manner as many other urban streams. In less than 25 years, Rose Creek's channel was re-aligned and armored by the U.S. Army Corps of Engineers to prevent floodwaters from flowing down El Camino Real-Coast Highway.

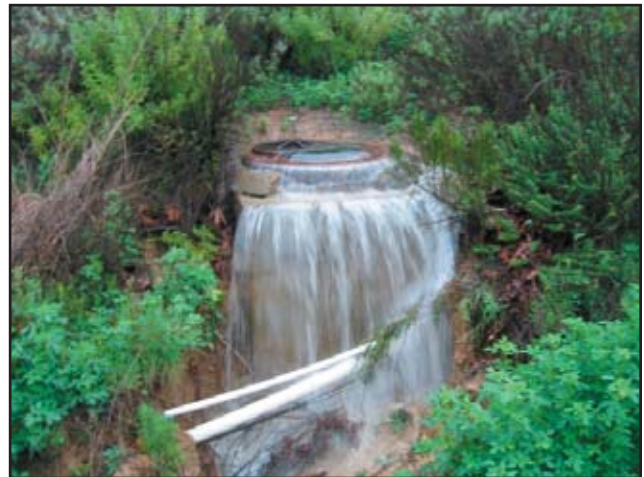
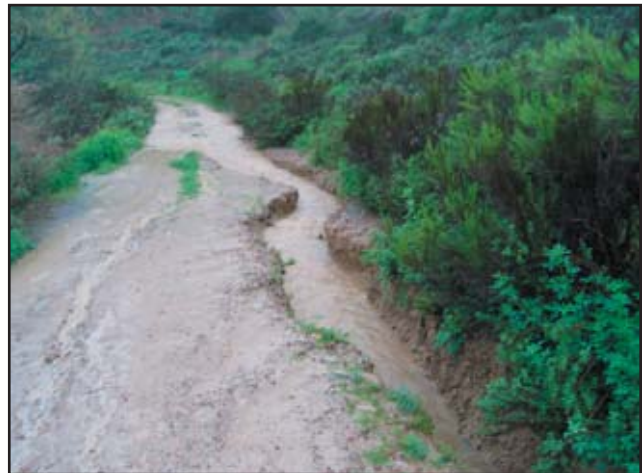
Figure 3-15: Hydromodifications

Understanding the degree to which the natural hydrology has been modified by land development and channel or floodplain modification is an important first step (Figure 3-15). As the lands within a watershed are converted from native vegetation communities to various types of developed land uses (e.g. transportation networks, commercial areas, and residential developments), the ability of the land surface to absorb rainfall is modified, causing higher rates of runoff to occur. These increases in storm water runoff, including dissolved and suspended pollutant loads, are often focused into street gutters, roadside ditches, and storm drainpipes, and conveyed and discharged into a canyon, tributary drainage, or main channel. This modifies the runoff volume and velocity typically experienced under natural conditions. The natural environment is forced to respond to these new forces in an effort to reach an adjusted state of dynamic equilibrium. Adjustments often appear as the formation of stream channels in canyon bottoms that did not previously have them, or the enlargement of an existing stream's cross-sectional area via streambed down-cutting or stream bank erosion. As more natural land area is converted to developed land uses, the volume and rate of runoff typically continues to increase, which in turn causes the natural drainage system to continue to adjust. The drainage network will continue to try and adjust to a new equilibrium by incising channels deeper or widening them until the sediment transport capacity of the stream reaches a point of dynamic equilibrium, which is when the sediment input to the system approximately equals the sediment being transported through the system.

A hydrologic modification is the alteration of the natural circulation or distribution of water by the placement of structures or other activities (USEPA, 1992). Hydrologic modifications are typically human modifications to the surface water hydrology (e.g. dams, stream channelization, culverts, roads, roofs, and urban development storm drains) and are typically categorized into three categories: 1) dams; 2) channelization and channel modifications; and 3) streambank and shoreline erosion. These modifications can adversely impact the hydrology and quality of surface waters and aquatic and riparian habitats in a variety of ways.

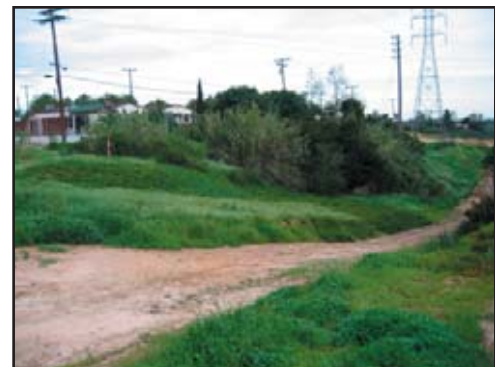
Access from Lehrer Drive and SDG&E maintenance road

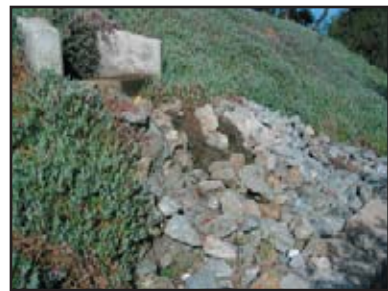
Most of the storm drain systems servicing the developed areas of the watershed have outfalls in tributary canyons that then drain into Rose or San Clemente creek (Figure 3-27). In certain locations, the storm drain systems have their outlets directly into Rose or San Clemente Creek. This is particularly true within the lower portions of the watershed. The vast majority of the storm drain outfalls are characterized by immediate downstream erosion and gully formation, with some of the gullies being as large as 40 feet across and 20 feet deep.

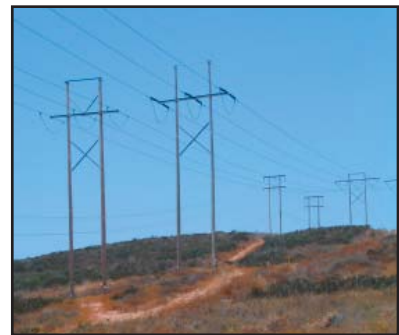
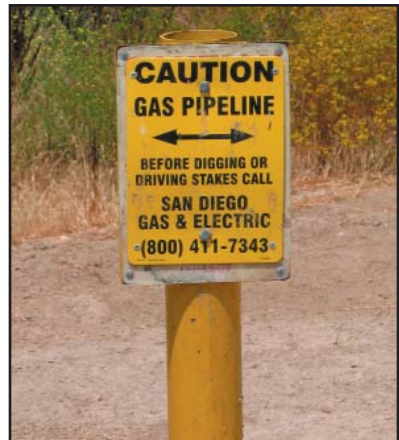
Figure 3-28: Gas and Electrical Distribution

San Diego Gas and Electric (SDG&E) operates and maintains four high-voltage transmission lines that cross the RCW (Figure 3-28). The high voltage transmission lines run predominantly east – west throughout the watershed with one main line running north – south along Interstate 805 and at Miramar Road directs east towards a SDG&E Substation just across the road from MCAS Miramar. A second SDG&E Substation is located in the northwest portion of the watershed in Sycamore Canyon off of Spring Canyon Road. The rights-of-way and easements associated with these high-voltage transmission lines could provide an opportunity for multi-use trails. Smaller community and neighborhood distribution lines are not shown in the figure.

San Diego Gas & Electric (SDG&E) operates and maintains a number of gas lines that distribute gas across the RCW (Figure 3-28). The main operating location of the gas lines is almost entirely between Interstate 5 and Interstate 805 excluding one line that runs west underneath Interstate 805 near Miramar Ranch North. Smaller community and neighborhood distribution lines are not shown in the figure.

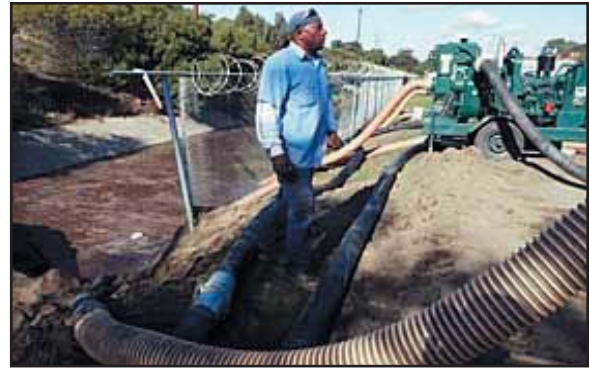
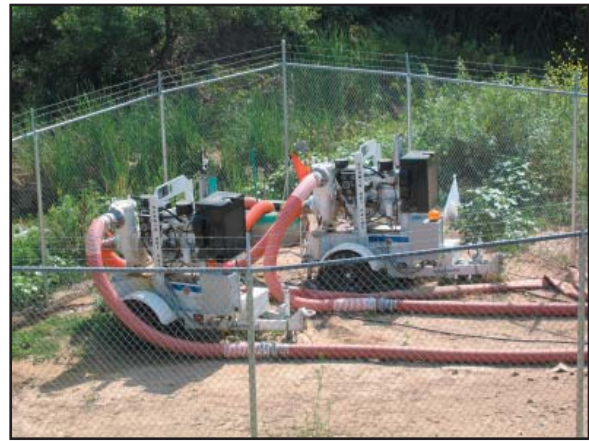
Figure 3-30: Sanitary Sewer Overflows

Since 1995, there have been 68 sewer overflow spills throughout the RCW recorded by the San Diego Regional Water Quality Control Board (Figure 3-30). Of these spills, 41% have been caused by root intrusion and 22% by grease buildup and the remaining 37% by other factors. In 1995-1996, there were 14 recorded spills in City of San Diego owned land of the RCW. Another 14 spills were recorded in between 1996-1997 throughout the same area. The 68 incidents collectively spilled nearly 525,000 gallons of sewage into the streams and only 8.4% of it was recovered before flowing completely downstream and entering Mission Bay. In May of 1996, the Regional Board adopted Order No. 96-04 which are waste discharge requirements prohibiting sanitary sewer overflows by sewage collection agencies. This order was adopted in response to what the Regional Board had been seeing as a serious and growing sewage problem in the region. The Board was very concerned and wanted a way to reduce the number and volume of spills and protect water quality, the environment and public health.

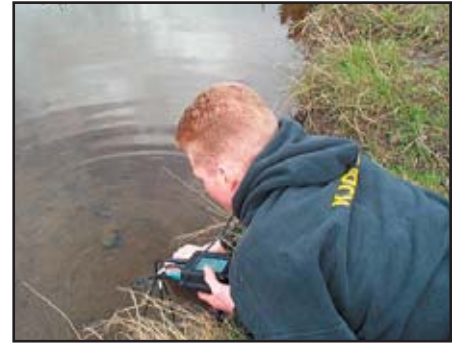
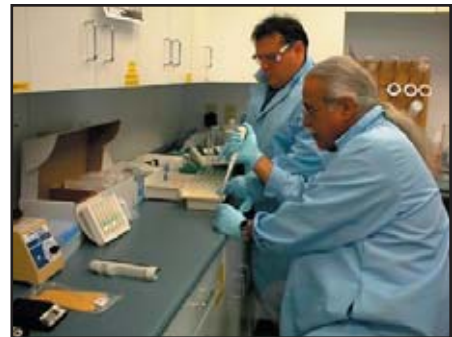
Figure 3-31: City of San Diego Dry and Wet Weather Monitoring

The Mission Bay Water Quality Survey, initiated by the City of San Diego Metropolitan Wastewater Department in 2001, collected data from 14 stations within the RCW (Figure 3-31). The focus of this monitoring has been on bacterial contaminants, but other physical and chemical analytes have been collected as well. This program collected weekly samples during both dry and wet weather conditions for 36-months. Additionally, as part of the MOU with the City of San Diego for this Assessment, the City has continued to collect dry weather monitoring data within the RCW at 24 stations. Sixteen of these stations are being used as field screening stations only and eight are being used for both field screening and laboratory analysis. The purpose of this monitoring is to detect and eliminate illicit connections and illegal discharges into the storm drain system. When tests reveal elevated levels of pollutants, follow up investigations are conducted as soon as possible to identify the source of pollution. Once the source is found, monitoring staff coordinate with the Storm Water Code Enforcement to eliminate the source so that they do not continued to contribute to lower water quality in Rose Creek. The monitoring data is evaluated annually to compare water quality data between the Rose Creek and other watersheds in the City and across the county. This assessment is included in the City of San Diego's annual Municipal Storm Water Permit report to the San Diego Regional Water Quality Control Board. As the results from these monitoring efforts are completed and released additional coordination with City staff will be required to determine what how to best incorporate any identified water quality specific actions with the actions recommended in this Assessment.
