# *Rose Creek Watershed Wetland, Riparian & Water Quality Restoration Opportunities Analysis*

*City of San Diego, San Diego County, California*

## **FINAL REPORT**

*January, 2012*

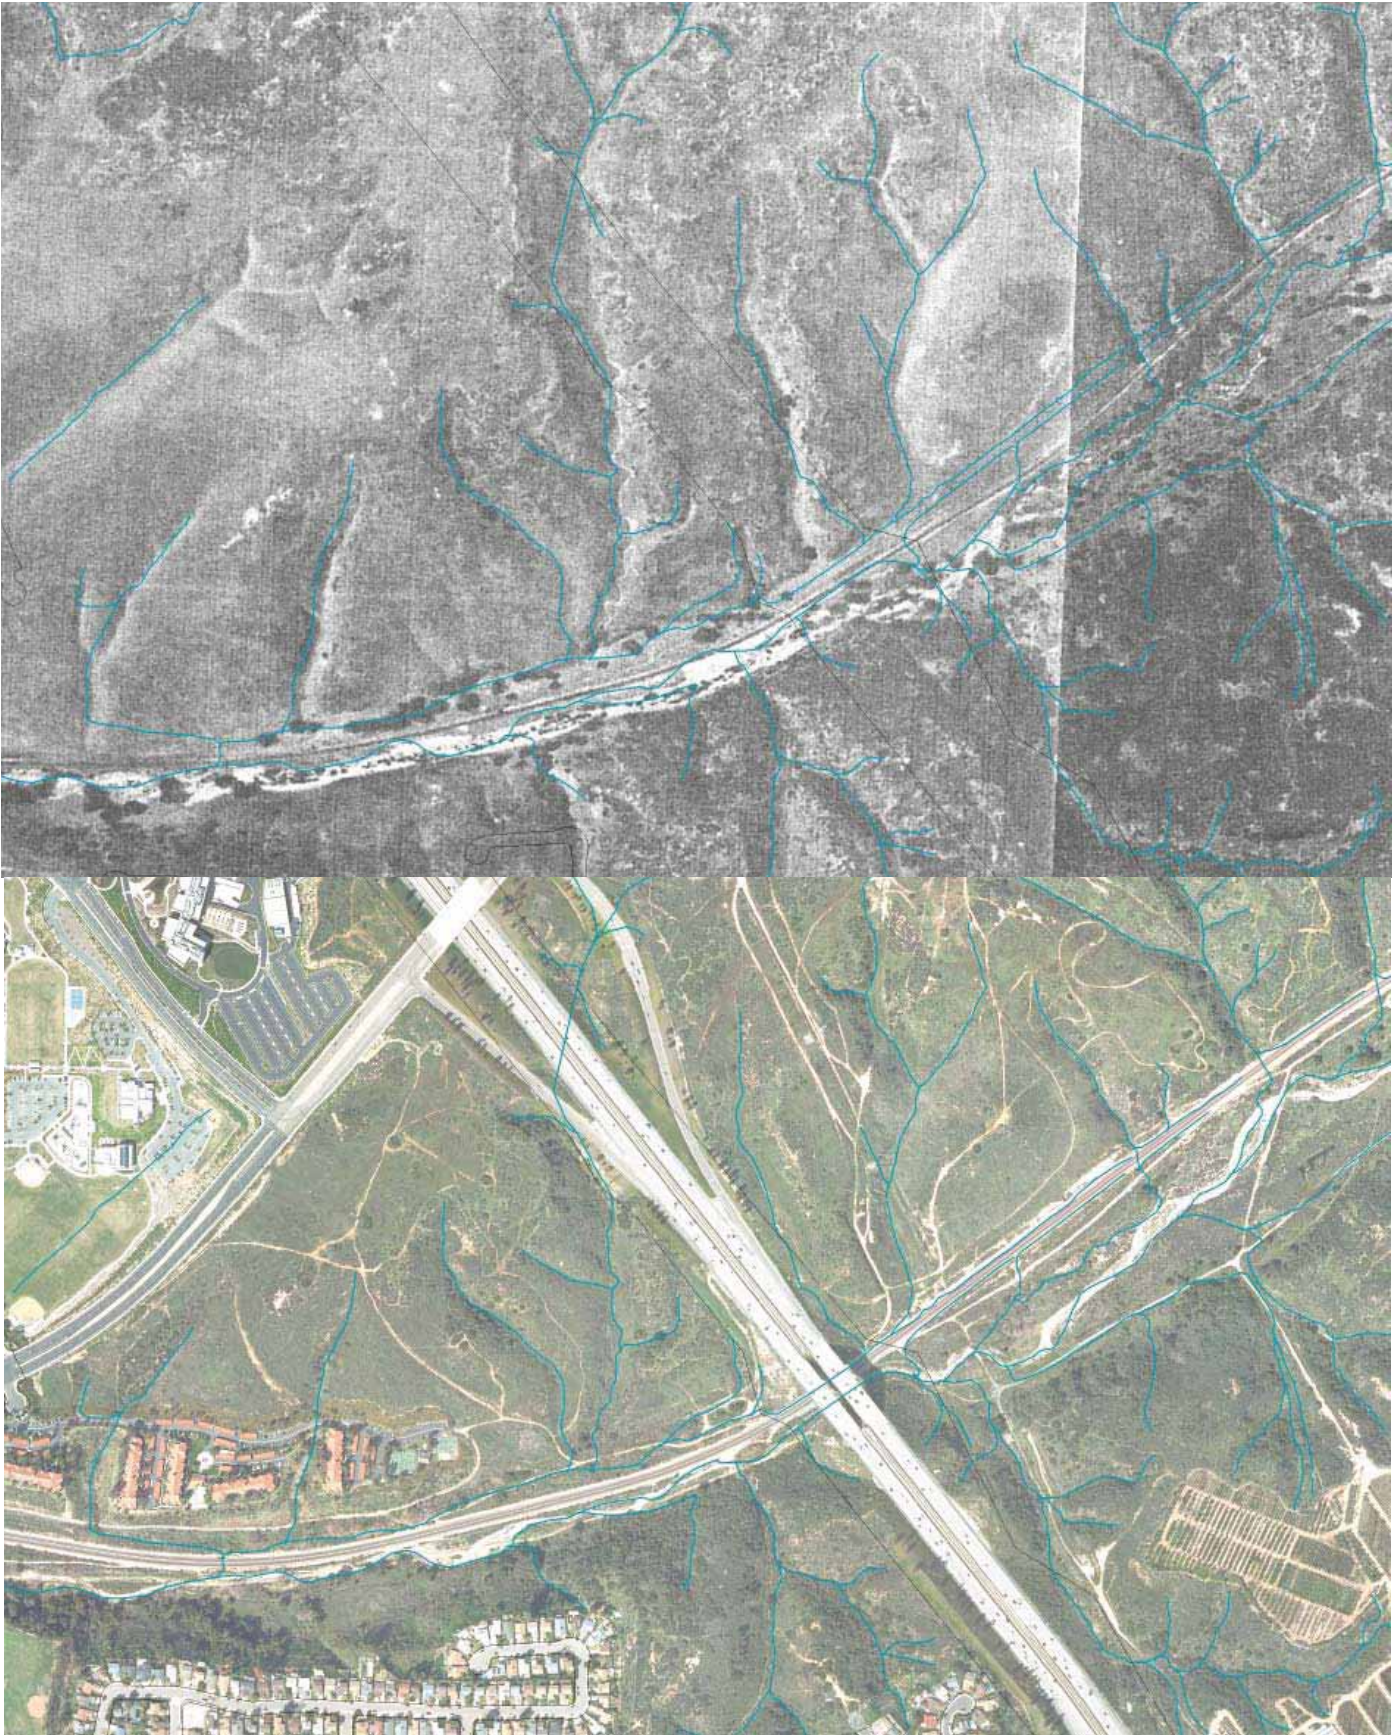
Figure 3 – Rose Canyon Comparison of 1928 and 2009 Aerial Photography

Examining historical aerial photographs dating back to 1928 (Figures 3 and 4), we can find areas with both limited and significant changes in the Rose Creek Watershed. Figure 3 shows a portion of Rose Canyon near Interstate 805 (I-805) where the riparian corridor east of the highway appears today much the way it did in 1928 because most of the contributing watershed is still undeveloped. This reinforces that observed changes within the riparian corridors in the watershed are more directly related to urban

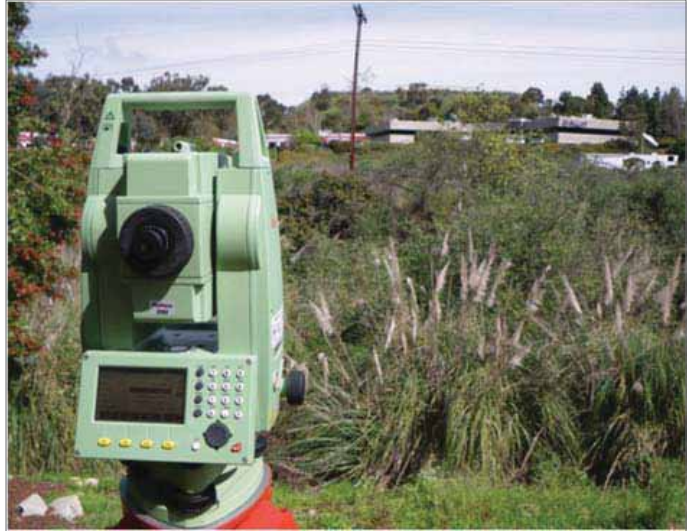
Photo 1: GPS Total Station used to survey cross sections

Cbec conducted a hydraulic field survey as a part of the baseline data collection effort and was used primarily in the development of the hydraulic model. This effort involved the collection of cross sectional topographic data of the low flow channel and the adjacent floodplain as well as other key features such as bridges and culverts, as shown in Figure 5. These data were prepared in California State Plane (CASP) 1983 Zone 6 (feet) and NAVD 88 vertical datum (feet). The relative densities in vegetative cover and channel bedforms that affect the efficiency of flow conveyance (hydraulic roughness) were also observed as a part of this effort.

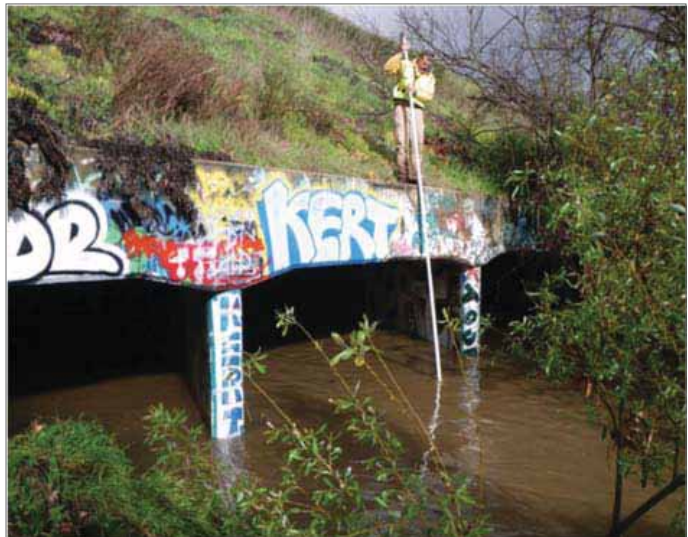
Photo 2: Stadia rod used to survey cross sections

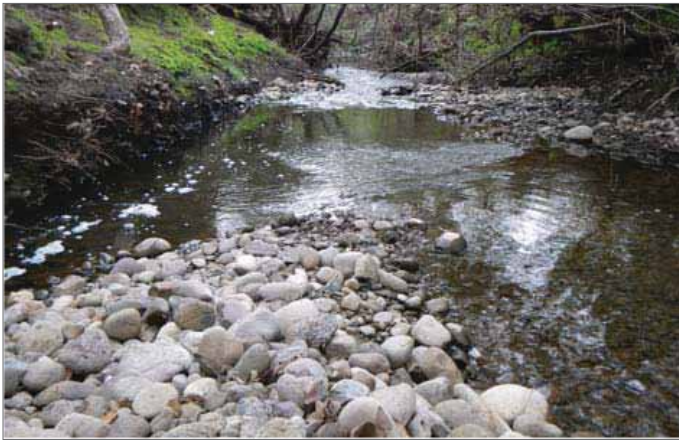
*Photo 3: Samples were collected to characterize the size of the streambed sediments within Rose and San Clemente Creek. These data were used to help determine the mobility of these sediments during specific flow events.*

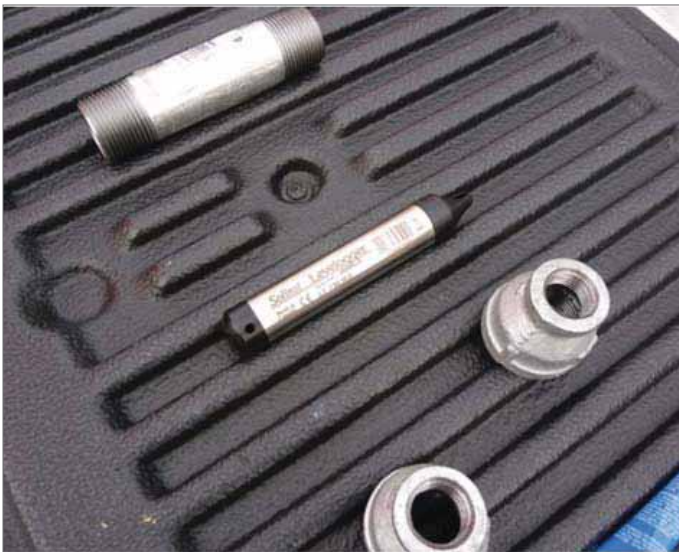
*Photo 4: Water level data logger components and protective housing*

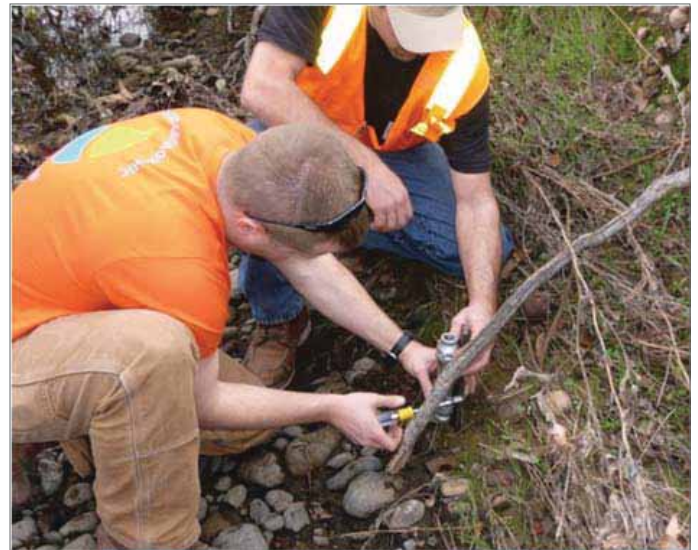
*Photo 5: Field installation of water level data logger*

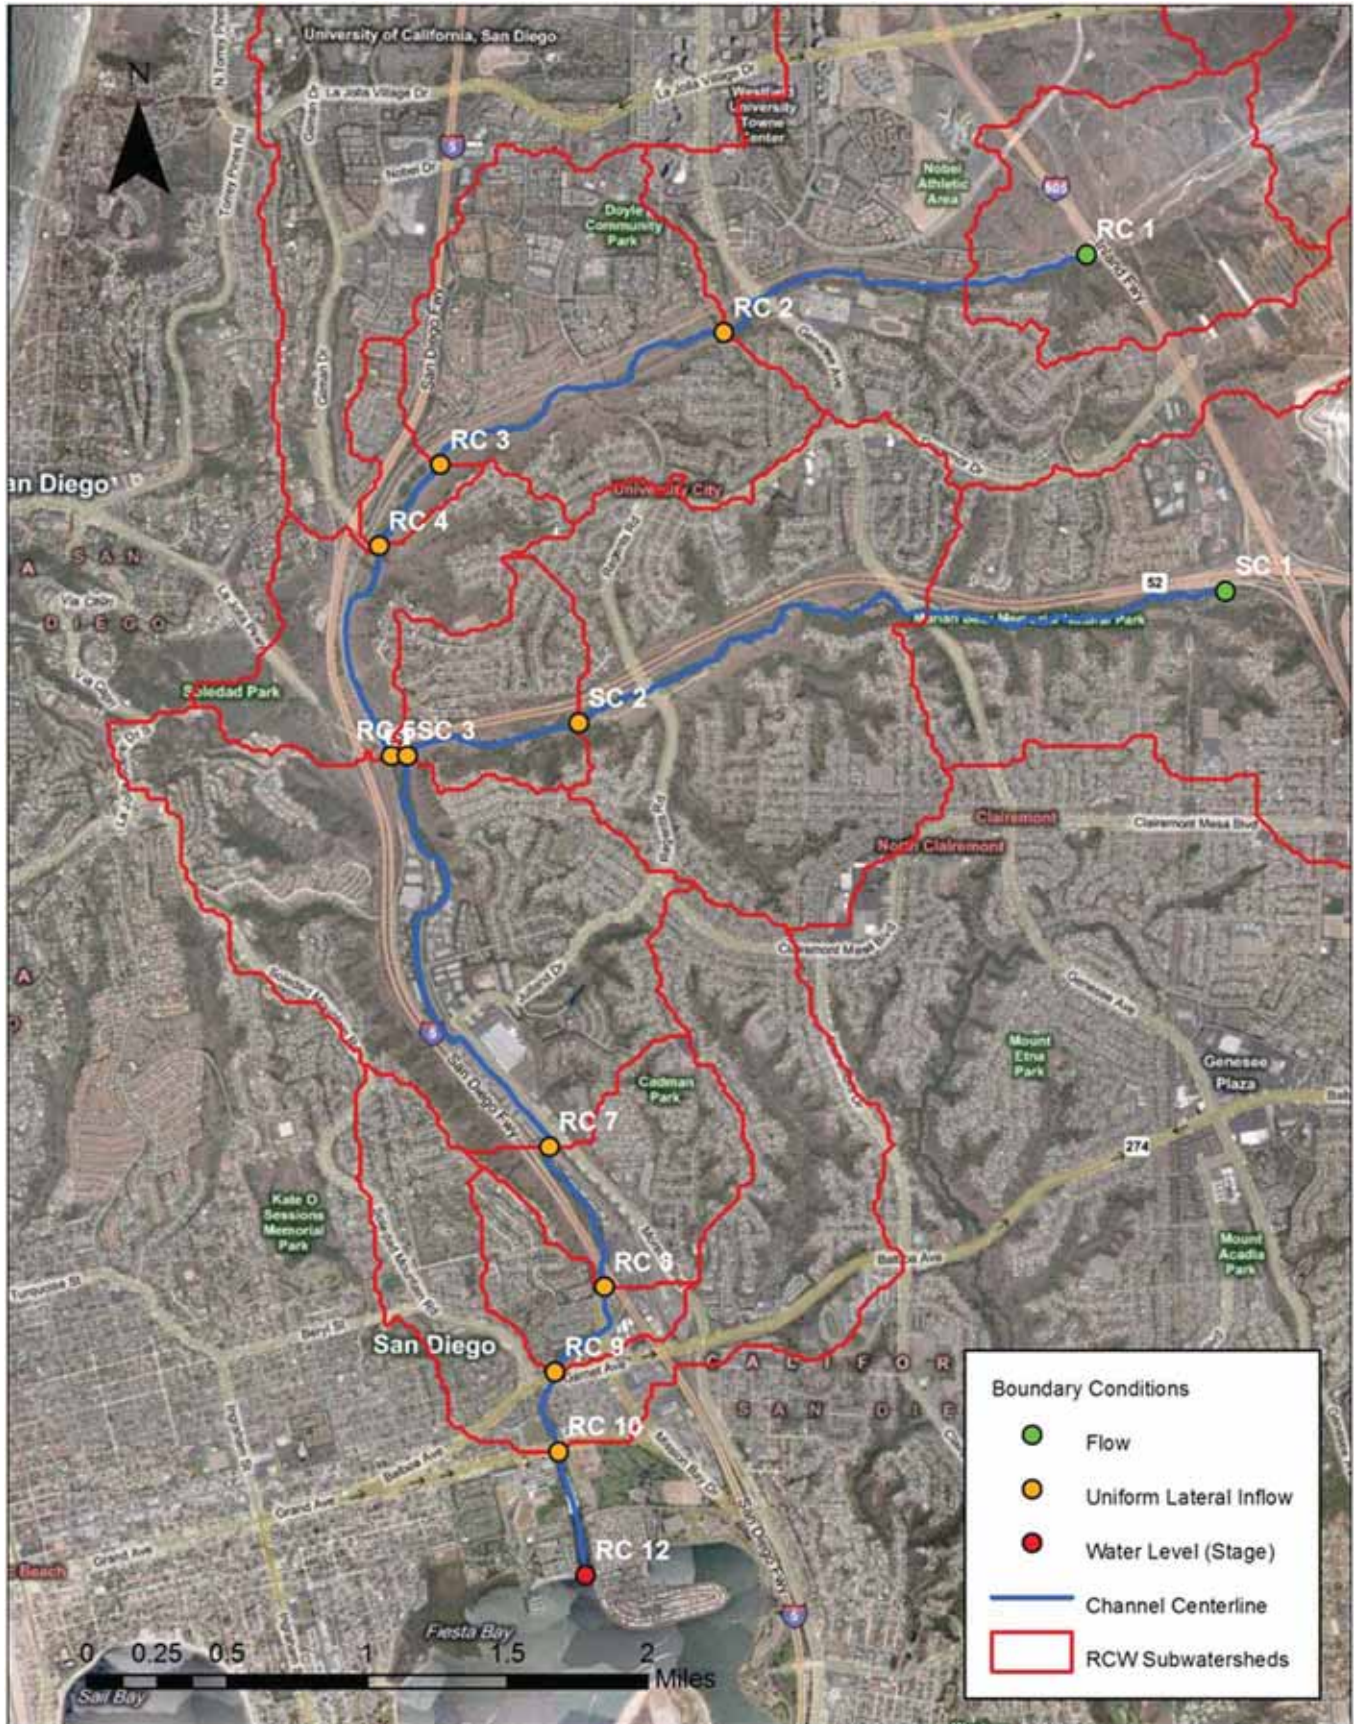
Figure 8 – Model boundary conditions

Notes: Uniform lateral inflow boundaries are distributed along the entire channel length within the subwatershed to allow for gradual flow increase. Aerial image from Bing maps.

The hydraulic model includes a total of 14 boundary conditions for 2- to 25-year return interval events as shown in Figure 8. Of these 14 boundary conditions, 13 were unsteady flow inputs derived from the HSPF hydrologic model. The hydraulic model includes two unsteady flow inputs immediately downstream of I-805. The remaining 11 flow inputs were modeled as lateral inflows along Rose and San Clemente Creeks. The downstream boundary is a water surface elevation that represents an average tide condition (6.0 ft) according to FEMA guidelines. The location of the boundary positions are as shown in Figure 6.

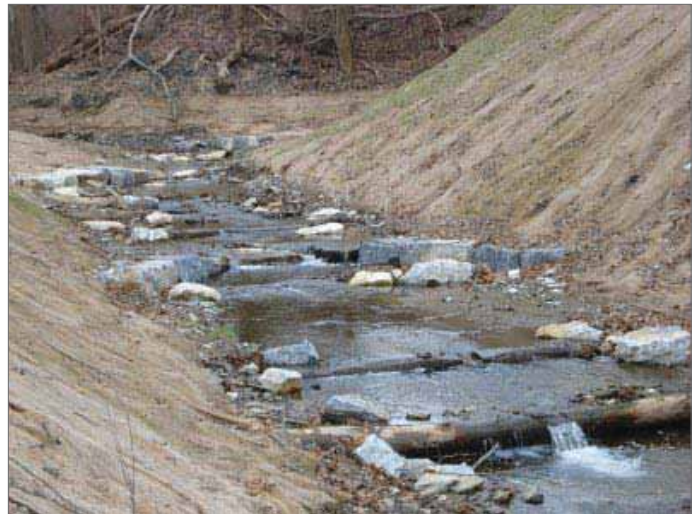
Photo 6: Example of step pools within a creek restoration

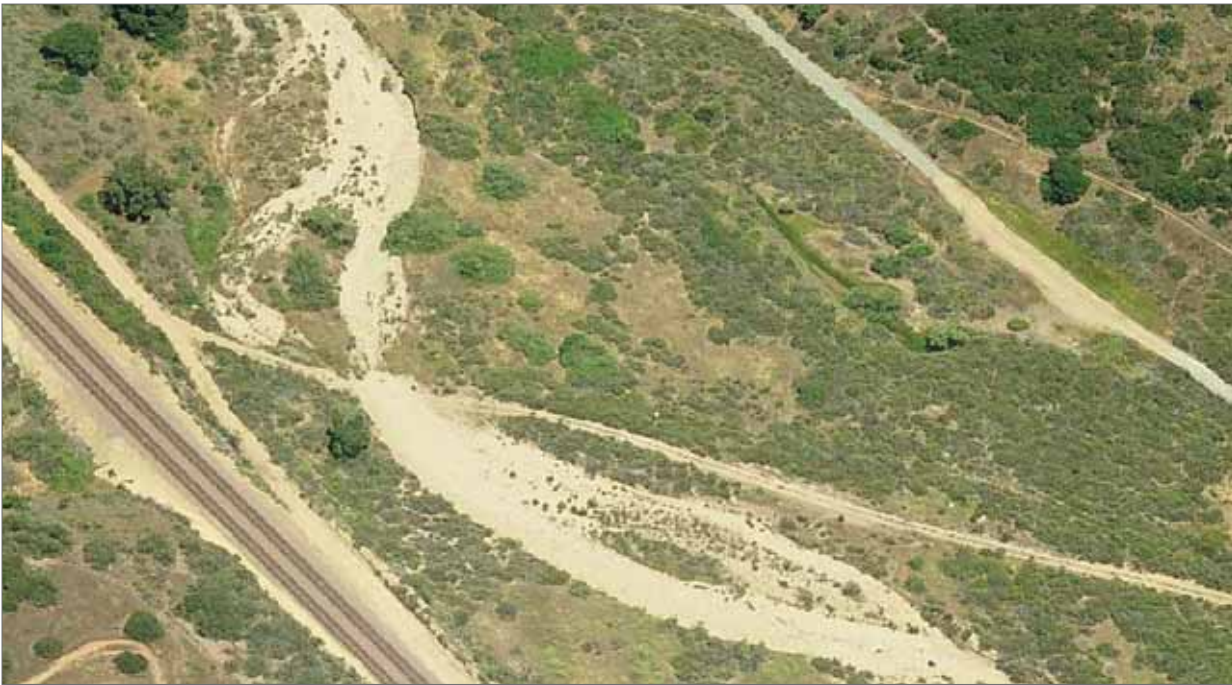
Photo 7: Reference Site east of Interstate 805 in Rose Canyon, Source Bing Maps

A reference site provides important information pertaining to the physical and biological conditions of a relatively undisturbed site. The reference site is used as the template when restoring or creating other like habitats or conditions. To the east of Interstate 805 within the bounds of Miramar Air Base, is a glimpse of what some of Rose Creek may have looked like prior to development. Examination of the 1928 aerial photographs of the watershed show similar conditions to this reference site (Figure X). A video of the site can be viewed at: <http://bit.ly/RReferenceSite>. Most of the substrate is cobble to gravel with very little sands, silts or clay. The active

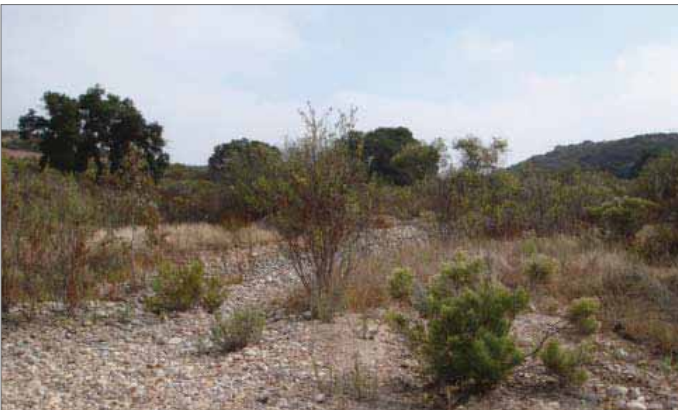
Photo 8: Overbank secondary channel at the Reference Site

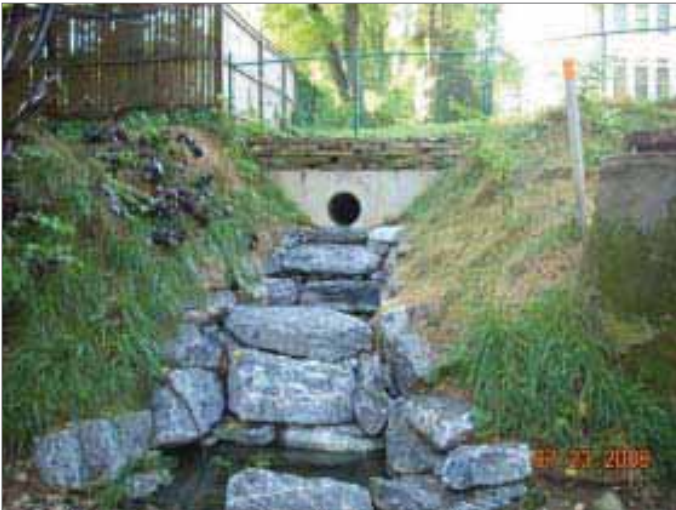
Photo 38: Sample Storm Drain BMP to slow water velocities and reduce erosion

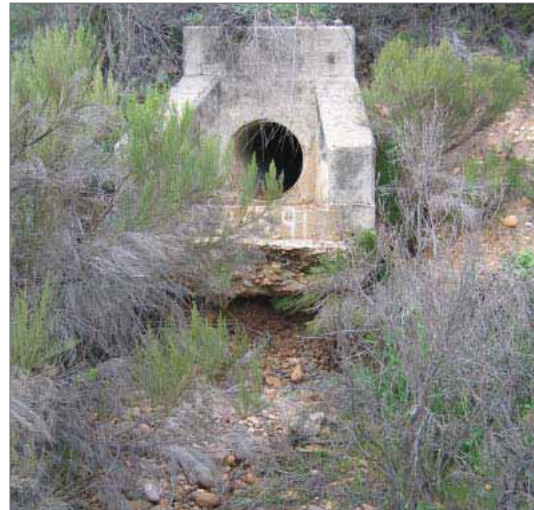
Photo 39: Storm drain outfall showing severe erosion downstream due to high water velocities

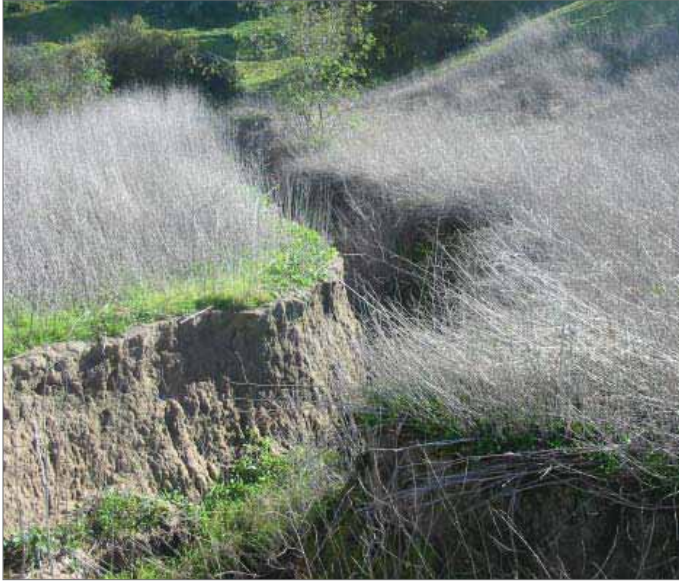
*Photo 40: Large gullies have formed below many storm drain outfalls*

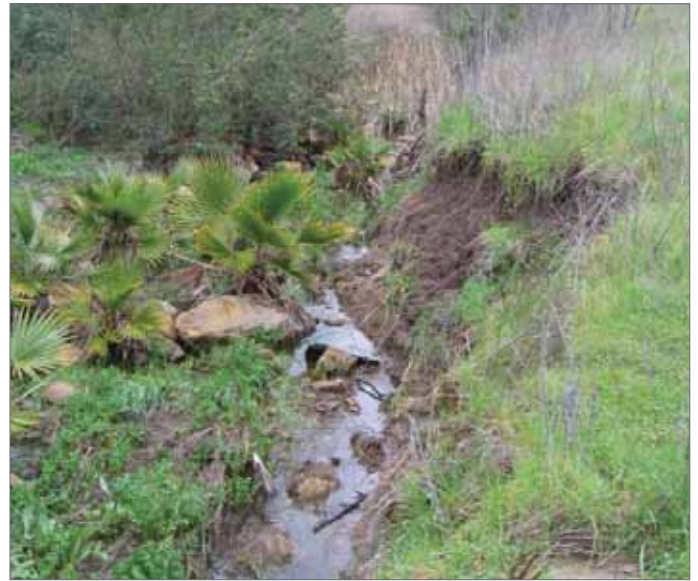
*Photo 41: Streambank erosion is common downstream of storm drain outfalls*

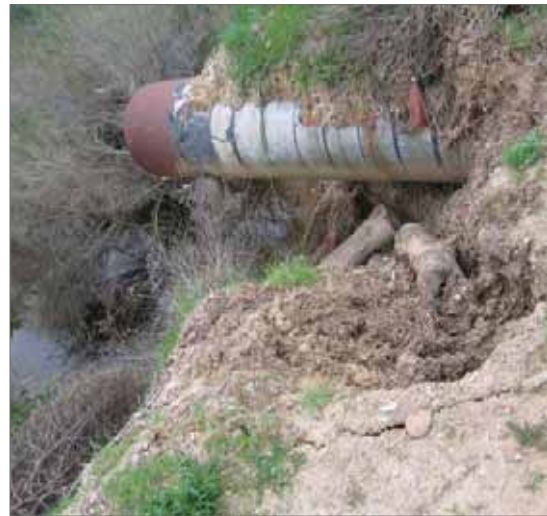
*Photo 43: Improperly installed culverts can create areas of severe erosion*

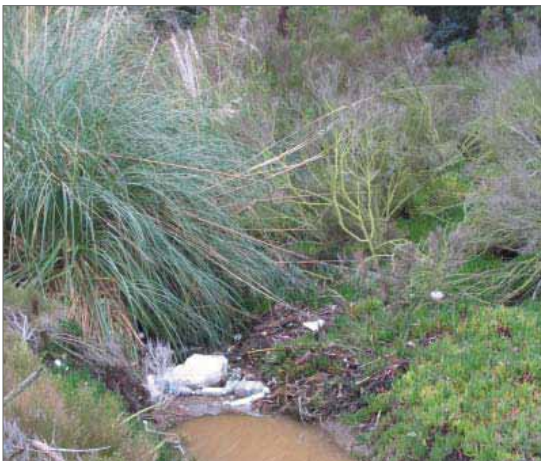
*Photo 44: Trash and invasive non-native species are common below storm drain outfalls*
